<b>AIRCRAFT ACCIDENT REPORT AND EXECUTIVE SUMMARY</b>
---

<b>Reference:</b>		CA18/2/3/10080	
<b>Aircraft Registration</b>	ZS-IGG	<b>Date of Accident</b>	26 November 2021		<b>Time of Accident</b>	1150Z	
<b>Type of Aircraft</b>	Cessna 421B Golden Eagle		<b>Type of Operation</b>		Private (Part 91)		
<b>Pilot-in-command Licence Type</b>	Commercial Pilot Licence		<b>Age</b>	37	<b>Licence Valid</b>	Yes	
<b>Pilot-in-command Flying Experience</b>	<b>Total Flying Hours</b>		394.8		<b>Hours on Type</b>	20	
<b>Last Point of Departure</b>	Hoedspruit Eastgate Aerodrome (FAHS) in Limpopo Province						
<b>Next Point of Intended Landing</b>	Rand Aerodrome (FAGM), Gauteng Province						
<b>Damage to Aircraft</b>	Substantial						
<b>Location of the accident site with reference to easily defined geographical points (GPS readings if possible)</b>							
On an open field, north of FAMB at Global Positioning System (GPS) co-ordinates determined to be S25° 41 08'.40" E029° 26 25'.90" at an elevation of approximately 4 886ft

<b>Probable Cause</b>							
Double-engine failure during approach for an emergency landing following the rough-running engines which were most likely induced by ice obstructing t

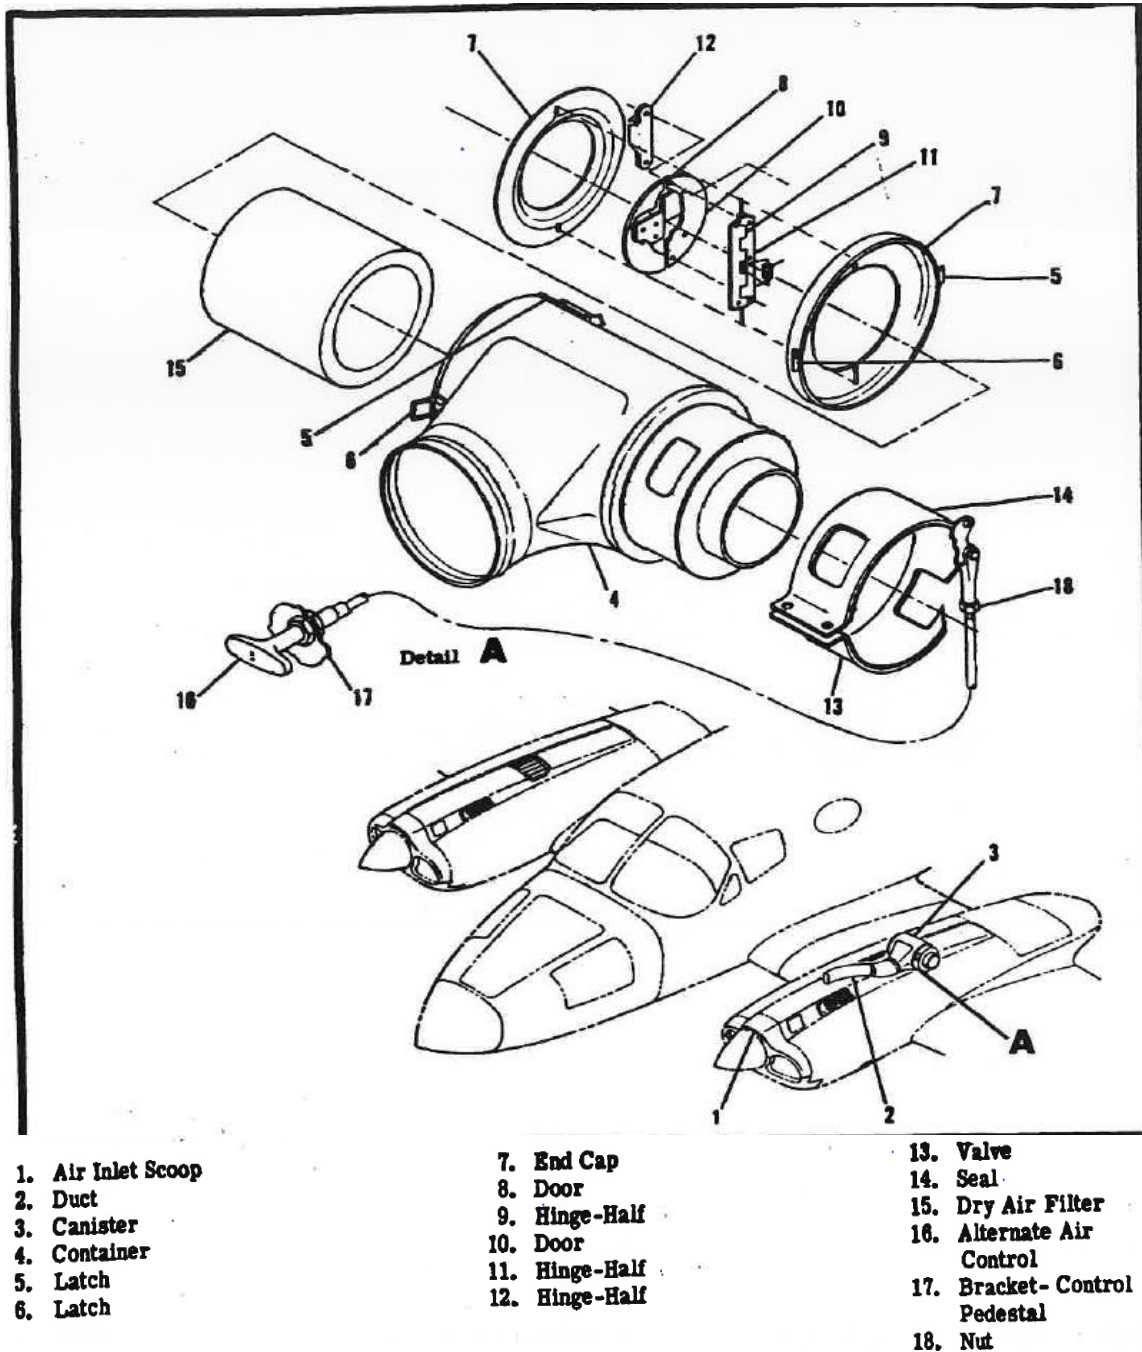
**Diagram 2:** Turbocharger induction air components. (Source: Engine Service Manual)

*Induction air enters the system through a ram air duct located on the inboard duct of each nacelle and is directed through a filter mounted to the turbocharger compressor air inlet. A magnetically controlled alternate air door incorporated in the airfilter permits compressor suction to open the door and admits alternate air if the air induction system becomes obstructed. A manually controlled alternate air door within the nacelle permits the pilot to open it to admit alternate (heated engine compartment air) if the air induction system should become obstructed. An exhaust driven turbocharger is automatically controlled by controllers to maintain a manifold pressure at 39.5 inches Hg, from sea level to acritical altitude (16.000ft) regardless of temperature. The turbocharger is completely automatic requiring no pilot action to critical altitudes.*
