LIMITED ACCIDENT INVESTIGATION REPORT

Reference Number	CA18/2/3/10083						
Classification	Accident	Date	19 November 2021	Time	0802Z		
Type of Operation	Remotely Piloted Aircraft (Part 101)						
Location							
Place of Departure	Andrew's Field (FAAF), Western Cape province		Place of Intended Landing	Andrew's Field (FAAF), Western Cape province			
Place of Accident	Runway 11 FAAF						
GPS Co-ordinates	Latitude	S 34° 45' 47"	Longitude	E 20° 2' 13"	Elevation	35 ft	
Aircraft Information							
Registration	ZT-UOI						
Model/Make	Astus II Tellumet (Serial Number: 301)						
Damage to Aircraft	Substantial		Total Aircraft Hours	1876.2			
Pilot-in-command							
Licence Valid	Yes	Gender	Male	Age	28		
Licence Type	Remote Pilot Licence (RPL)						
Total Hours on Type	41.6		Total Flying Hours	41.6			
Pilots Controlling	2 + 0	Injuries	0	Fatalities	0	Other (On Ground)	0
What Happened							
<p>On 19 November 2021, two pilots (internal and safety) operating an Astus II unmanned aerial vehicle (UAV) with registration ZT-UOI took off on a test flight for automatic take-offs and landings (ATOLs) at Andrew's Field (FAAF) in the Western Cape province. A flight plan was not filed. The flight was

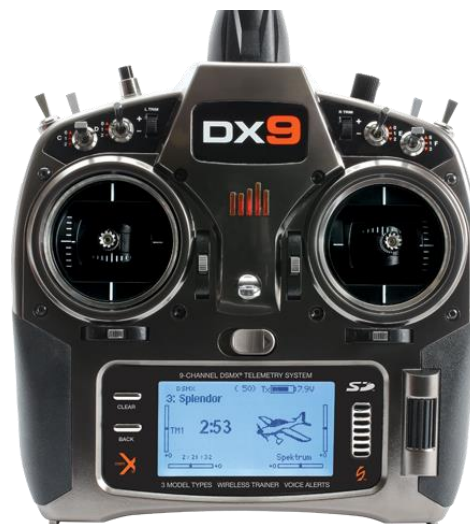
- The safety pilot was positioned next to the runway, utilising a Spektrum remote controller transmitter, whilst the internal pilot was stationed inside the container with the main controller. The pilots used an intercom system to communicate with each other and only one pilot had control of the system at a time.

Figure 3: Remote controller utilised by the safety pilot. (Source: spektrumrc.com)

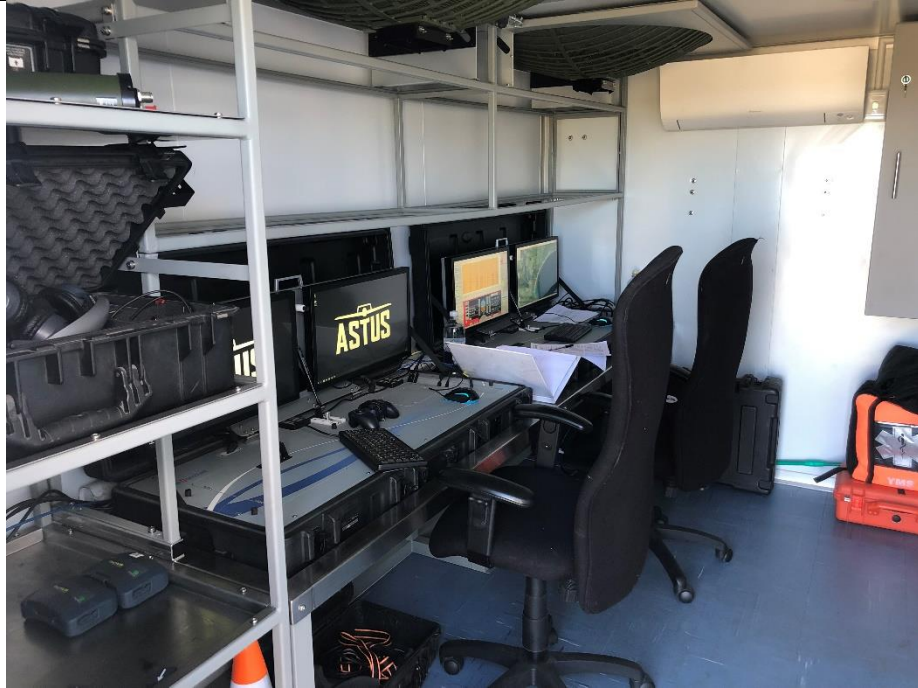
Figure 4: Main controller utilised by the internal pilot. (Source: Pilot)
