<b>LIMITED ACCIDENT INVESTIGATION REPORT</b>
--

<b>Reference Number</b>		CA18/2/3/10092					
<b>Classification</b>	Accident	<b>Date</b>	12 November 2021		<b>Time</b>	1115Z	
<b>Type of Operation</b>		Private (Part 91)					
<b>Location</b>							
Place of Departure		Kiesmet, Theunissen Farm, Free State Province		Place of Intended Landing		Mooipan Farm, Free State Province.	
Place of Accident		Private Airstrip near Mooipan Farm, Free State Province					
GPS Co-ordinates		Latitude	28°17'07.5"S	Longitude	26°37'56.0"E	Elevation	1398 feet
<b>Aircraft Information</b>							
Registration		ZS-MDO					
Model/Make		Piper 25-235 (Serial Number: 25-7556025)					
Damage to Aircraft		Substantial		Total Aircraft Hours		4 146.3	
<b>Pilot-in-command</b>							
Licence Type		Commercial Pilot Licence (CPL)		Gender		Male Age: 38	
Licence Valid		Yes					
Total Hours on Type		577.70		Total Flying Hours		1571.70	
People On-board		1 + 0	Injuries	0	Fatalities	0	Other (on ground) 0

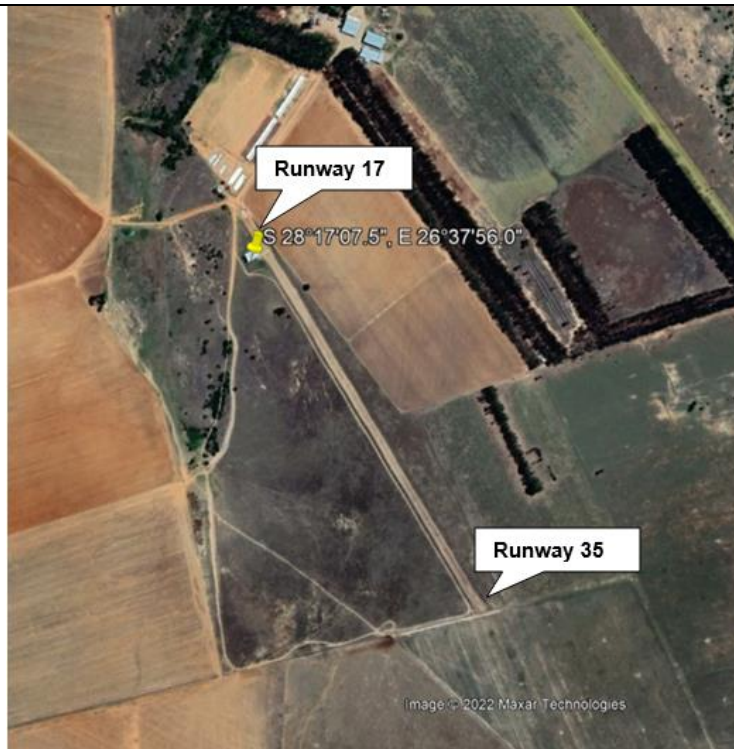
<b>What Happened</b>							
<p>On 12 November 2021 at about 1059Z, a pilot on-board a PA-25-235 aircraft with registration ZS-MDO took off on a repositioning flight from Kiesmet farm airstrip in Theunissen in the Free State province, to land at Mooipan farm airstrip, in the same province. The flight was conducted under visual flight rules (VFR) by day and under the provisions of Part 91 of the Civil Aviation Regulations (CAR) 2011 as amended.</p> <p>The pilot reported that after he had landed the aircraft on Runway (RWY) 35 at Mooipan farm airstrip, he turned the aircraft around and taxied at a very slow speed of approximately 5 – 10 knots to the hangar. Approximately 75 metres from reaching the hangar, a gusty wind pushed the tail of the aircraft causing it to veer sharply to the left of the RWY. The pilot reported that he attempted to correct the aircraft by pressing on the brakes, but the wind was too strong; it caused the pilot to lose control of the aircraft and the right wing to collide with the fence which was approximately 2 metres from the RWY edge.</p>

**Figure 1:** Mooipan Farm airstrip. (Source: Google Earth)
