<b>LIMITED ACCIDENT INVESTIGATION REPORT</b>
--

<b>Reference Number</b>		CA18/2/3/10093					
<b>Classification</b>	Accident	<b>Date</b>	19 December 2021	<b>Time</b>	0939Z		
<b>Type of Operation</b>	Private (Part 94)						
<b>Location</b>							
Place of Departure	Plettenberg Bay Aerodrome (FAPG), Western Cape Province		Place of Intended Landing	FAPG), Western Cape Province			
Place of Occurrence	Erica PI Drive, Plettenberg Bay Residential Area, Western Cape Province						
GPS Co-ordinates	Latitude	34°02'.55. 4" S	Longitude	023°21'.57.8" E	Elevation	475 feet	
<b>Aircraft Information</b>							
Registration	ZU-FYG						
Make/Model	Van's RV-7 (Serial No. 70120)						
Damage to Aircraft	Substantial		Total Aircraft Hours	283.04			
<b>Pilot-in-command</b>							
Licence Valid	No	Gender	Male	Age	49		
Licence Type	Invalid Commercial Pilot Licence (CPL)						
Total Hours on Type	71		Total Flying Hours	992			
People On-board	1 + 1	Injuries	1	Fatalities	0	Other (On Ground)	0

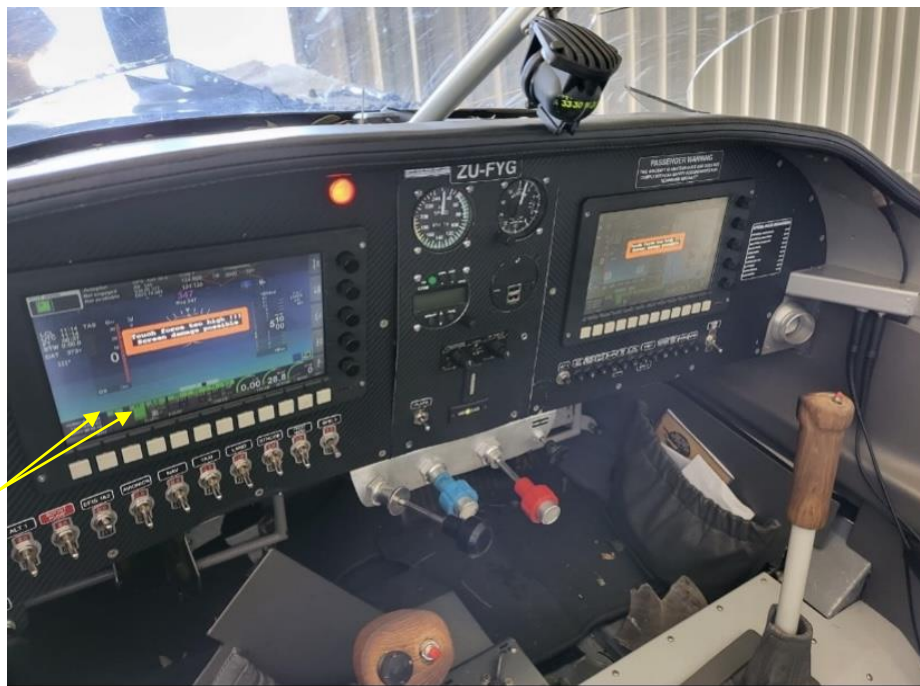
Fuel level indications displayed on the screen (Green)

**Figure 4:** The cockpit showing the EFIS glass panels and fuel level display.

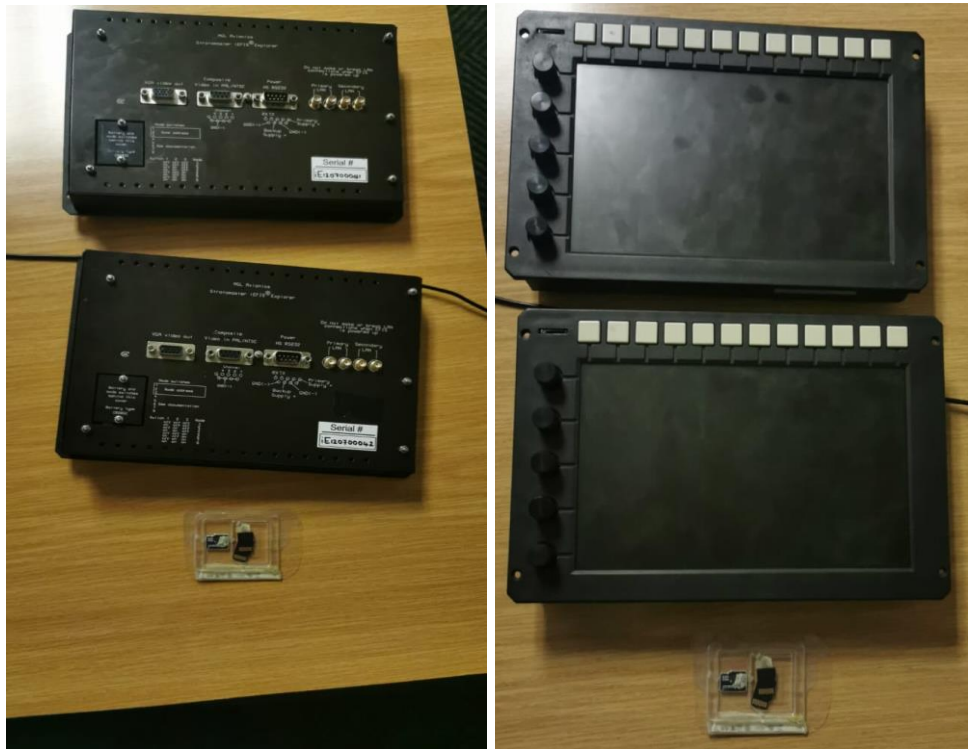
On 15 February 2022, after consultation with his attorney, the pilot brought the EFIS glass panels and three "loose" SD cards to the Accident and Incident Investigations Division (AIID) offices for downloading with the intention to obtain the total amount of fuel in the tanks prior to the commencement of the accident flight on 19 December 2021. Upon receiving the glass panels, they were checked and the serial numbers on the tags matched with the numbers on the aircraft equipment maintenance list (EML). Upon examining their condition, signs were observed which suggested that they have been opened before they were brought to the AIID.

**Figures 9 and 10:** The EFIS glass panels with SD cards.

The first technical report from MGL Avionics' Chief Executive Officer (CEO) confirmed what the AIID had observed; the glass panels seemed to have been opened prior to being delivered. According to the report, it was impossible for the CEO to identify which SD card belongs to which EFIS glass panel. *The glass panels were, according to the report, not configured for automatic flight detection and that normal recording did not take place. The report further stated that the aircraft was operated for a long period without any form of fuel quantity indication.*

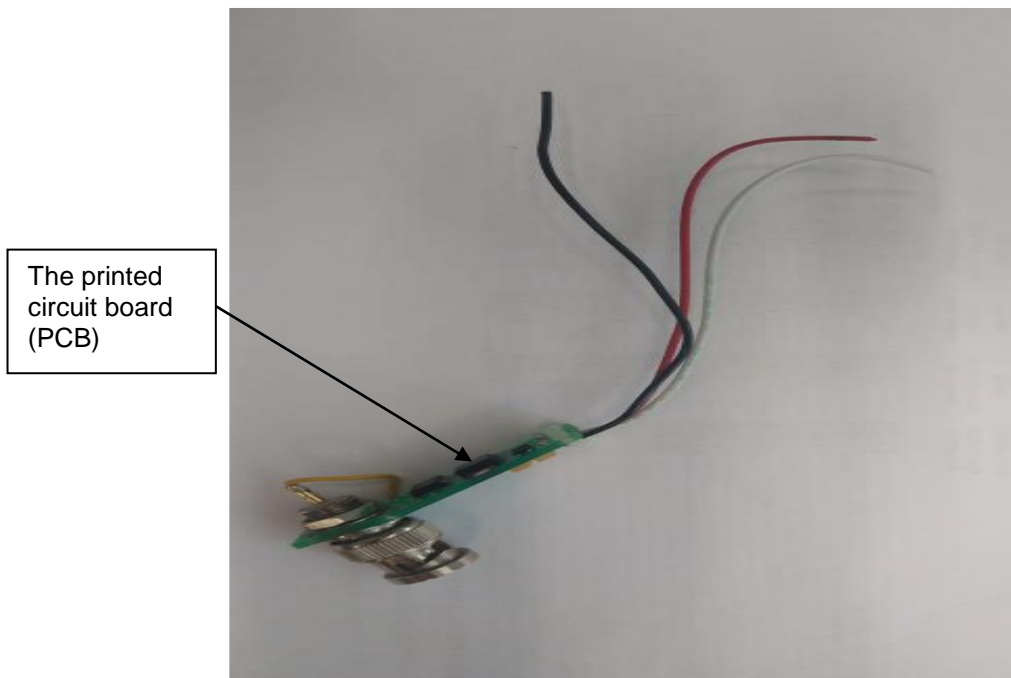
**Figure 12:** Right-side tank fuel level converter.

The printed circuit board (PCB) for the right-side tank fuel level converter was severely damaged, most probably from impact during the accident sequence and had broken in half at the connector point. The converter would have given a “zero” reading as it disconnected from one of the probe plates.
