**LIMITED ACCIDENT INVESTIGATION REPORT**

<b>Reference Number</b>	CA18/2/3/10098					
<b>Classification</b>	Accident	<b>Date</b>	4 January 2022	<b>Time</b>	2305Z	
<b>Type of Operation</b>	Remotely Piloted Aircraft (Part 101)					
<b>Location</b>						
Place of Operation	2.2 nm from TFR station around Pullens Hope, near Hendrina Power Station in Mpumalanga Province					
GPS Co-ordinates	Latitude	S26°1'39.80"	Longitude	E028°36'10.77"	Elevation	5390 ft
<b>Aircraft Information</b>						
Registration	ZT-XEJ					
Model/Make	DJI Mavic Advanced (Serial number: Mav0036)					
Damage to Aircraft	Destroyed		Total Aircraft Hours	117		
<b>Pilot-in-command</b>						
Licence Type	Remote Pilot Licence	Gender	Male	Age	22	
Licence Valid	Yes					
Total Hours on Type	128.4		Total Flying Hours	128.4		
<b>What Happened</b>						
<p>On 4 January 2022, a pilot was conducting security surveillance work using a DJI Mavic Advanced drone with registration mark ZT-XEJ. The pilot was operating the drone 2.2 nautical miles (nm) from station, which is around Pullens Hope near Hendrina Power Station in Mpumalanga Province. The operation was conducted under visual flight rules (VFR) and under the provisions of Part

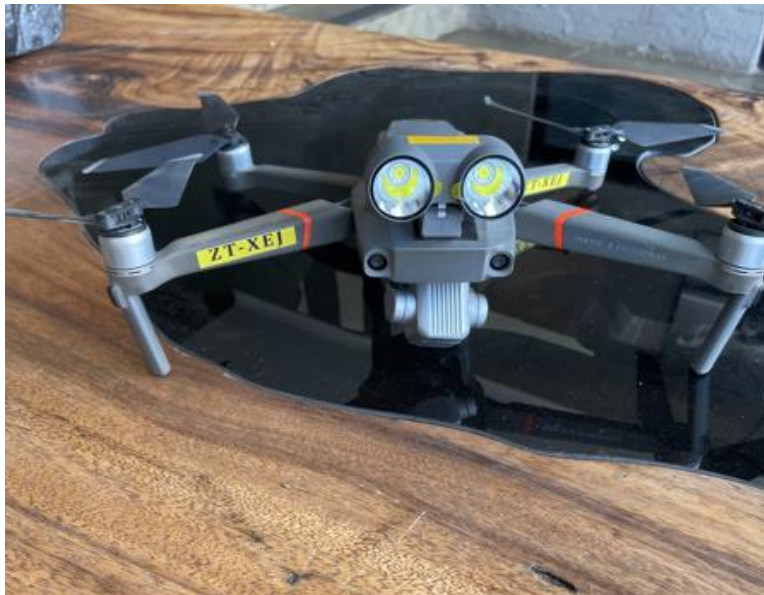
The drone is programmed to return to launch (RTL) point using the most direct route; the drone responded as programmed. However, because of the position at which the drone was launched, it routed directly overhead the power station; it is suspected to have collided with an Eskom water tower.

**Figure 1:** Photo of the drone. (Source: Operator)
