**LIMITED ACCIDENT INVESTIGATION REPORT**

<b>Reference Number</b>	CA18/2/3/10104						
<b>Classification</b>	Accident	<b>Date</b>	16 January 2022	<b>Time</b>	2003Z		
<b>Type of Operation</b>	Remotely Piloted Aircraft (Part 101)						
<b>Location</b>							
Place of Departure	Glencore Goedgevonden Near Ogies, Mpumalanga Province			Place of Intended Landing	Glencore Goedgevonden Near Ogies, Mpumalanga Province		
Place of Accident	Goedgevonden Mine near Ogies						
GPS Co-ordinates	Latitude	S 26°03'31.4"	Longitude	E029°03'26.9"	Elevation	5 200 feet	
<b>Aircraft Information</b>							
Registration	ZT-WUL						
Model/Make	DJI Matrice-200 (Serial Number: M200-27)						
Damage to Aircraft	Destroyed			Total Aircraft Hours	211.4		
<b>Pilot-in-command</b>							
Licence Type	Remote Pilot Licence (RPL)	Gender	Male		Age: 24		
Licence Valid	Yes						
Total Hours on Type	136.05			Total Flying Hours	1 455.32		
People On-board	N/A	Injuries	0	Fatalities	0	Other (on ground)	0

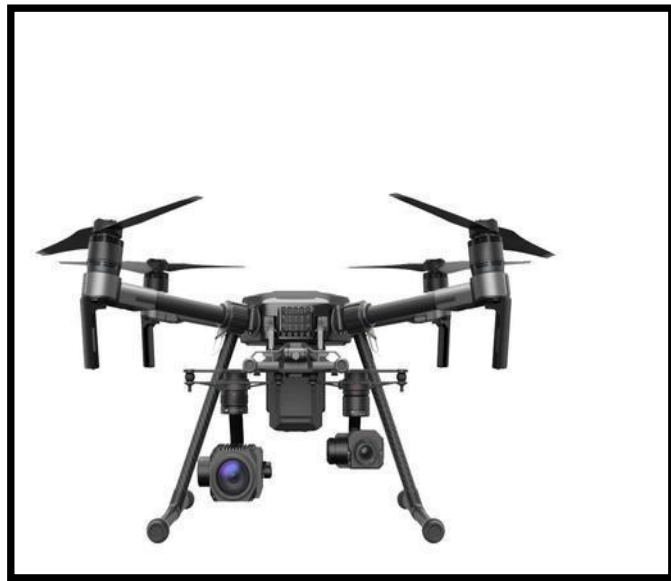
the tracking unit; however, the aircraft was not found at the crash site. The aircraft had 60% battery power remaining at the time of accident.

**Figure 1:** Retrieved parts of the RPA. *Note that the core of the remotely piloted aircraft was missing, presumably stolen.* (Source: Operator). **Figure 2:** A Matrice M200 picture taken from the DJI website.
