LIMITED INVESTIGATION ACCIDENT REPORT

Reference Number	CA18/2/3/10115						
Classification	Accident	Date	10 February 2022	Time	1130Z		
Type of Operation	Private (Part 94)						
Location							
Place of Departure	Light Flight Aerodrome Cato Ridge, KwaZulu-Natal Province			Place of Intended Landing	Light Flight Aerodrome Cato Ridge, KwaZulu-Natal Province		
Place of Accident	Open grass area at Light Flight Aerodrome						
GPS Co-ordinates	Latitude	29°45'58.48" S	Longitude	030°35'14.35" E	Elevation	2 497 ft	
Aircraft Information							
Registration	ZU-LIZ						
Make / Model	Rotorway Executive 162F (Serial No. 7039)						
Damage to Aircraft	Substantial			Total Aircraft Hours	644.0		
Pilot-in-command							
Licence Valid	Yes			Gender	Male		Age: 71
Licence Type	Private Pilot Licence (PPL)						
Total Hours on Type	683.0			Total Flying Hours	2 631.0		
People On-board	1 + 0	Injuries	0	Fatalities	0	Other (On Ground)	0
What Happened							
<p>On Thursday, 10 February 2022, the pilot who was also the owner of the helicopter, a Rotorway Executive 162F registered ZU-LIZ stated that he had just performed some maintenance on the helicopter when he found some play on the swashplate/slider ball as

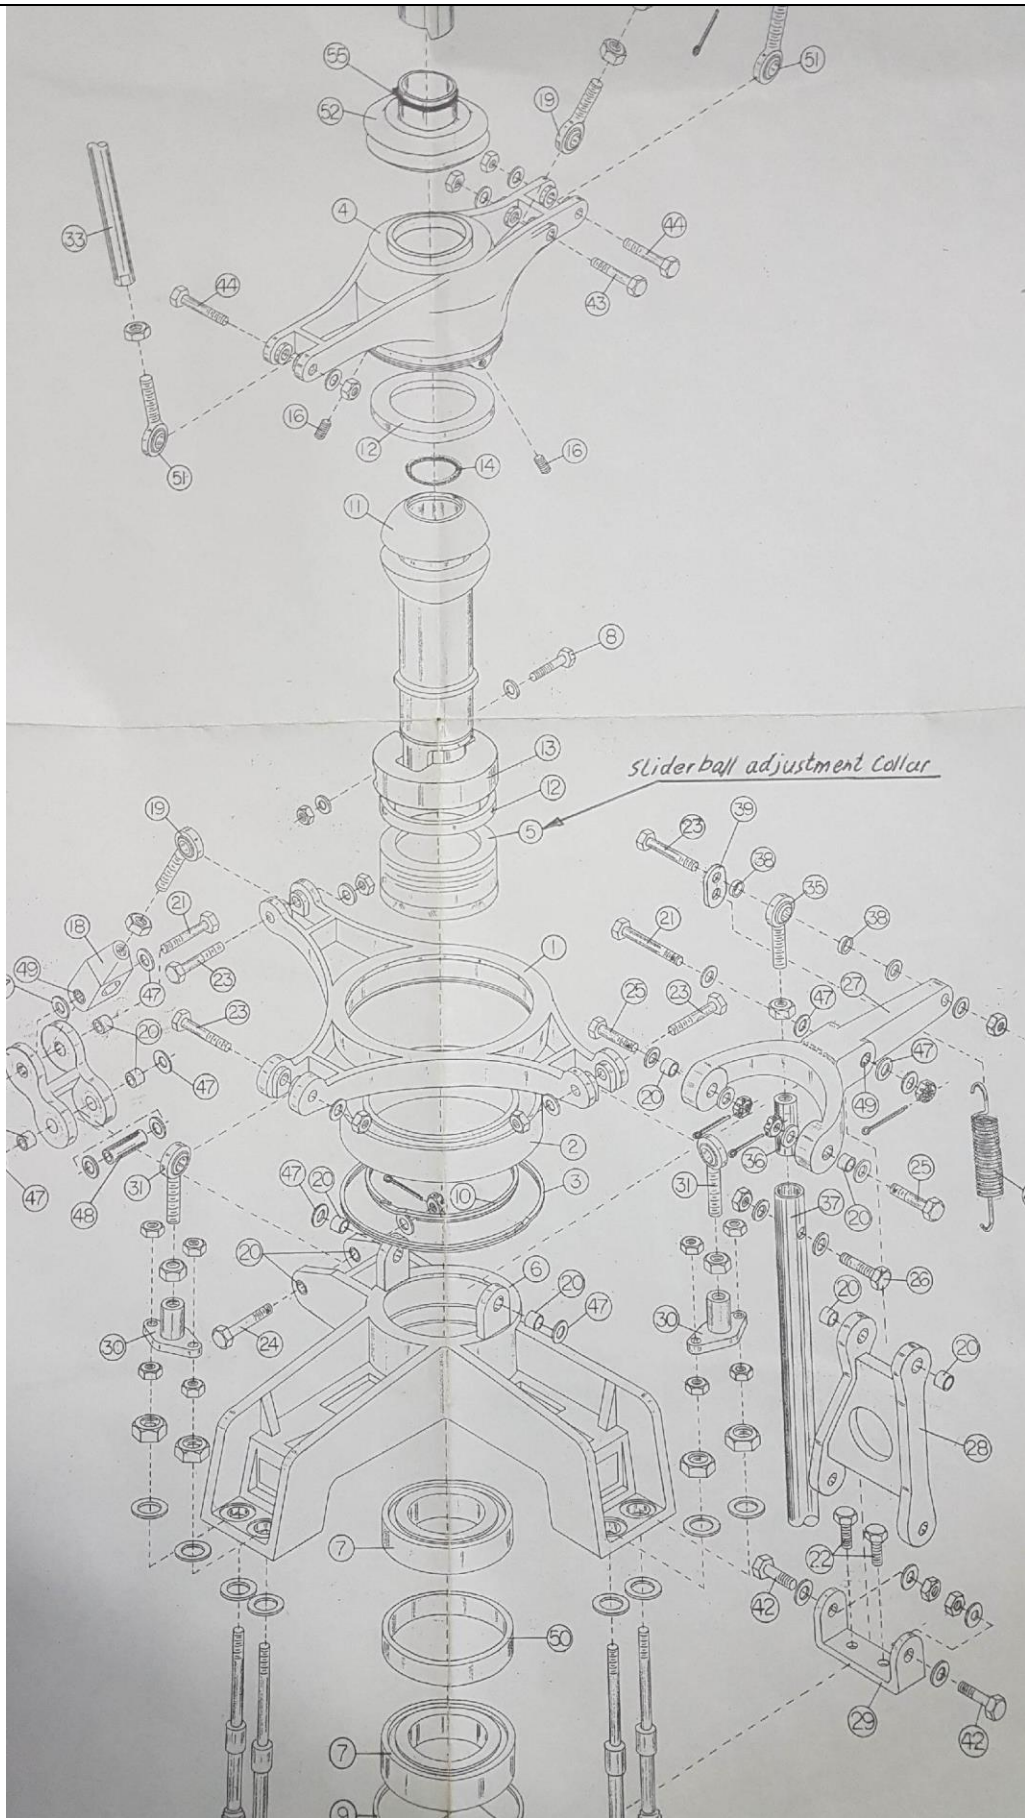
Schematic of the main rotor drive assembly.

"I have dismantled the whole assembly and examined everything. The collar has a fine thread with about 1mm pitch per turn. Before the accident I found about 0.2 mm play. By turning the collar 35° the play would have been reduced to 0.1mm. I made sure there was some play left and the slider ball did move freely. That seemed to be correct before everything got heated up. Apparently, it was too tight to run under heat and prolonged hovering."

If incorrectly adjusted, the slider ball adjustment collar will produce a feedback through the cyclic controls that feels like the cyclic wants to travel in any one direction independent of any input from the pilot. The amount of feedback felt by the pilot indicates how much the collar is incorrectly adjusted. (Feedback usually means the collar is too tight rather than too loose). If feedback through the cyclic continues, you may back off the adjustment collar another 1/4", for a total 3/4" maximum from the starting index mark. If an undesirable condition still exists, contact the factory.
