LIMITED ACCIDENT INVESTIGATION REPORT
--

Reference Number		CA18/2/3/10118								
Classification		Accident		Date		11 February 2022	Time		0825Z	
Type of Operation		Training (Part 141)								
Location										
Place of Departure		Wonderboom Aerodrome (FAWB), Gauteng Province			Place of Intended Landing		Wonderboom Aerodrome (FAWB), Gauteng Province			
Place of Occurrence		Runway 11, Wonderboom Aerodrome (FAWB), Gauteng Province								
GPS Co-ordinates		Latitude		25° 39' 13.19" S		Longitude		028° 13' 34.31" E	Elevation	4 085ft
Aircraft Information										
Registration		ZS-SLY								
Model/Make		Cessna 172M (Serial Number: 172-67263)								
Damage to Aircraft		Substantial			Total Aircraft Hours		9 669.1			
Pilot-in-command										
Licence Valid		Yes			Gender		Male	Age	25	
Licence Type		Student Pilot Licence (SPL) Aeroplane								
Total Hours on Type		30.5			Total Flying Hours		30.5			
People On-board		1 + 0	Injuries		0	Fatalities		0	Other (on ground)	0

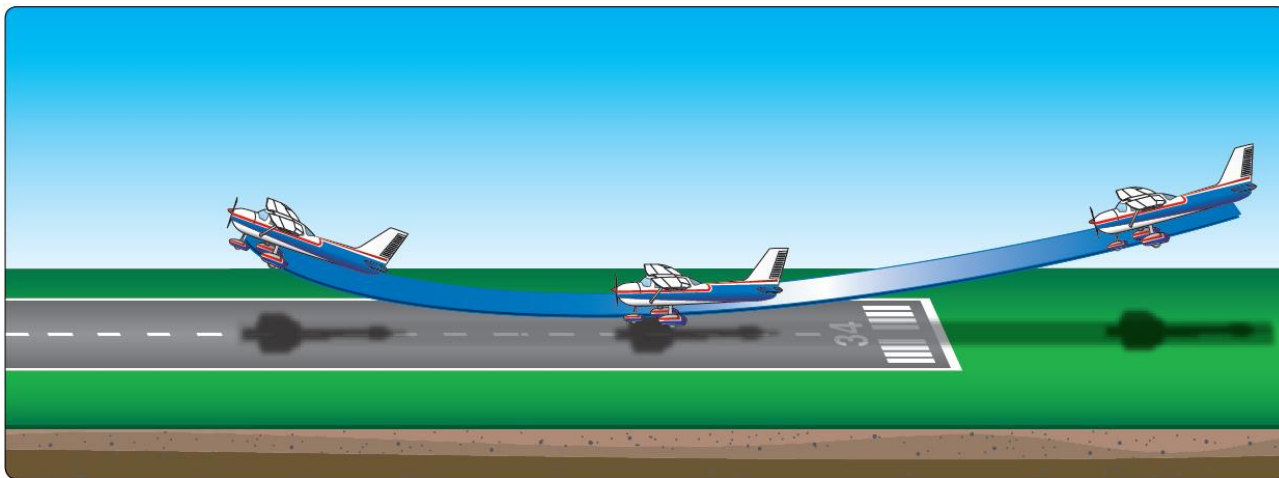
Figure 8-35. *Ballooning during roundout.*

This not only stops the descent but starts the airplane climbing. This climbing during the round out is known as ballooning. [Figure 8-35] Ballooning is dangerous because the height above the ground is increasing, and the airplane is rapidly approaching a stalled condition. The altitude gained in each instance depends on the airspeed or the speed with which the pitch attitude is increased.

When ballooning is excessive, it is best to execute a go-around immediately; do not attempt to salvage the landing. Power must be applied before the airplane enters a stalled condition.
