LIMITED ACCIDENT INVESTIGATION REPORT
--

Reference Number	CA18/2/3/10129						
Classification	Accident	Date	25 February 2022	Time	0735Z		
Type of Operation	Training (Part 141)						
Location							
Place of Departure	Lanseria International Aerodrome (FALA), Gauteng Province		Place of Intended Landing	Lanseria International Aerodrome (FALA), Gauteng Province			
Place of Accident	Open field, approximately 1.1 nautical miles (nm) from the threshold of Runway 07 at FALA						
GPS Co-ordinates	Latitude	25°57'26.80" S	Longitude	027°53'47.40" E	Elevation	4411ft	
Aircraft Information							
Registration	ZS-FIF						
Make/Model	Cessna 172I (Serial Number: 172-56705)						
Damage to Aircraft	Substantial		Total Aircraft Hours	12 657.8			
Pilot-in-command							
Licence Type	Student Pilot Licence		Gender	Male		Age: 21	
Licence Valid	Yes						
Total Hours on Type	58.5		Total Flying Hours	58.5			
People On-board	1 + 0	Injuries	1	Fatalities	0	Other (On ground)	0

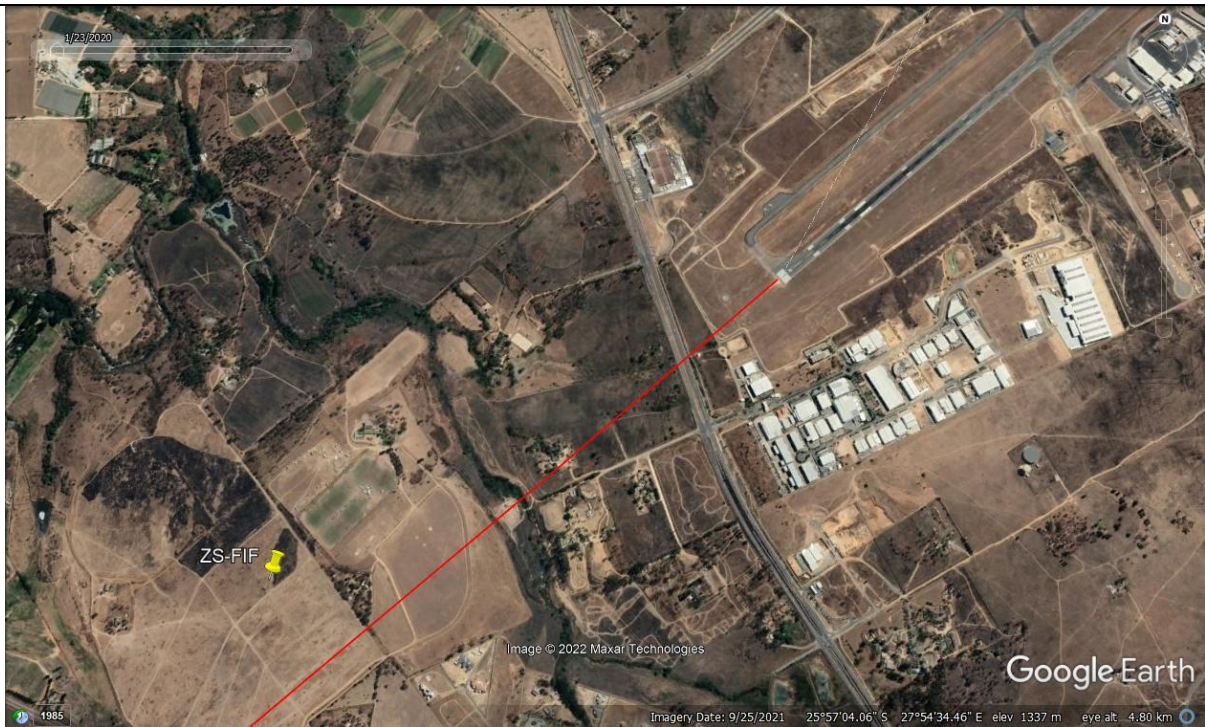
During the forced landing, approximately 50m after touchdown on the open field, the aircraft collided with a concealed embankment of about 40 centimetre (cm) in height. The aircraft’s nose wheel broke off and the aircraft nosed over and came to rest in an inverted attitude approximately 1.1 nautical miles (nm) from the threshold of Runway 07.

Figure 1: Overlay of where the accident (ZS-FIF) occurred in relation to FALA. (Source: Google Earth)

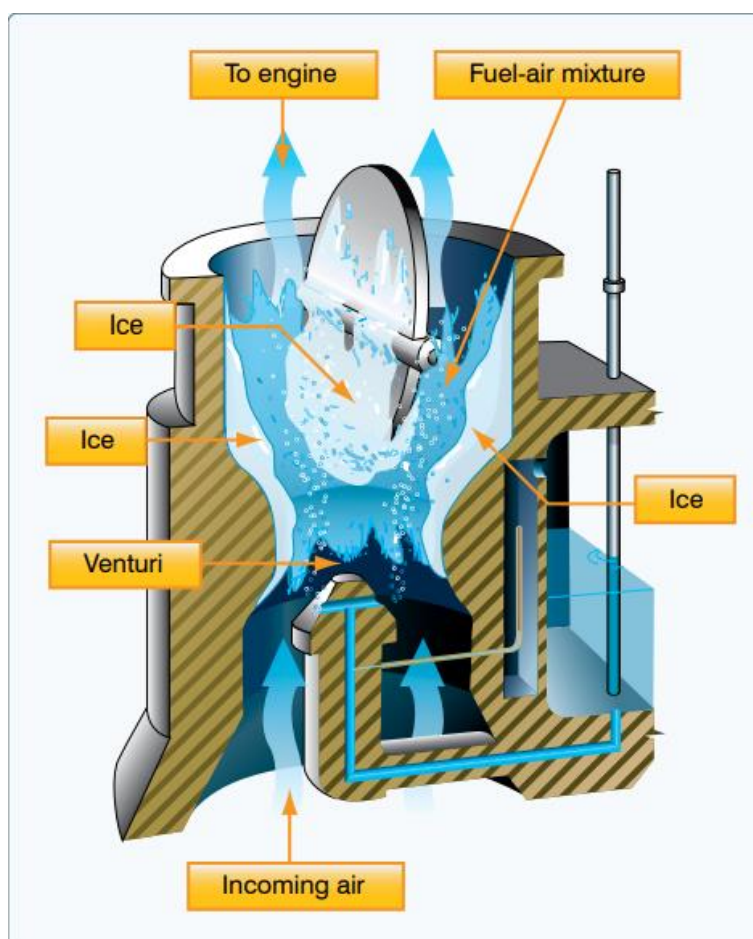
According to the carburettor icing-probability chart, serious icing conditions could have been encountered during descent with the prevailing weather conditions at the time.

The reduced air pressure, as well as the vaporization of fuel, contributes to the temperature decrease in the carburettor. Ice generally forms in the vicinity of the throttle valve and in the venturi throat. This restricts the flow of the fuel-air mixture and reduces power. If enough ice builds up, the engine may cease to operate. Carburettor ice is most likely to occur when temperatures are below 70°F or 21°C and the relative humidity is above 80%. Due to the sudden cooling that takes place in the carburettor, icing can occur even in outside air temperatures as high as 100°F (38°C) and humidity as low as 50%. This temperature drop can be as much as 60°F to 70°F. (Remember there are 180°F from freezing to boiling versus 100°C). Therefore, an outside air temperature of 100°F (38°C), a temperature drop of an absolute 70°F (21°C) results in an air temperature in the carburettor of 30°F (-1°C). [Figure 6] The first indication of carburettor icing in an aircraft with a fixed-

Figure 6: The formation of carburettor ice may reduce or block fuel air-flow to the engine.
