LIMITED ACCIDENT INVESTIGATION REPORT
--

Reference Number		CA18/2/3/10131					
Classification	Accident	Date	28 February 2022	Time	16:30Z		
Type of Operation		Private (Part 94)					
Location							
Place of Departure		Private Airstrip Near Coligny, North West Province		Place of Intended Landing		Private Airstrip Near Coligny, North West Province	
Place of Accident		Private Airstrip Near Coligny					
GPS Co-ordinates		Latitude	S 26°22'20.27"	Longitude	E 26°11'43.62"	Elevation	4970ft
Aircraft Information							
Registration		ZU-SVA					
Model/Make		Savanna S (Serial Number: 12-10-54-0213)					
Damage to Aircraft		Substantial		Total Aircraft Hours		200.38	
Pilot-in-command							
Licence Valid		Yes		Gender		Male	
						Age 51	
Licence Type		National Pilot Licence (Aeroplane)					
Total Hours on Type		200		Total Flying Hours		220	
People On-board		1+0		Injuries		0	
				Fatalities		0	
				Other (On ground)		0	
What Happened							
<p>On Monday, 28 February 2022, a pilot on-board a Savanna S aircraft with registration ZU-SVA took off on a local flight from Oppaslaagte Farm private airstrip from Runway 15 in Coligny, North West province, with the intention to land back at the same take-of

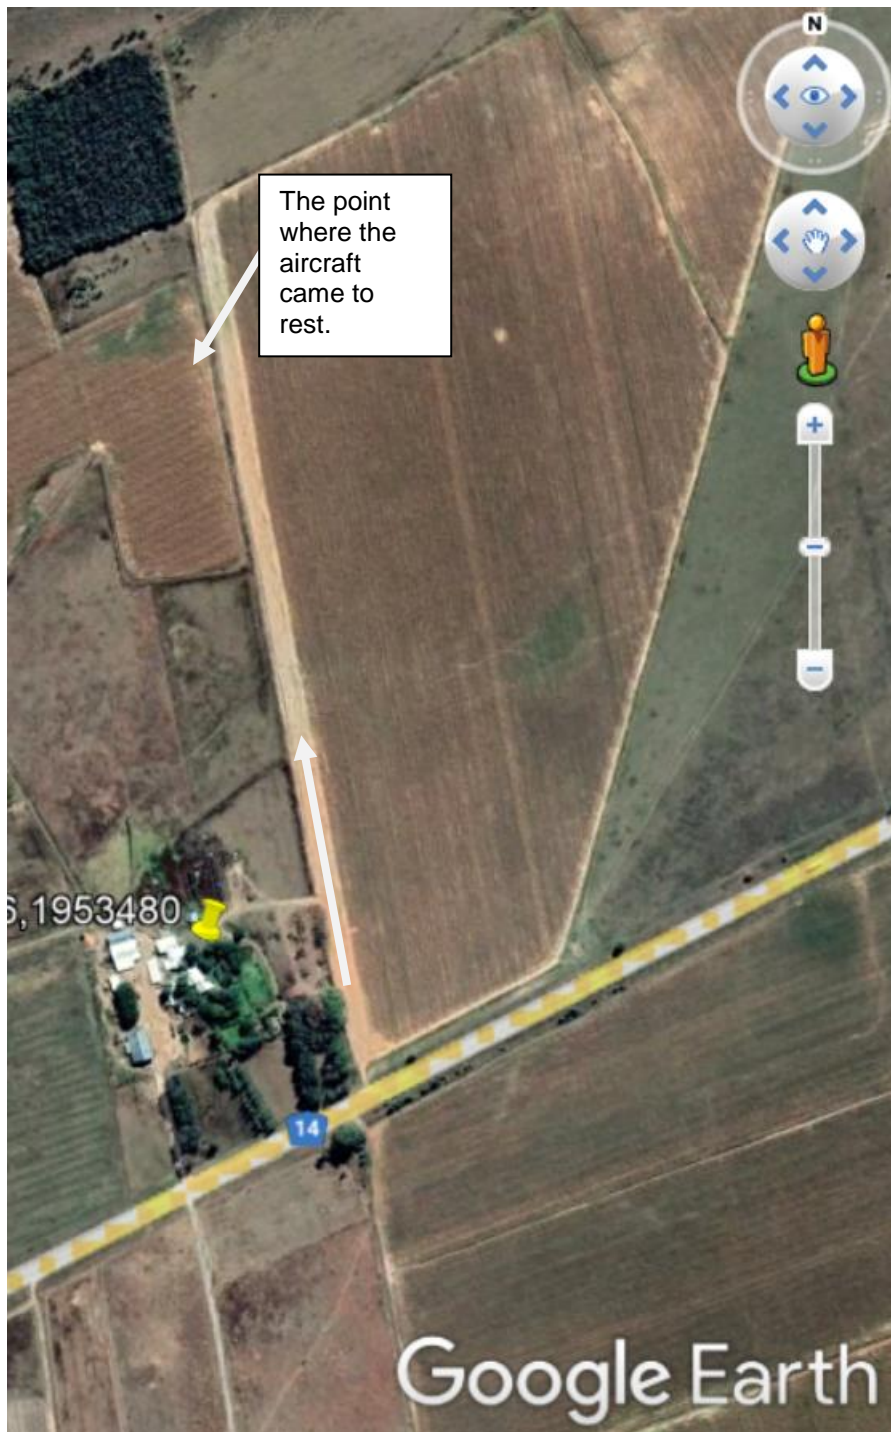
Figure 1: The white arrow shows the direction of landing and where the aircraft had come to a stop. (Source: Google Earth)
