Section/division Accident and Incident Investigations Division

LIMITED ACCIDENT INVESTIGATION REPORT

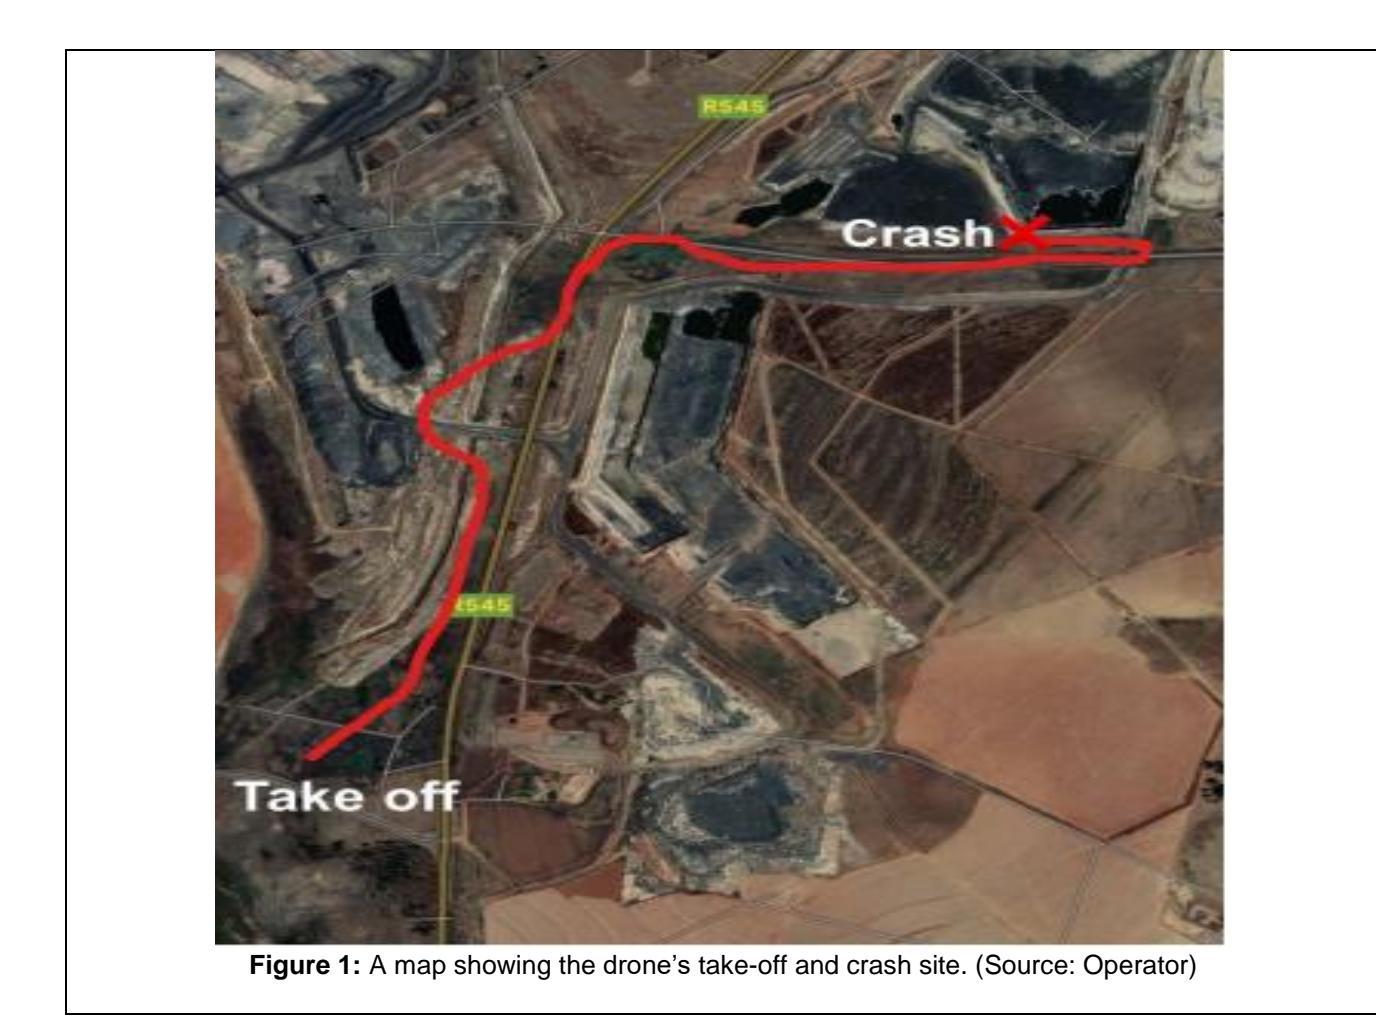
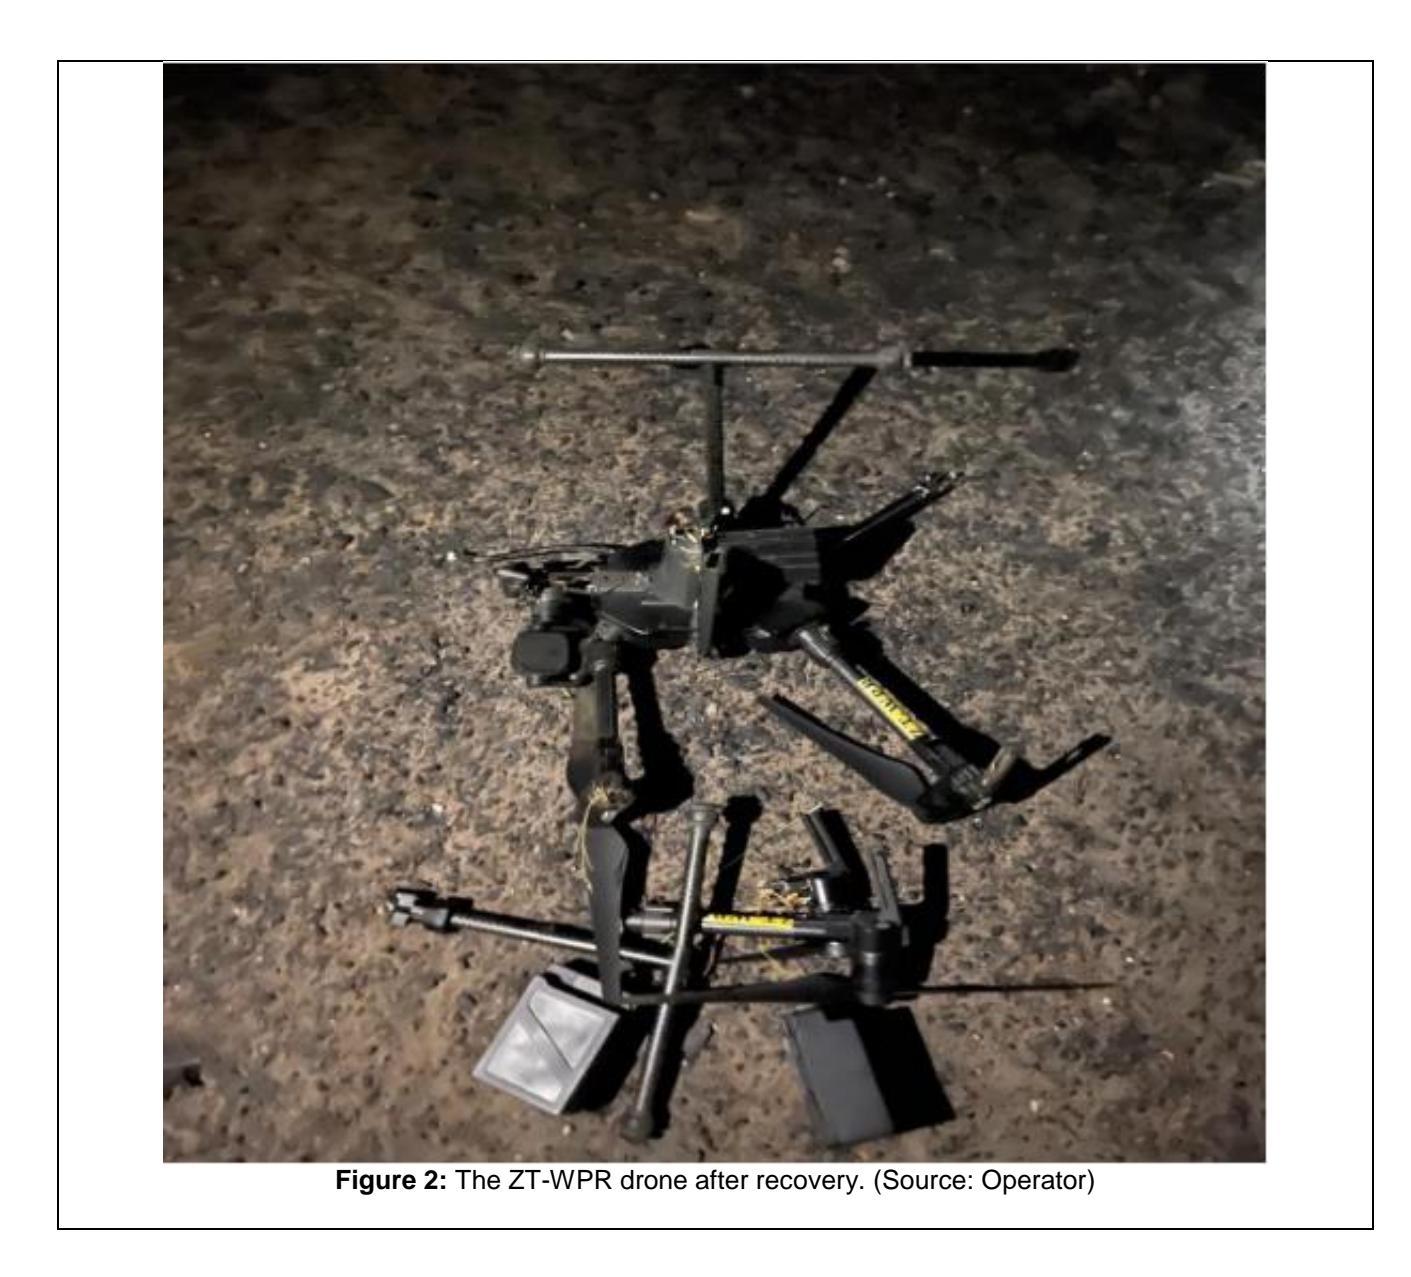
People 0		lı	njuries		0	Fatalities		0		Other (on around)			0
What Happened										gic			
On Tuesday, 8 M registration ZT-V when the accide night and under According to the were inspected were set correct with temperature The pilot flew the the direction wh minutes into the it crashed to the	March 2 WPR went occ the pro- pilot, h and fo tly for e at 18 e drone here th flight, groune	2022 /as c urrec ovision ne co und the d °C an e at a ne se the c d, dis	at 21 onduct d. The ons of nduct to be frone nd cle approx ecurity drone	19Z, a flight v Part 10 ed pre- in good operati ar skie v office sudder ecting f	pilot v surve vas co 1 of t flight d con on. C s. y 65 f rs ha hly be rom t	who was y flight onducte he Civil checks dition fo Good we deet abc dearlie came u he pilot	s remot at Glen ed in vis Aviatio during or the fl eather of eve grou er repo inrespo 's contro	ely piloti core Co ual mete n Regula which th light. Fa condition und level rted sus nsive an oller unit	ng a D. al Mine eorolog ations (e batte il safes is preva (AGL) pect ill od spira . The p	JI Ma a, Mp ical CAF ries we ailec anc lega illed	atrice 200 oumalanga conditions () 2011 as and other re also che d at the tin d at 15 kno l activities out of con went to the	dror a pro- a (VM ame equi ecke ne o ts to . Af trol	ne with ovince, MC) by ended. pment ed and f flight owards ter six before sh site
