**AIRCRAFT ACCIDENT REPORT AND EXECUTIVE SUMMARY**

<b>Reference:</b>		<b>CA18/2/3/10144</b>	
<b>Aircraft Registration</b>	ZS-AXE	<b>Date of Accident</b>	8 April 2022		<b>Time of Accident</b>	1050Z	
<b>Type of Aircraft</b>	Piper PA-38-112 (Tomahawk)		<b>Type of Operation</b>		Training (Part 141)		
<b>Pilot-in-command Licence Type</b>	Commercial Pilot Licence (CPL)		<b>Age</b>	27	<b>Licence Valid</b>	Yes	
<b>Pilot-in-command Flying Experience</b>	<b>Total Flying Hours</b>		316.7	<b>Hours on Type</b>	137		
<b>Last Point of Departure</b>	Cape Town International Airport (FACT), Western Cape Province						
<b>Next Point of Intended Landing</b>	Cape Town International Airport (FACT), Western Cape Province						
<b>Damage to Aircraft</b>	Substantial						
<b>Location of the accident site with reference to easily defined geographical points (GPS readings if possible)</b>							
Private farm near Diemerskraal Aerodrome at Global Positioning System (GPS) determined to be 33°35'0.10" South 018°54'47.45" East, at 300ft above mean sea level (AMSL)

**Synopsis**

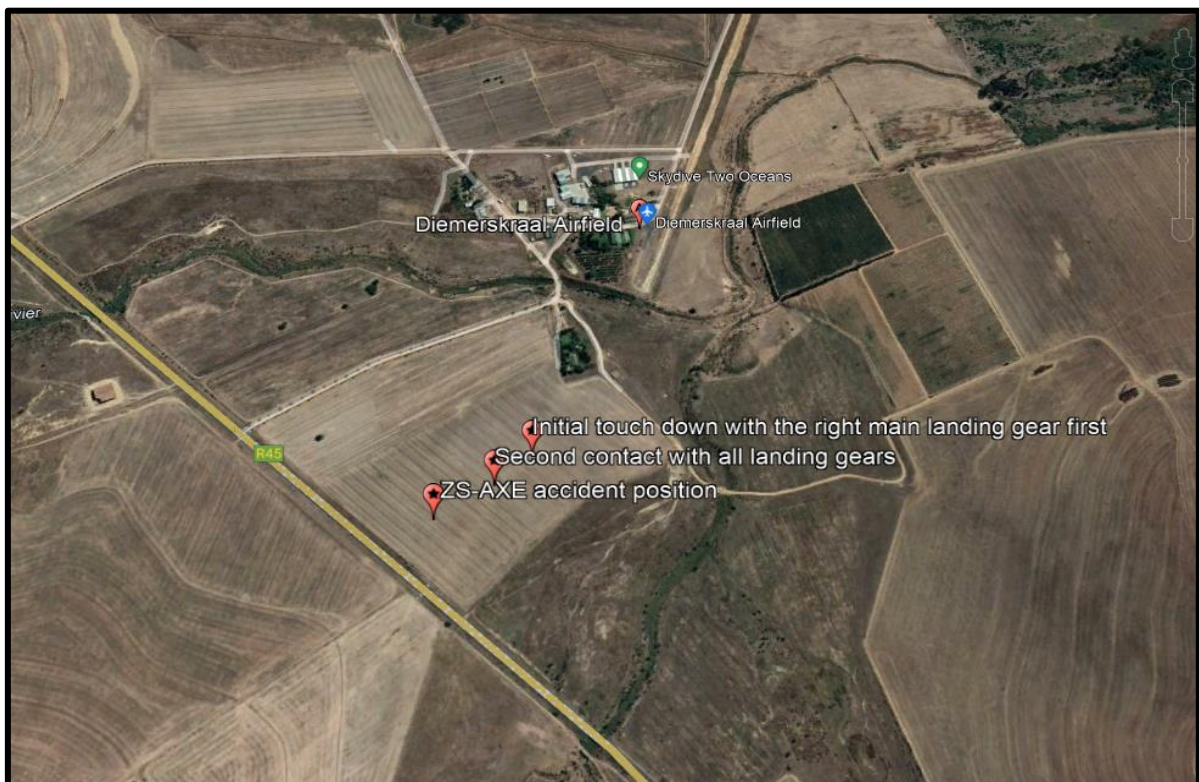
- 1.1.7. The accident occurred on a private farm at Global Positioning System (GPS) determined to be 33°35'0.10" South 018°54'47.45" East, at an elevation of 300ft.

**Figure 1:** Aerial view of the accident site. (Source: Google)
