AIRCRAFT INCIDENT SHORT REPORT

CA18/3/2/1201: While the ZS-HAI helicopter was hovering in ground effect, the fan-wheel assembly failed and the helicopter was landed safely without further damage or injury.

Aircraft registration : ZS-HAI

Aircraft manufacturer and model : Robinson Helicopter Company, R22 Beta

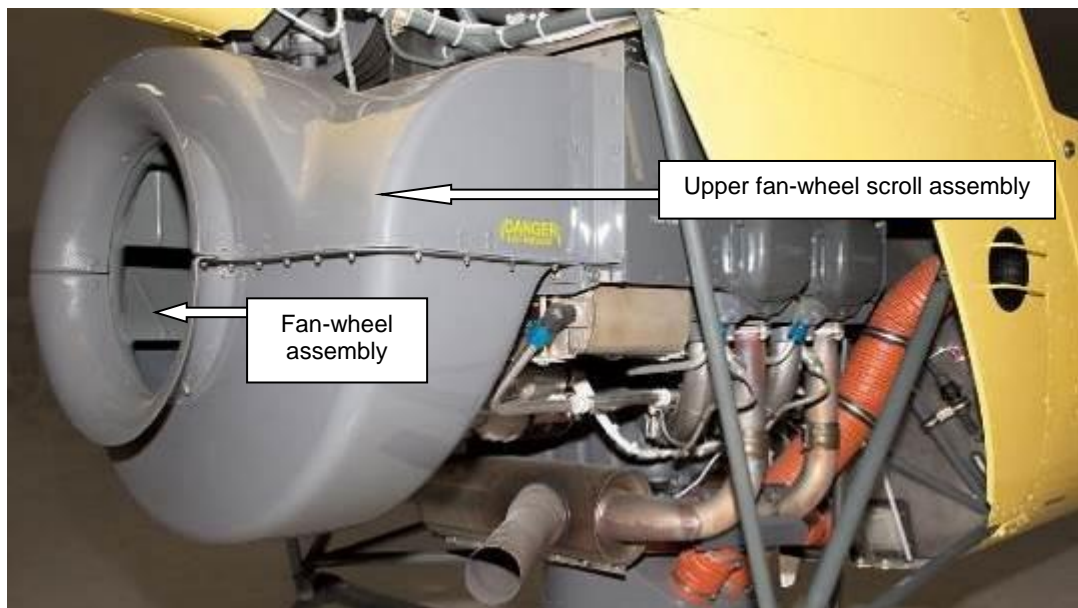
2.1.3 Once on the ground, he closed the throttle and could see debris lying on the runway. He proceeded to shut down the helicopter and, after disembarking, he conducted a walk-around inspection and saw that the fan-wheel assembly had failed.

Figure 3: Another view of the damage caused by the fan-wheel assembly

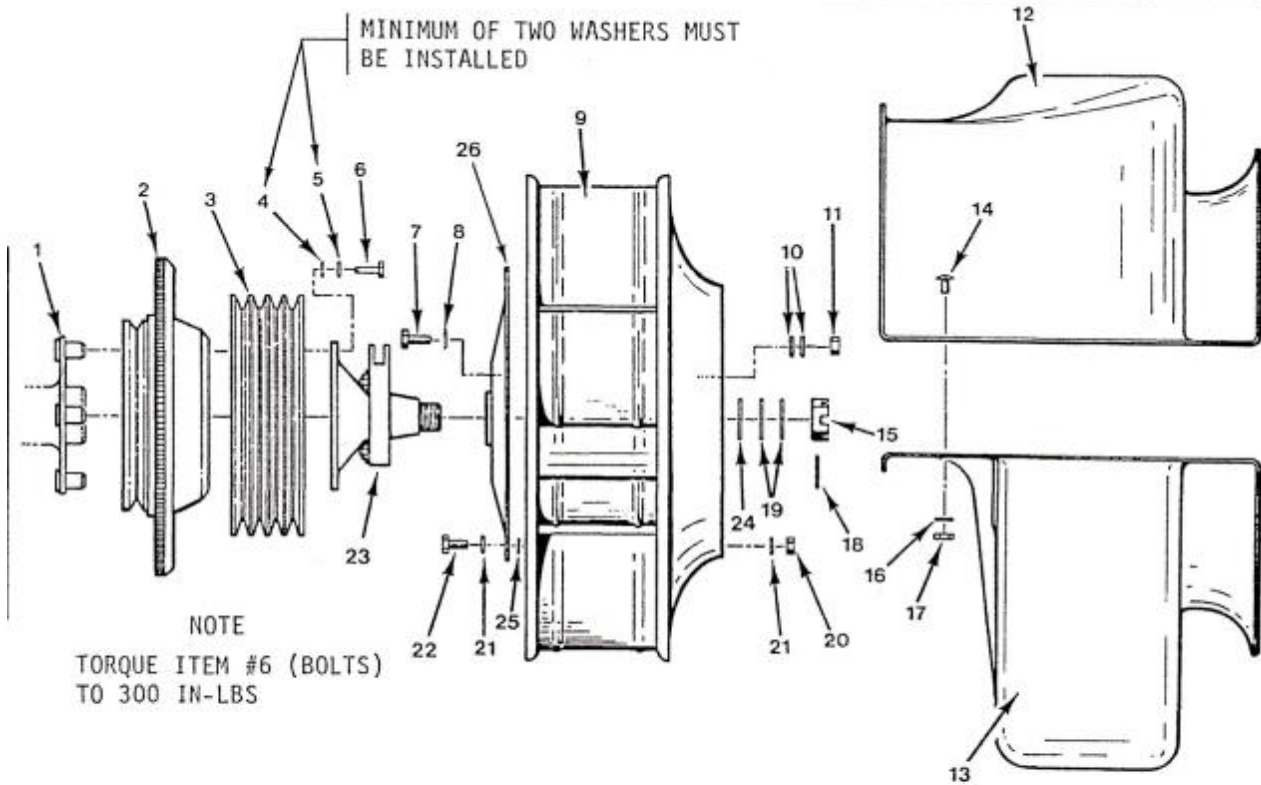
Figure 4: The fan-wheel scroll and fan-wheel assembly (Source: Robinson Helicopters website)
