AIRCRAFT INCIDENT REPORT AND EXECUTIVE SUMMARY

Reference:	CA18/3/2/1202	
Aircraft Registration	ZS-KGW	Date of Accident	26 March 2018		Time of Accident	0445Z
Type of Aircraft	Beechcraft B200		Type of Operation		Private (Part 91)	
Pilot-in-command Licence Type		Commercial Pilot's Licence	Age	52	Licence Valid	Yes
1st Officer Licence Type		Commercial Pilot's Licence	Age	40	Licence Valid	Yes
Pilot-in-command Flying Experience		Total Flying Hours	9105		Hours on Type	2 434.4
1st office Flying Experience		Total Flying Hours	4 471.2		Hours on Type	1 913.6
Last point of departure		Wonderboom Airport (FAWB), Gauteng Province				
Next point of intended landing		OR Tambo International Airport (FAOR), Gauteng Province				
Location of the accident site with reference to easily defined geographical points (GPS readings if possible)						
At FAWB on Runway 29 at a point with GPS Coordinates, S25°39'13" E028°13'28"						
Meteorological Information		Wind direction: variable, air speed: calm, air temperature: 12°C, visibility: 10 km

AIRCRAFT INCIDENT REPORT

Name of Owner : Tacet Transport (Pty) Ltd
Name of Operator : Multimedia Entertainment Group (Pty) Ltd
Manufacturer : Beechcraft
Model : B200
Na

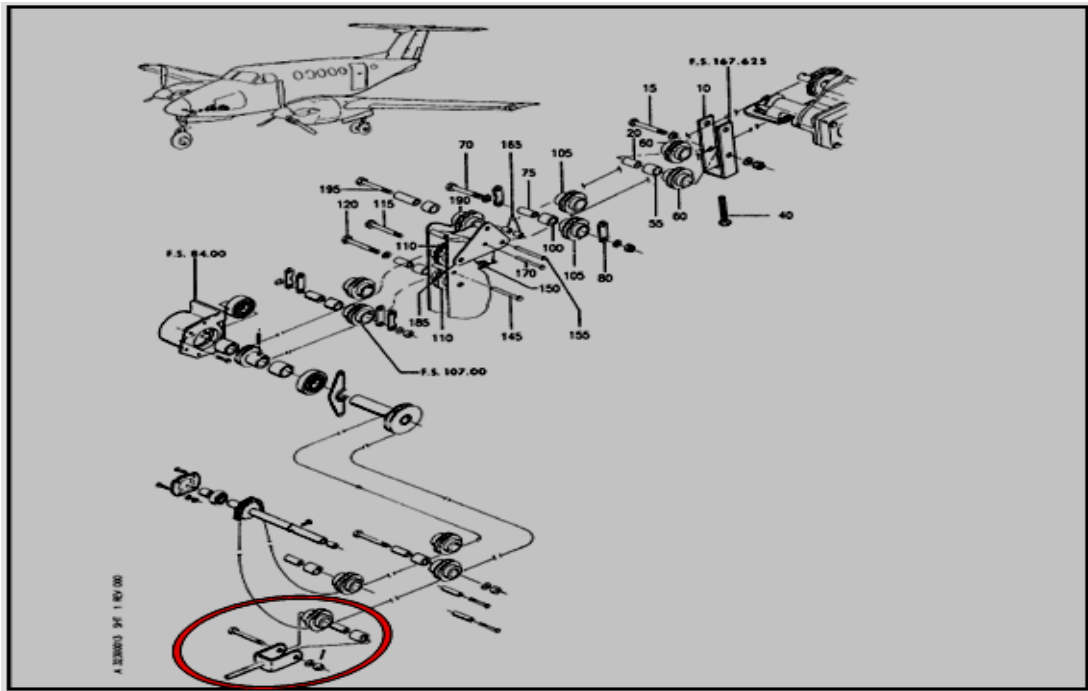
Figure 9: Schematic of illustrated parts of the nose gear retraction mechanism

- 1.16.1 The preliminary investigation determined that the cause of the landing gear not extending was due to a jammed extension/retraction chain in the nose wheel well. (See: Figures 4 and 8.)
- 1.16.2 Figures 9 and 10 were extracted from the aircraft type illustrated part catalogue (IPC). The red circle shows where the retraction/extension chain got jammed against component 675 (bracket) and the bracket chain lightener. The retraction/extension chain consists of a set of two chains combined together, running on a sprocket (520) that consists of two sets of teeth. During the investigation, it was observed that the chain jumped out of one set of sprocket teeth onto the other, causing the chain to be against bracket 675.

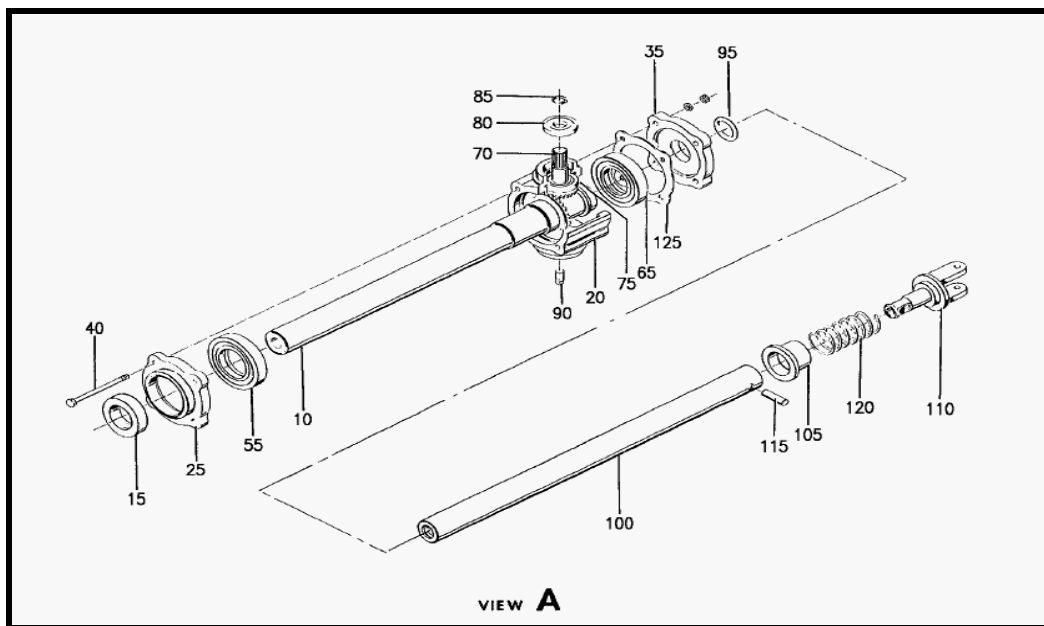
Figure 12: The nose gear actuator schematic

On initial inspection, it was found that the nose gear forward operating chain was jammed against the assembly bracket. The chain had moved out of the sprocket due to misalignment. This prevented the gear from operating either normally or during emergency procedure. Further inspection revealed that the right-hand actuator support bearing and inner sleeve had egressed out of the bearing plate. With the chain tension to the short chain driven torque shaft, the outboard small end of the torque shaft disengaged from the side wall bearing in the landing gear bay. Chain tension was able to distort the actuator mounting and cock the torque shaft, thereby misaligning the chain, which then tempered the chain tensioner sprocket and caused the chain entrapment. (See: Figure 8.) Figure 12 shows the actual position of the actuator assembled in a normal condition.

1.16.4 The sleeve acts as a spacer that helps to keep the actuator in position within the bearing assembly. The two brackets hold the actuator in position during assembly and operation as shown in Figure 12. If the sleeve is removed, the space induced will allow the actuator to move sideways (rotate along its longitudinal axis) during operation. The sleeve also holds the actuator in position to allow the chain-driven shaft to connect to the actuator inserted through the spline fitting. (For parts names as numbered, refer to Appendix A.)

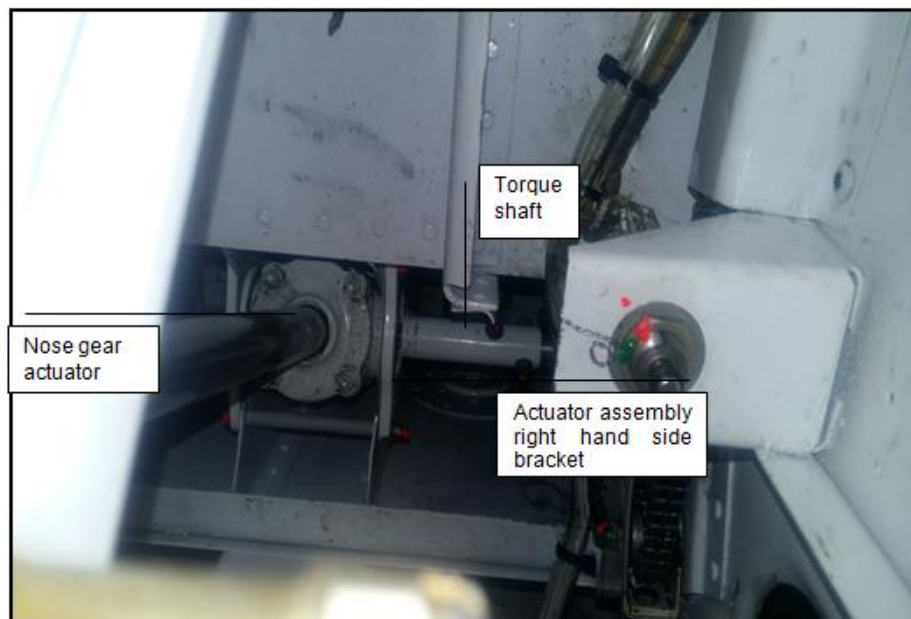
Figure 14: An actuator in a normal condition on assembly

1.16.5 The chain is also subjected to tension, which can also be longitudinally spread along the actuator driving shaft. The shaft, with a set of chain sprockets, is assembled on the airframe and connects to

the actuator through a spline end.
