<b>AIRCRAFT INCIDENT REPORT AND EXECUTIVE SUMMARY</b>
---

Reference:	CA18/3/2/1206	
<b>Aircraft Registration</b>	ZS-VDP	<b>Date of Incident</b>	4 May 2018		<b>Time of Incident</b>	0728Z
<b>Type of Aircraft</b>	Boeing 737-300		<b>Type of Operation</b>	Part 121 (Air Transport Operations)		
<b>Pilot-in-command Licence Type</b>	ATPL	<b>Age</b>	54	<b>License Valid</b>	Yes	
<b>Pilot-in-command Flying Experience</b>	Total Flying Hours	8217		<b>Hours on Type</b>	3026	
<b>Last point of departure</b>	Port Elizabeth International Airport (FAPE), Eastern Cape					
<b>Next point of intended landing</b>	O.R. Tambo International Airport (FAOR), Gauteng					
<b>Location of the incident site with reference to easily defined geographical points (GPS readings if possible)</b>						
75 NM outbound from VOR PEV en-route to FAOR						
<b>Meteorological Information</b>	Wind: 060 <sup>0</sup> /10 <sup>0</sup> kt, Temperature: 19°C, Dew point: 08°C, Visibility: 9999m					
<b>Number of people on board</b>	8+116	<b>No. of people injured</b>	0	<b>No. of people killed</b>	0

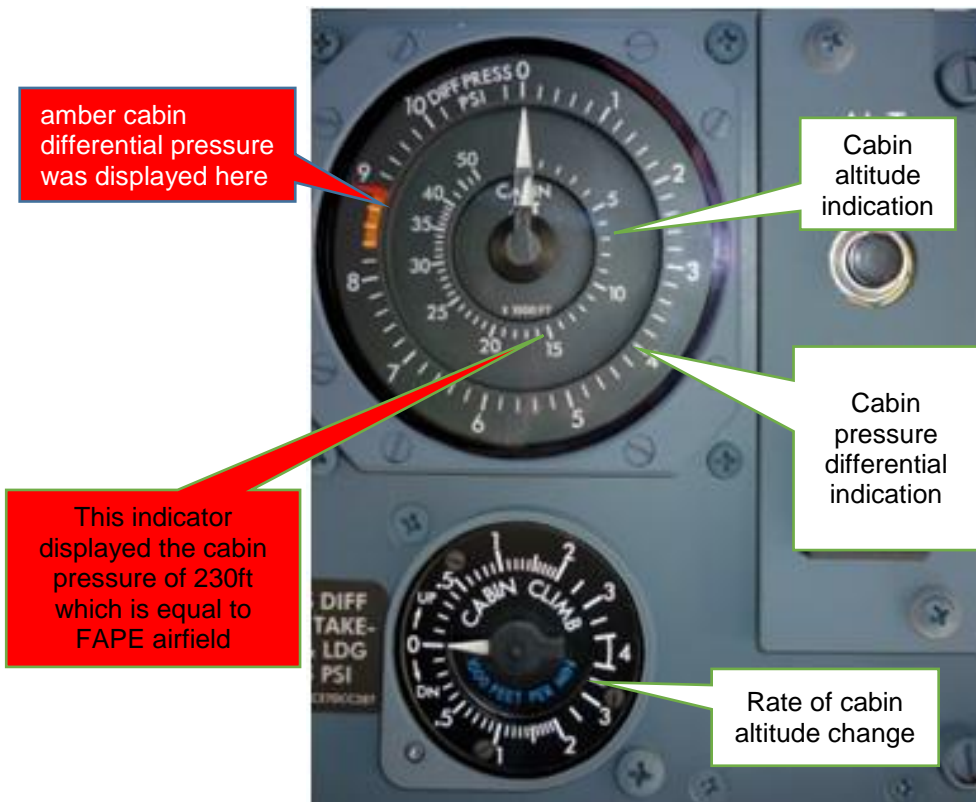
- 1.1.3 Approximately 75 NM from the VOR “PEV” abeam Fort Beaufort in the Eastern Cape, while in the climb to its allocated flight level, the flying crew noticed the cabin differential pressure indicator was in the amber band (see Figure 3). The rate of cabin pressure change had remained at zero. The cabin pressure remained at approximately 230 ft., which is the elevation of FAPE.

**Figure 3:** The visual indicators displaying the cabin altitude, the cabin pressure and the rate of cabin altitude change

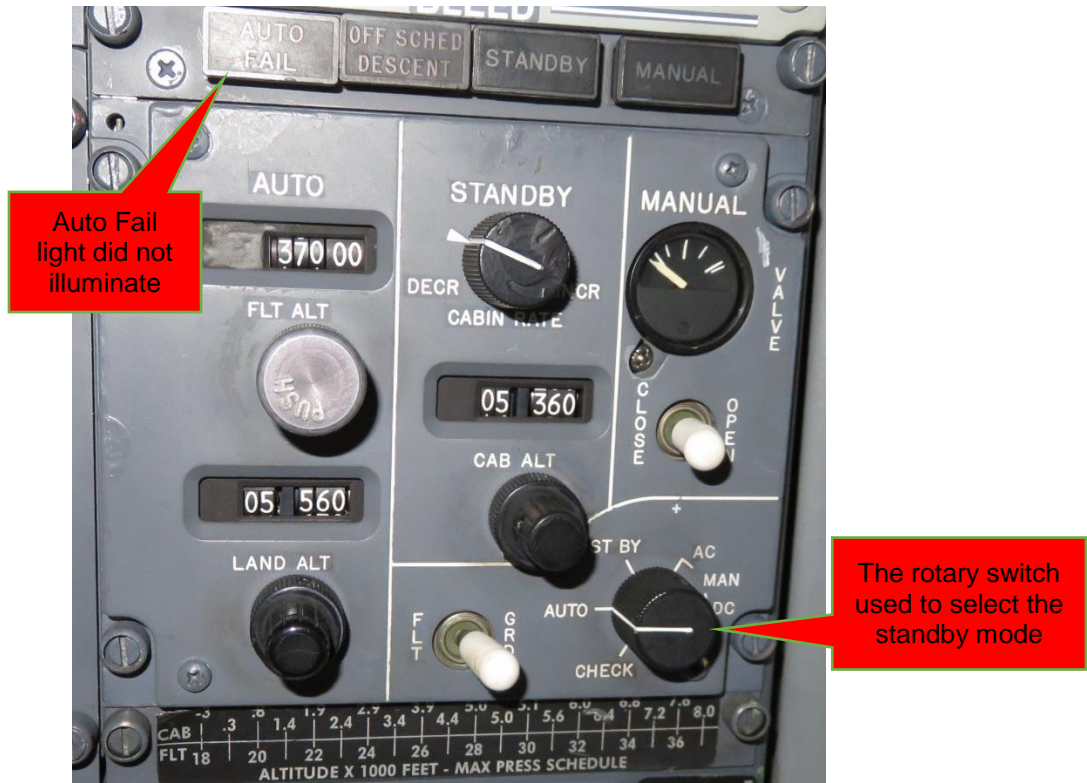
- 1.1.4 After some fault finding, the crew decided to move the rotary switch for the pressurisation control from the automatic (AUTO) mode to the standby (STBY) position (see Figure 4). Immediately after the switch had been moved, the outflow valve began moving to the full open position, causing the cabin to depressurise while the aircraft was passing FL230. The flight crew commenced a rapid descent to FL100. The aircraft flew the remainder of the flight in an unpressurised configuration.

Figure 4: The aircraft pressurisation controls

- 2.6 Once airborne, upon passing FL230, the PIC saw the cabin pressure differential entering the amber band. He then selected the STBY mode, which caused the outflow valve to move towards the full open position. This caused the cabin to depressurise. In AUTO mode, the static ports provide the airplane altitude, while in STBY mode, the altitude is gathered electrically from the air data computers (ADC). Due to a failure in the CPC, correct pressure calculations were not achieved, leading to the incorrect positioning of the main outflow valve.

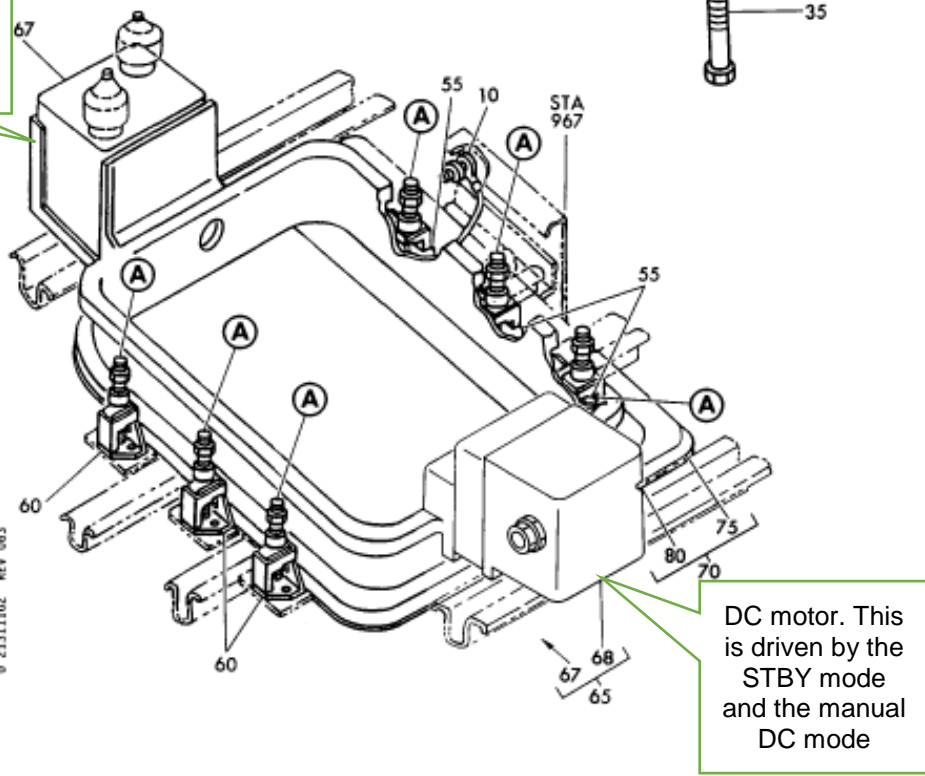
DC motor. This is driven by the STBY mode and the manual DC mode

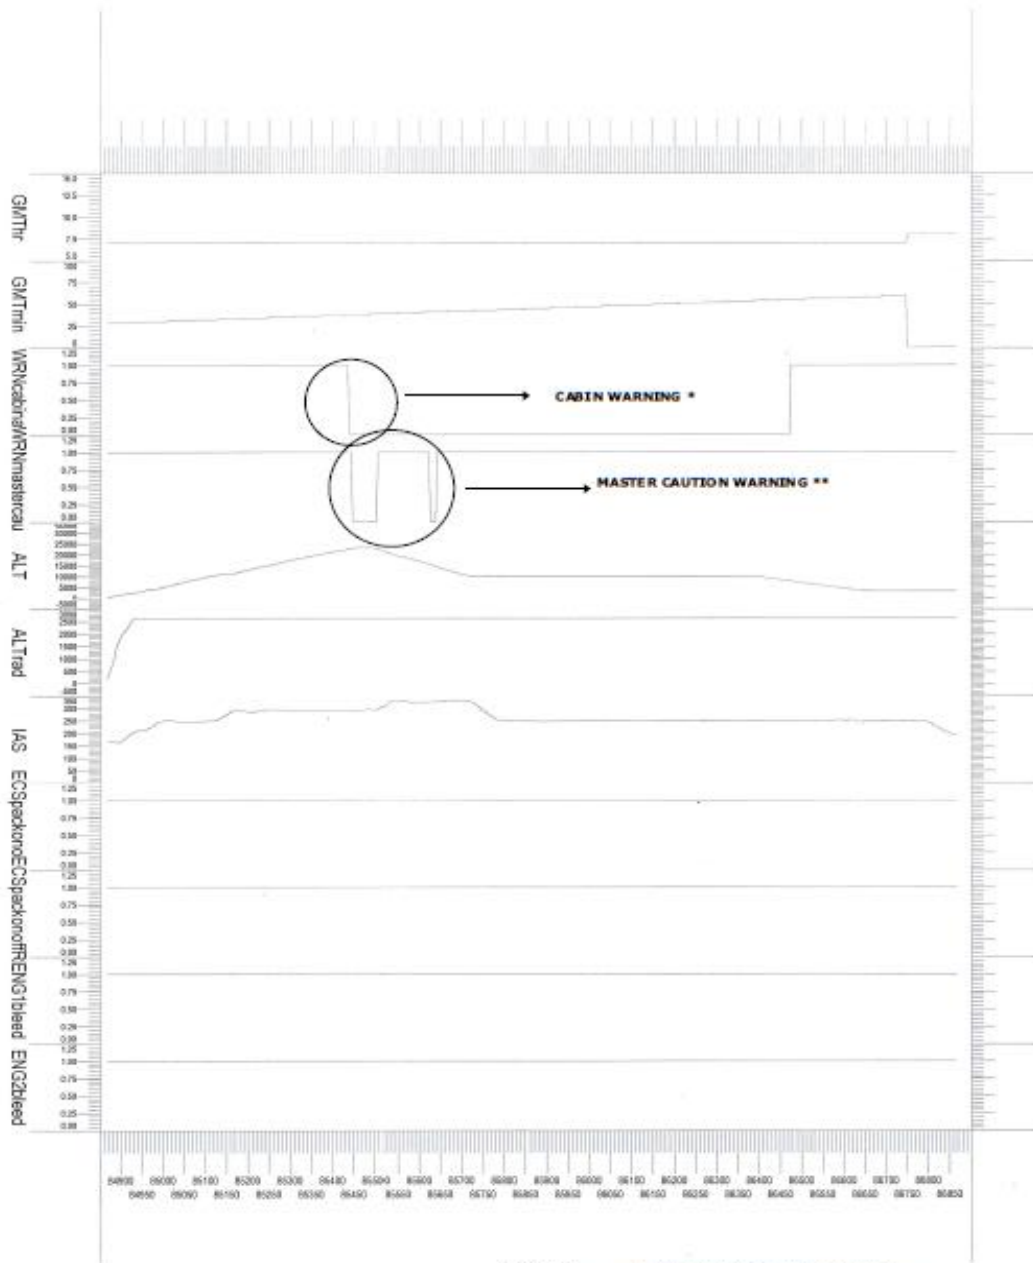
COUNTER \* CABIN WARNING AT COUNTER # 85437  
 \*\* MASTER CAUTION WARNING AT COUNTER # 85440
