AIRCRAFT INCIDENT SHORT REPORT

CA18/3/2/1207: ZU-WCG, Nose landing gear collapse on touchdown runway 08 at Port Elizabeth Airport

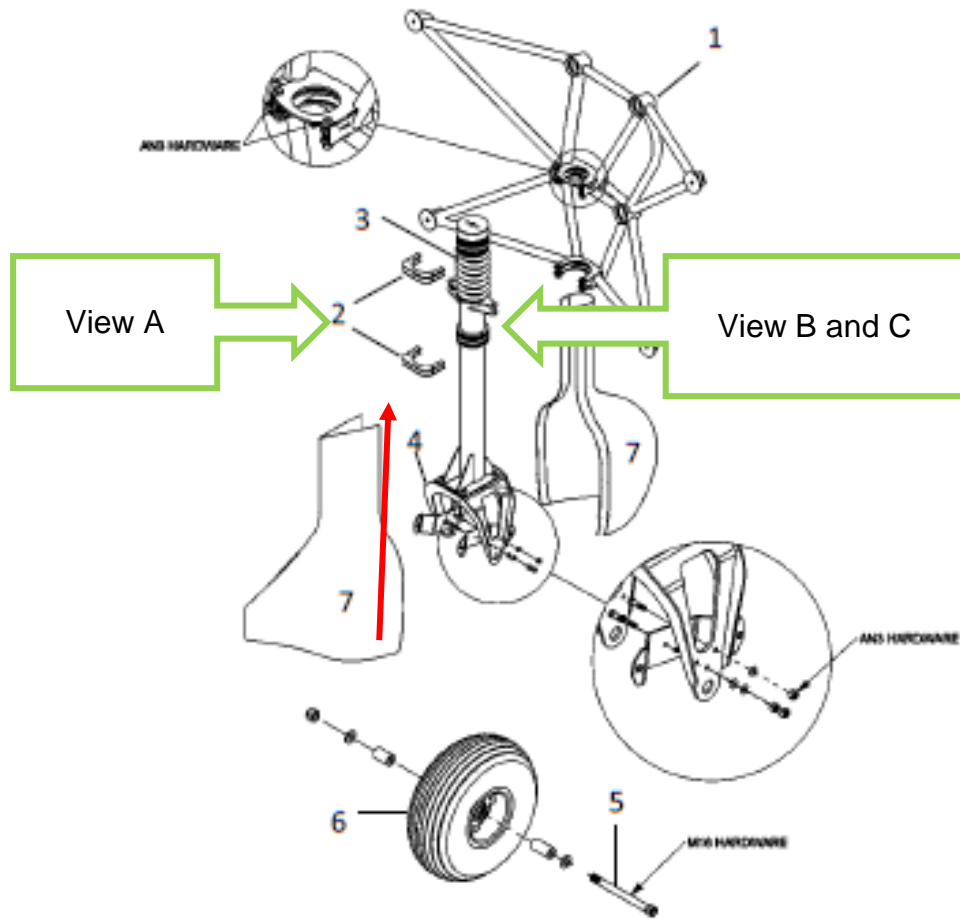
APPENDIX D

- 3.2.1 The aircraft had flown 34 hours since the last inspection. The aircraft was in possession of a valid certificate of Release to Service and Authority to Fly.
- 3.2.2 The nose gear collapsed backward. (See Appendix C and D). The paint on the strut showed signs of peeling. This process had happened over time as corrosion had become evident on the strut.
- 3.2.3 The wind direction was a head wind of 14 knots. No wind gusts were reported on the day. Therefore, the weather may not have played a factor in the incident.
- 3.2.4 The Sling 2 aircraft type has had in excess of 12 nose gear collapses in the past 5 years (See appendix E for photos of previous incidents)

Due to weakening of the nose gear strut over time, a possible excessive force applied to the gear on touch down caused the nose gear strut to bend backward and collapse.

Safety message: It is recommended that operators of the Sling 2 aircraft carry out more frequent inspections on the nose landing gear strut for signs of distortion or damage. This is more pertinent to operators especially in the training environment who carry out a large amount of cycles between maintenance inspections.
