AIRCRAFT INCIDENT SHORT REPORT

CA18/3/2/1217: ZS-WZP, Runway excursion after an aborted take-off

Aircraft registration : ZS-WZP

Aircraft manufacturer and model : Atlas Angel X328

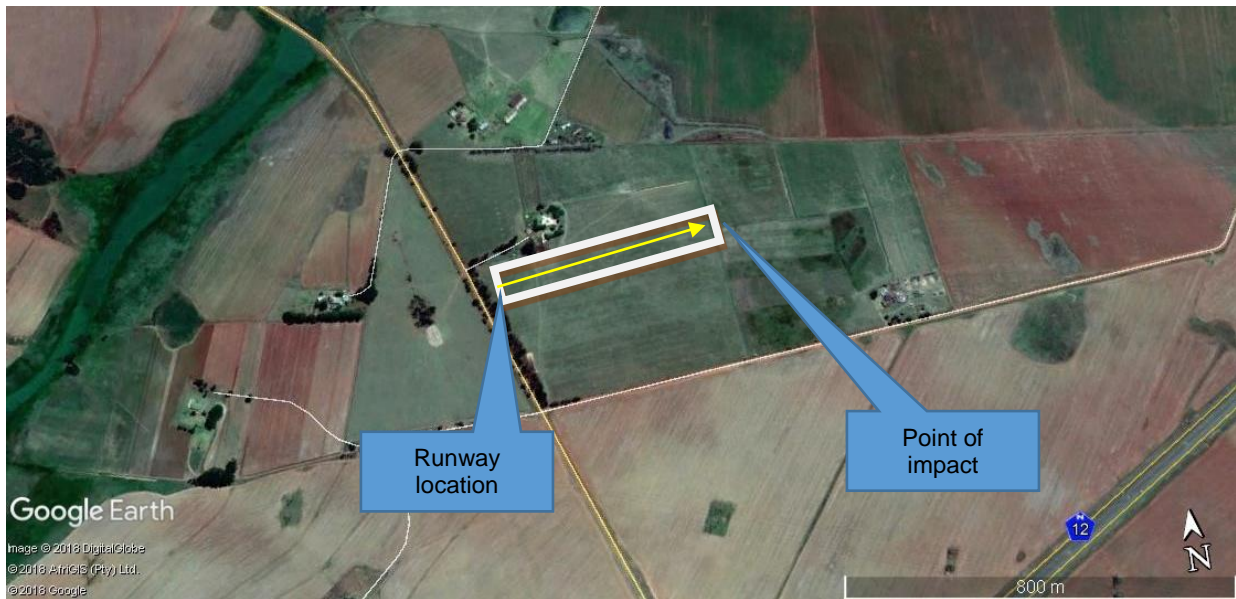
- 2.4 The pilot elected to abort the take-off and landed the aircraft on the remaining runway. The aircraft overshot the runway and impacted a perimeter fence near the threshold of runway 27.

- 2.5 The pilot stated that the aircraft sustained damage to its propeller, landing gear and fuselage.
- 2.6 None of the occupants on board sustained injuries.

Figure 3: The runway location and the point of impact (Google Earth)

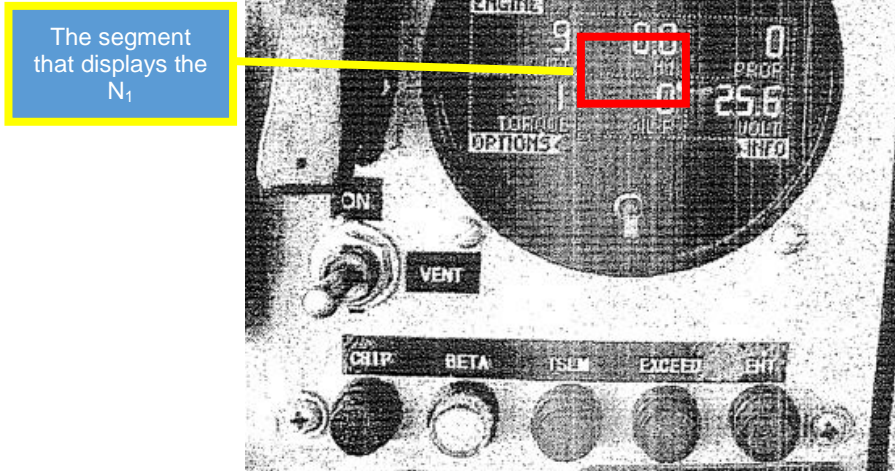
- 3.8 The flap configuration prior to beginning the take-off roll was set at 33° position, which is position 1.
- 3.9 The aircraft is fitted with a digital engine instrument display. This instrument is split into 6 separate segments and simultaneously displays the following engine perimeters:
- ITT – Inter turbine temperature – degrees Celsius
 - N1 – gas generator speed – percentage of maximum
 - Prop – propeller – revolutions per minute
 - Torque – engine torque – pounds per square inch
 - Oil pressure – oil pressure – pounds per square inch
 - Voltage – busbar voltage – volts

Figure 6: Digital engine instrument display (Atlas Angel POH)
