AIRCRAFT INCIDENT SHORT REPORT

CA18/3/2/1218: Inflight engine failure resulting in an autorotation landing which was unsuccessful as the helicopter landed hard. Damage limited to the skids and no injuries were reported.

Aircraft manufacturer and model : Bell Helicopter Textron 206B Jetranger-III

SUBJECT: EXAMINATION OF A MODEL 206B3 PC SAFETY VALVE FROM WARNE AVIATION IN SOUTH AFRICA

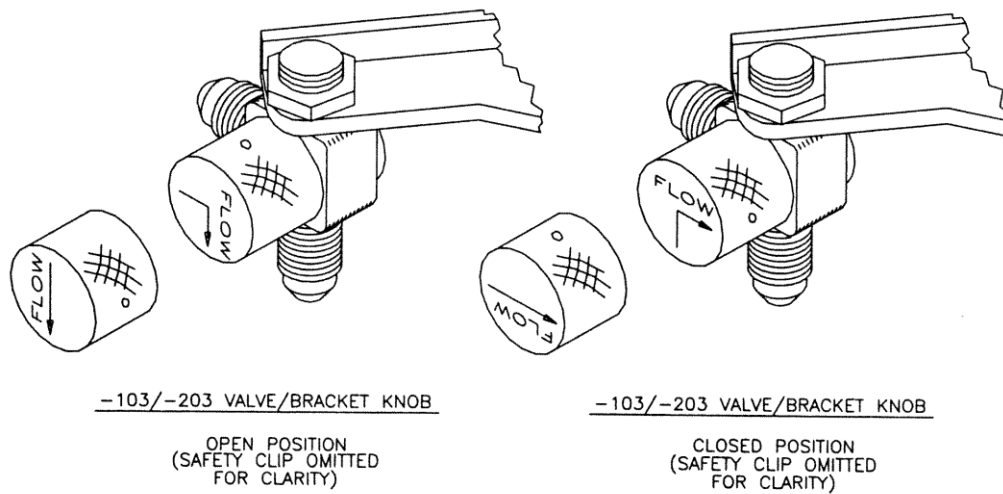
- 2.1.7. The Pc Safety Valve™ kit is an aftermarket product installed on the Allison 250-C20 series to provide a convenient method of isolating pneumatic pressure and sense lines during engine compressor water rinse and compressor chemical wash operations. The closing of these safety valves prevents water, washing solvents and other contaminants from entering such critical components as fuel controls, governors and bleed valves, and effectively reduces compressor wash/rinse time significantly in all engine applications. It closes off each applicable pneumatic line for the specific engine installation.

Figure 7: The Pc Safety Valve in the opened and closed position.
(Source: Aeronautical Accessories Continued Airworthiness Doc)
