AIRCRAFT SERIOUS INCIDENT SHORT REPORT

CA18/3/2/1224: ZS-PHX, cabin decompression while cruising at FL200

PAGE 1 OF 9		
COMPILED FOR: Federal Airlines (Pty) Ltd	FAILURE ANALYSIS REPORT: CABIN WINDOW, BEECHCRAFT 1900D, ZS-PHX	DOCUMENT NUMBER FA-006-11-18		
		<table border="1" style="width: 100%; border-collapse: collapse;"> <tr> <td style="width: 70%;">DATE 2018-11-19</td> <td style="width: 30%;">ISSUE 1</td> </tr> </table>	DATE 2018-11-19	ISSUE 1
DATE 2018-11-19	ISSUE 1			
<p>ITEM: RIGHT-HAND FORWARD EMERGENCY EXIT CABIN WINDOW, PART No 129-430041-1, BEECHCRAFT 1900D, SERIAL No UE-145, No ZS-PHX</p> <p>1. BACKGROUND INFORMATION</p> <p>1.1. The remainder of a failed cabin window (Photo's 2 and 3; Part no 129-430041-1) originating from the forward right-hand (pilot's view) emergency exit position from a Beechcraft 1900D, No ZS-PHX (Photo1), was submitted to determine the most probable root- and contributory causes towards failure during operation.</p> <p>1.2. The relevant cabin window failed during flight at approximately 20000' MSL (FL020) while the aircraft was under pressurization (Photo 2).</p> <p>1.3. The cabin window base material conforms to Polymethyl Methacrylate (PMMA) of

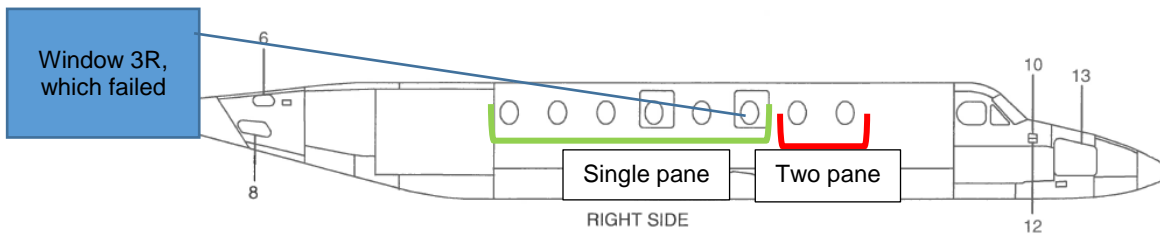
Figure 5: View of the right side of the fuselage
(source: B1900D MM, 06-20-00-001, Figure 2 (Rev Nov 1/09))

- 3.12 The B1900D has two types of cabin windows fitted: numbers 1 and 2 are two-pane windows, while the remainder of the cabin windows are single pane.

- 3.13 The B1900D single-pane cabin windows have a life span of 43 600 flight hours or 61 700 pressure cycles. The life span is designed to ensure the windows are in a serviceable condition during the previously mentioned inspections. At the time of the window failure, the aircraft had flown a total of 26 508.6 airframe hours and completed 32 884 cycles.
