AIRCRAFT INCIDENT SHORT REPORT

CA18/3/2/1229: ZS-VRA, Nose landing gear collapse during landing because the emergency landing gear extension T-handle was not pulled as required by POH.

Date and time : 10 November 2018, 0758Z
Location : Progress Aerodrome, Port Elizabeth (FAPZ)
Aircraft registration : ZS-VRA
Aircraft manufacturer and model : Vulcanair P.68R
Last point of departure : Progress Aerodrome, Port Elizabeth (FAPZ)
Next point of intended landing : Progress Aerodrome, Port Elizabeth (FAPZ)
Location of incident site with reference to easily defined geographical points (GPS readings if possible) : Progress Aerodrome, Port Elizabeth (FAPZ)
: 33°55'30"S 025°22'20"E elevation 740,feet AMSL
Meteorological Information : Surface wind: 250°/10 kt, temperature: 20°C, visibility: +10 km
Type of operation : Training (Part 141)
Persons on board : 1+2
Injuries : None
Damage to aircraft : The aircraft sustained minor damage.

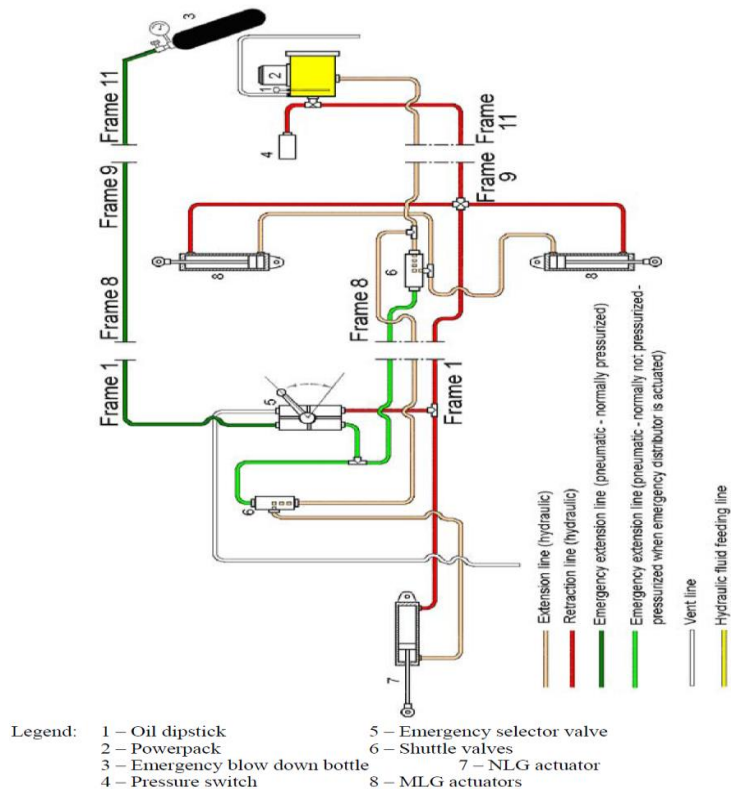
Figure 5: Schematic of the Vulcanair P.68 landing gear hydraulic system and emergency pneumatic system. (Source: Vulcanair P.68R POH)

- 2.10 Post-incident inspection by the AMO revealed no malfunctions with the hydraulic landing gear system. No leaks were visible during the operation of the landing gear. The damage sustained by the aircraft was minor which was limited to the nose landing gear doors and rod ends.

- 3.12 The investigation revealed that the nose gear collapsed on landing as a result of the extended nose gear not locked. The failure of the down lock mechanism was undetermined as the landing gear extension and retraction system operated normal during the testing post the accident.
