AIRCRAFT SERIOUS INCIDENT SHORT REPORT

CA18/3/2/1233: ZS-PHX, un-commanded auto feather of the left hand propeller while passing FL110 during the climb phase

Date and time : 22 November 2018, 0854Z
Location : 8.8 nm east of O.R. Tambo International Airport
Aircraft registration : ZS-PHX
Aircraft manufacturer and model : Beechcraft (Textron) B1900D
Last Point of departure : O.R. Tambo International Airport (FAOR), Gauteng
Next point of intended landing : Londolozi Aerodrome (FALD), Mpumalanga
Location of incident site with reference to easily defined geographical points (GPS readings if possible) : 8.8 nm east of O.R. Tambo International Airport (FAOR), overhead Petit Airfield in Bronkhorstspuit, Gauteng: S26°05'06" E028°23'24"
Meteorological Information : FAOR METAR at 0930Z: temperature: 23°C, dew point: 2°C wind: 280°/6 kts, variable between 240° and 360°, Ceiling and visibility OK, QNH: 1020 hPa
Type of operation : Commercial (Part 135)
Persons on board : 2 + 9
Injuries : None
Damage to aircraft : None

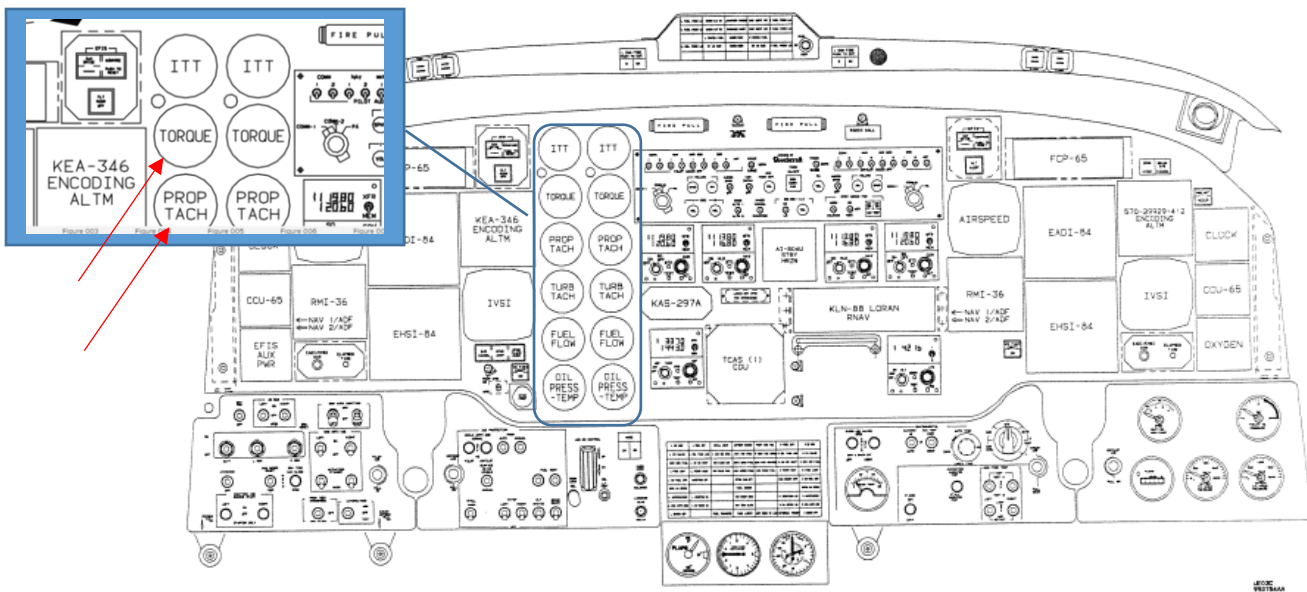
- 2.2 During the climb phase whilst passing through flight level (FL)110 and 8.8 nm east of FAOR, the crew noticed a reduction in the left-hand propeller revolutions per minute (RPM) and torque indicators. The left-hand propeller subsequently entered an un-commanded feather position following the reduction of the RPM. The crew declared a mayday and requested to return to FAOR. Other than the propeller RPM and torque indicator for the left engine displaying abnormal parameters, the remainder of the engine parameters were all-normal. This prompted the crew to elect not to shut down the left engine.

Figure 4: The location of the torque indicator and propeller RPM indicator on the flight deck of a B1900D airliner (B1900D systems description, section 3)

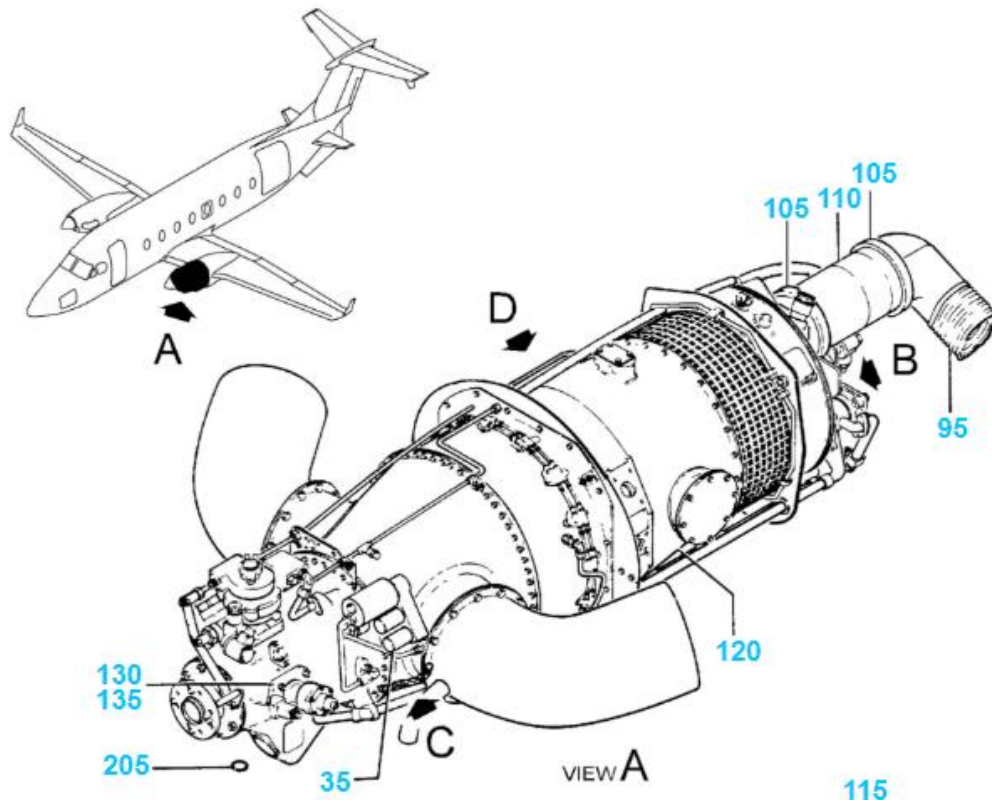
Figure 5: The B1900D is fitted with two Pratt and Whitney Canada PT6A-67D power plants (source: B1900D IPC, Figure 03: Sheet 1: POWER PLANT)
