AIRCRAFT INCIDENT REPORT AND EXECUTIVE SUMMARY

Reference:	CA18/3/2/1240	
Aircraft Registration	ZS-ARI	Date of Incident	6 January 2019		Time of Incident	0523Z
Type of Aircraft	Cirrus SR22T		Type of Operation	Private Part 91		
Pilot-in-command Licence Type	Private Pilot Licence	Age	74		Licence Valid	Yes
Pilot-in-command Flying Experience	Total Flying Hours	1585		Hours on Type	700	
Last point of Departure	Lanseria Aerodrome (FALA), Gauteng Province					
Next Point of Intended Landing	Lanseria Aerodrome (FALA), Gauteng Province					
Location of the incident site with reference to easily defined geographical points (GPS readings if possible)						
Lanseria International Aerodrome (FALA) Runway 07, S25°56.64' E 027°55.30'						
Meteorological Information	Wind:100/03KT; Visibility: CAVOK; Temperature: 19°C; Dew point: 14°C: QNH: 1020					
Number of People On-board	1 + 1	No. of People Injured	0		No. of People Killed	0
Synopsis	<p>The aircraft took off from Lanseria International Aerodrome (FALA) on Runway (RWY) 07 at 0520Z with a pilot and a passenger on-board for exercises within the circuit in relation to the private pilot licence (PPL) renewal. The first circuit was completed without a

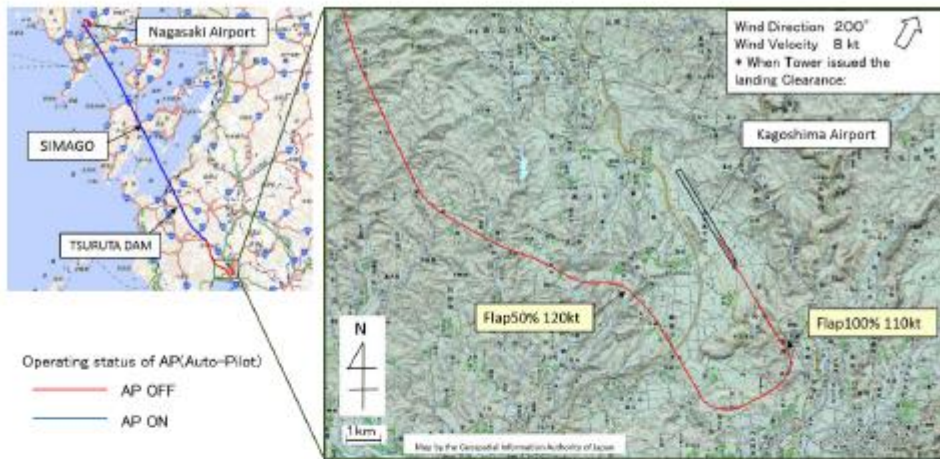
Figure 1 Estimated Flight Route

- 13:18:20 The Aircraft started final approach at ground altitude 620 ft and IAS 110 kt.
- 13:18:26 The Tower added the traffic information of the preceding arrival aircraft in process of vacating the runway, issued landing clearance to the runway 34 and reported wind direction 200° and wind velocity 8 kt. The Aircraft read back.

- 13:19:22 The Aircraft touched down on the runway 34.
- 13:19:50 The Aircraft reported to have the nose landing gear collapsed and stranded. The Tower acknowledged and made an emergency call.

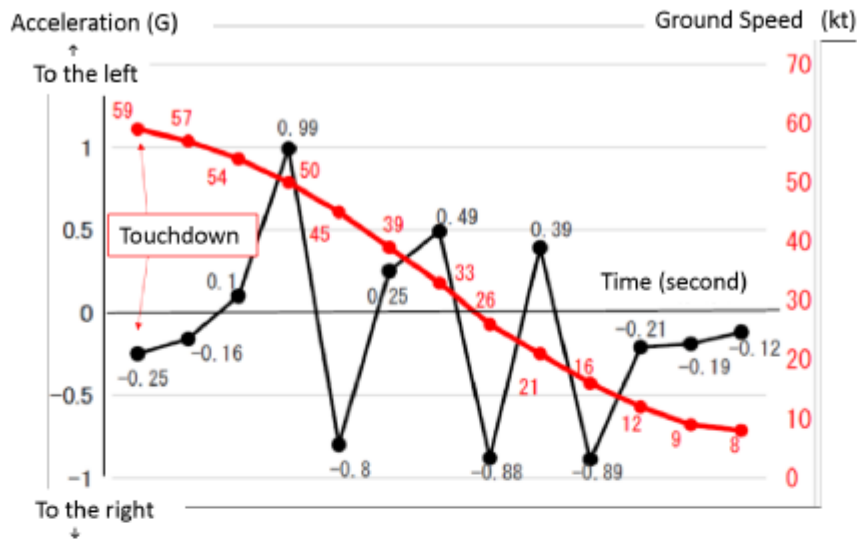
Figure 5 Lateral Acceleration and Ground Speed variations
(Measuring values: once per second)

From the 29 times to vacate from the taxing T2 by the control of the Captain, the lateral acceleration after the touchdown was within the range of 0.14 G to 0.99 G. The variation of lateral acceleration and ground speed after the touchdown at the time to mark the 0.99 G for the lateral acceleration are as shown in Figure 5. Furthermore, including this case, the similar landing cases with wide swing of lateral acceleration to + and - were saved as in Table 1.

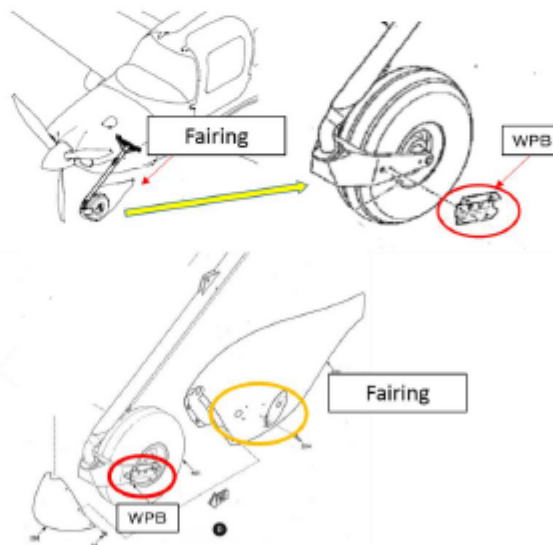
Figure 6 Fairing and WPB

Number of Replacement	Date of Replacement	Number of Landing
First time	October 15, 2015	88 times (since receiving the plane)
Second time	December 26, 2015	66 times (since the first replacement)
Third Time	March 13, 2016	63 times (since the second replacement)

There was no malfunction to require to replace WPB of other several aircrafts of the same type managed by the Maintenance company.

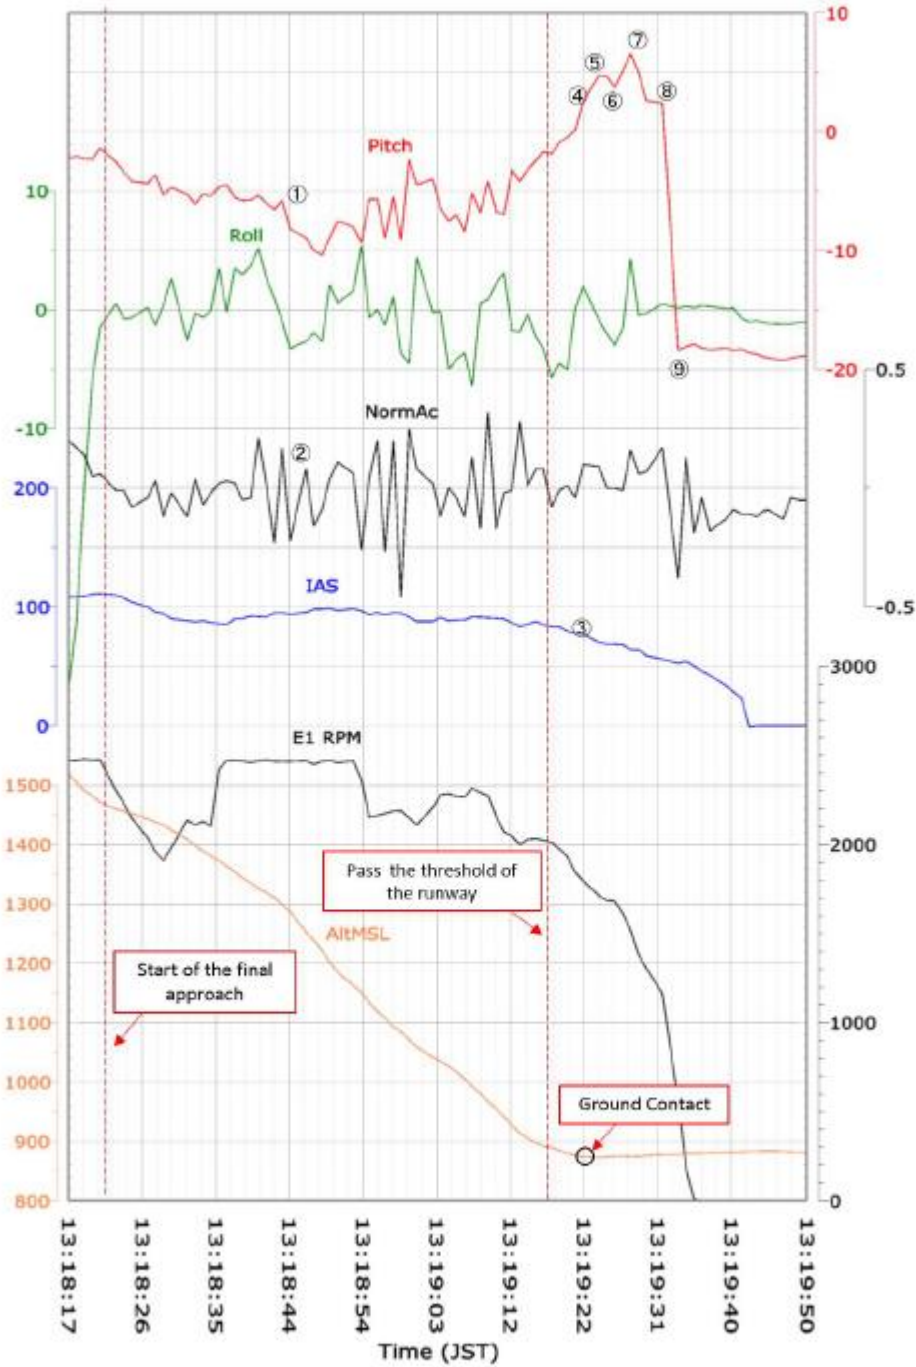
Appended Figure 2: Records of ADL

According to the records of ADL (see 2.7), the Aircraft was at the ground altitude of 620 ft and the airspeed of 110 kt at the time to complete the turning for the final approach. Then, as shown in Appended Figure 2, ① and ②, there were the fluctuation in pitch angle between about -10° and -2° from the ground altitude of 400 ft and the fluctuation in a vertical acceleration^{*4} between about -0.5 G and +0.3 G, which continued till near the runway threshold. After that, without big fluctuations in the pitch angle, the Aircraft touched down at approximately 340 m inside of the runway threshold.
