AIRCRAFT INCIDENT SHORT REPORT

CA18/3/2/1241: Forced landing following an engine failure on final approach

Date and time : 12 January 2019 at 1210Z
Aircraft registration : ZS-IIL
Aircraft manufacturer and model : Cessna Textron, C182N
Last Point of departure : Grand Central Aerodrome (FAGC)
Next point of intended landing : Iwamanzi Game Lodge, Koster, North West
Location of incident site with reference to easily defined geographical points (GPS readings if possible) : S25°52'52" E026°59'41", 6nm east of Koster
Meteorological information : FARG METAR: wind: 330°/5kt; temperature 32°C; dew point: 18°C; QNH: 1012 hPa
Type of operation : Private (Part 91)
Persons on board : 1 + 1
Injuries : None
Damage to aircraft : Substantial

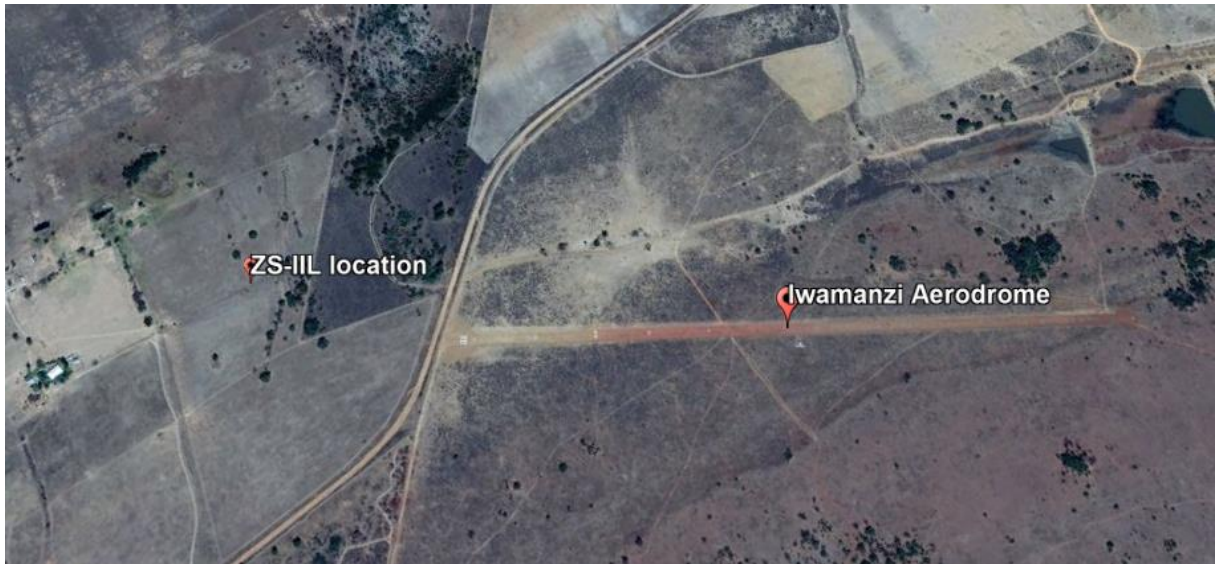
Figure 5: Location of the accident site
(Source: Google Earth)

- 2.4 When it became evident that the engine would not start, the pilot configured the aircraft for landing. He saw telephone lines near the threshold of Runway 33 and he deemed it unsafe to attempt to clear the lines. He chose to land the aircraft in a field approximately 300m short of threshold of Runway 33.

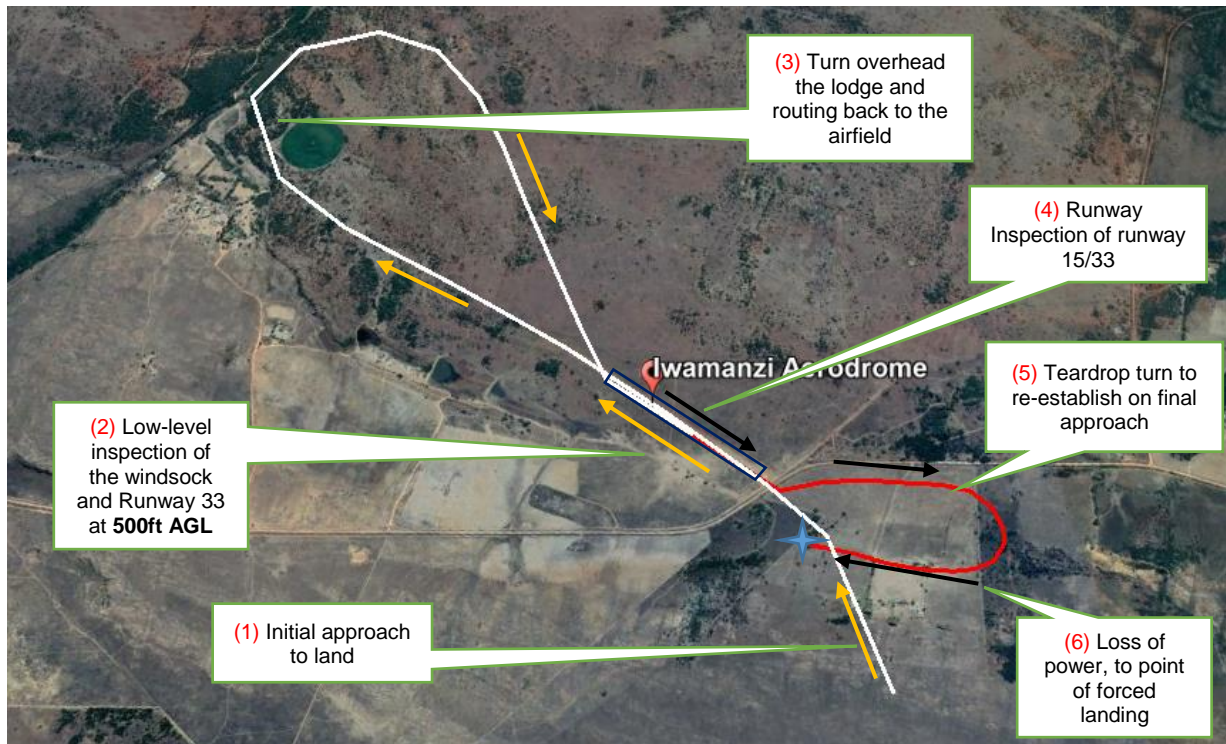
Figure 6: The approach to land was broken up into two sectors. The initial approach (white path and orange arrows) followed by the second runway inspection and final approach to land (red path and black arrows) (Source: Google Earth)
