AIRCRAFT INCIDENT REPORT AND EXECUTIVE SUMMARY

Reference:	CA18/3/2/1261	
Aircraft Registration	ZS-SJH	Date of Incident	19 April 2019		Time of Incident	1430Z
Type of Aircraft	Boeing 737-800		Type of Operation		Commercial (Part 121)	
Pilot-in-command Licence Type		Airline Transport Pilot Licence	Age	49	Licence Valid	Yes
Pilot-in-command Flying Experience		Total Flying Hours	6360		Hours on Type	2307
Last Point of Departure		O.R. Tambo International Aerodrome (FAOR) – Gauteng Province				
Next Point of Intended Landing		Cape Town International Aerodrome (FACT) – Western Cape Province				
Location of the incident site with reference to easily defined geographical points (GPS readings if possible)						
On taxiway "Alpha" where it intersects with taxiway "November" at O.R. Tambo International Aerodrome (FAOR) at GPS co-ordinates: 26° 07' 06.30" South 028° 14' 28.92" East and at an elevation of 5508 feet.						
Meteorological Information		Wind direction: 320°; Wind speed: 14kts; Temperature: 24°C; Visibility: +10km; Dew point: 11°C; Cloud base: 4500ft

Reference Number : CA18/3/2/1261
Name of Owner/Operator : Mango Airlines
Manufacturer : Boeing Aircraft Company
Model : 737-800
Nationali

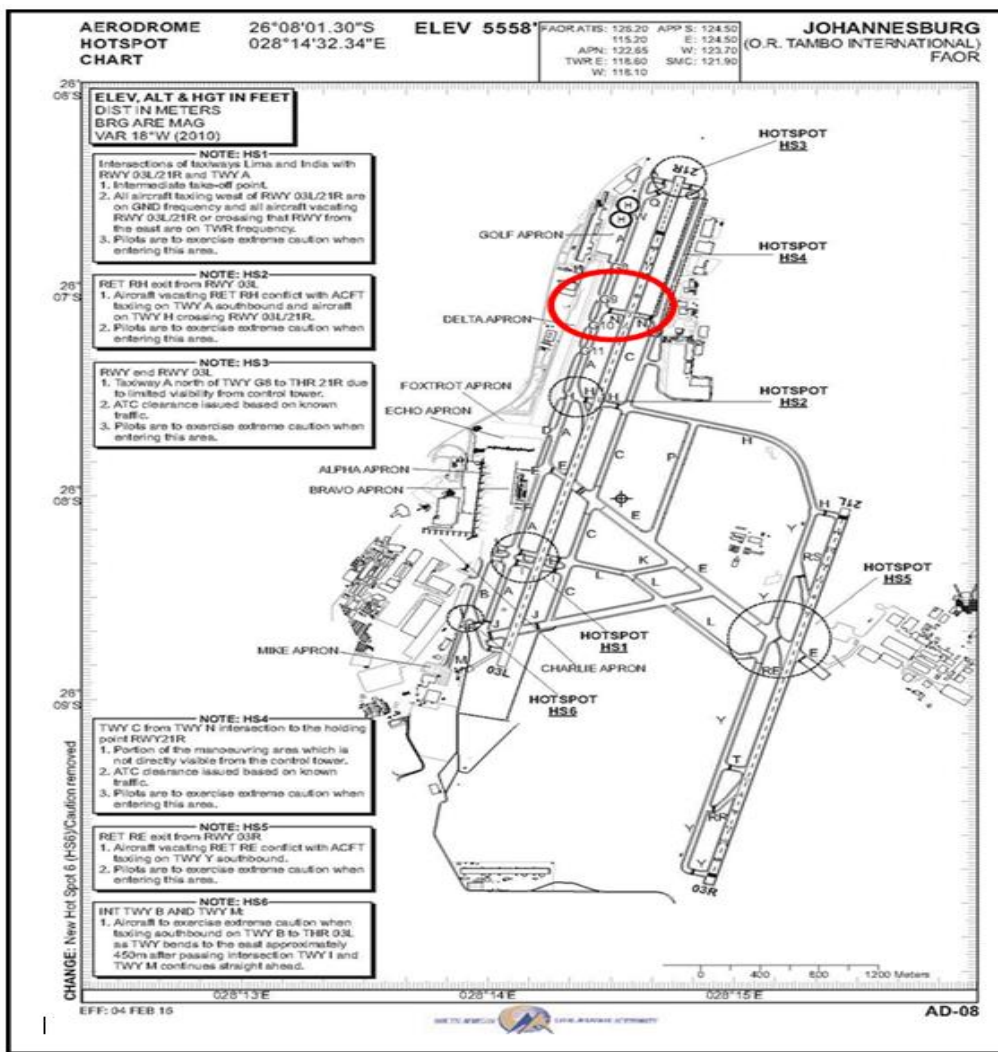
Figure 7: Shows FAOR Aerodrome hot spot chart.

1.10.1 Both aircraft have an overall length of 39.47 metres (m) with a wingspan of 35.79m. The distance from the holding point Echo to the centreline of Alpha is 54.7m, which leaves the area of manoeuvrability to be 18.91m. The FO stated that ZS-ZWV aircraft's nose wheel was 5m short of holding point lines. The 5m was not taken into consideration as the radome of the aircraft would have been above the holding point lines. The total length from the holding point line to the end of taxiway Alpha is 68.5m.
