Accident and Incident Investigations Division

AIRCRAFT SERIOUS INCIDENT REPORT AND EXECUTIVE SUMMARY

Reference:	CA18/3/2/1264	
Aircraft Registration	ZS-DFJ	Date of Incident	5 April 2019		Time of Incident	0546Z
Type of Aircraft	Dassault Aviation Falcon 900B		Type of Operation	Air Transport (Part 135)		
Pilot-in-command Licence Type	ATPL		Age	51	Licence Valid	Yes
Pilot-in-command Flying Experience	Total Flying Hours		5328		Hours on Type	1550
Last point of departure	Robert Gabriel Mugabe International Airport (FVRG), Zimbabwe					
Next point of intended landing	Victoria Falls International Airport (FVFA), Zimbabwe					
Location of the incident site with reference to easily defined geographical points (GPS readings if possible)						
50 nm South-East of FVFA (18° 33' 36" South, 026° 44' 00" East)						
Meteorological Information	Wind: 120°/8 kt, Temperature: 23°C, Dew point: 8°C, Visibility: CAVOK, QNH: 1023 hPa					
Number of people on-board	2 + 8	No. of people injured	0	No. of people killed	0	
Synopsis

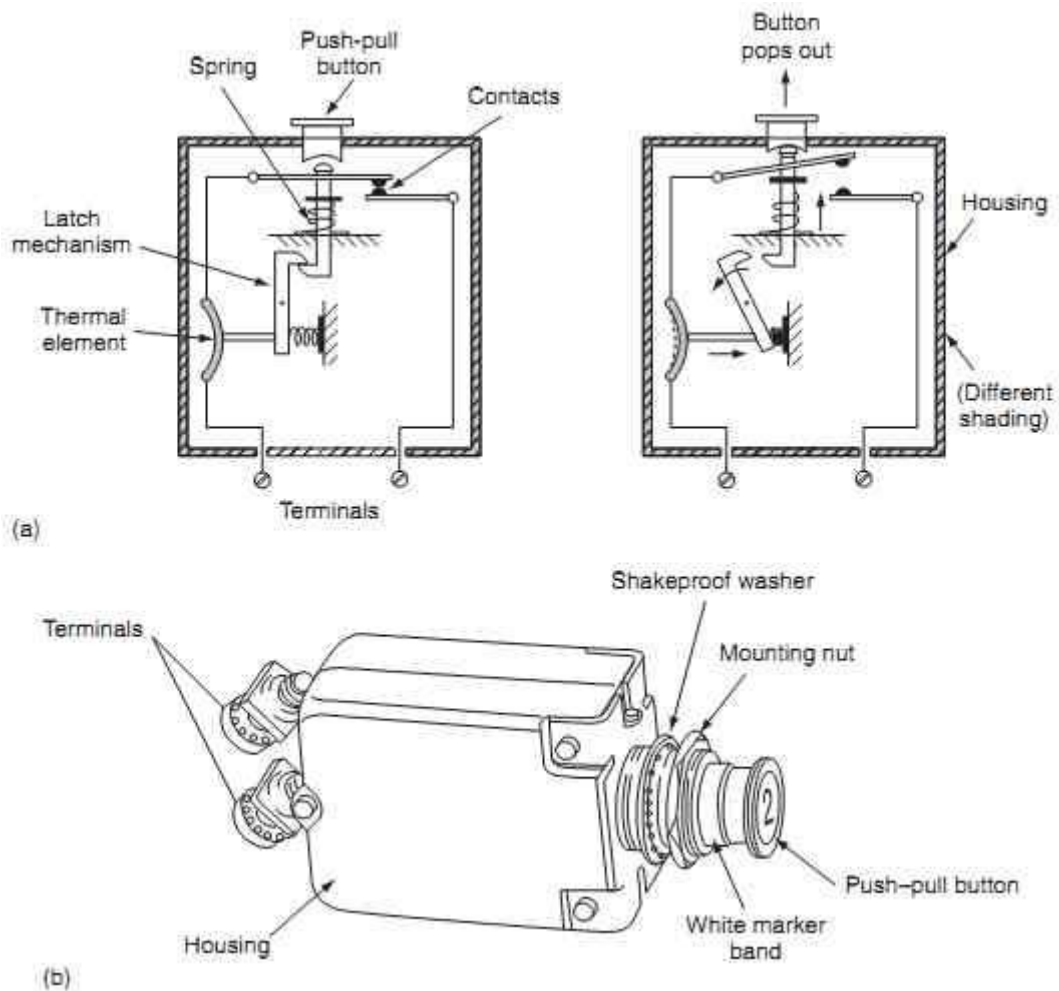
1.16.7 With reference to Figure 12, during normal operation, the thermal element remains in place and the latch mechanism holds the button in place. This keeps the current flowing through the circuit. If an overheat condition occurs, the thermal element expands, which then pulls back the latch mechanism and the spring-loaded button pops out. This causes a break in the circuit, essentially switching the system off.

Figure 12: A typical aircraft circuit breaker. (Source: <http://www.industrial-electronics.com>)
