Accident and Incident Investigations Division

AIRCRAFT INCIDENT REPORT AND EXECUTIVE SUMMARY

Reference:	CA18/3/2/1273		
Aircraft Registration	ZS-ZWE	Date of Incident	8 July 2019		Time of Accident	1112Z	
Type of Aircraft	Boeing 737-800NG		Type of Operation	Commercial (Part 121)			
Pilot-in-command Licence Type	Airline Transport Pilot Licence			Age	41	Licence Valid	Yes
First Officer Licence Type	Airline Transport Pilot Licence			Age	30	Licence Valid	Yes
Pilot-in-command Flying Experience	Total Flying Hours	10569	Hours on Type	6879			
First Officer Flying Experience	Total Flying Hours	3459	Hours on Type	1012.5			
Last Point of Departure	Cape Town International Aerodrome (FACT), Western Cape Province						
Next Point of Intended Landing	Lanseria International Aerodrome (FALA), Gauteng Province						
Location of the incident site with reference to easily defined geographical points (GPS readings if possible)							
In-flight south of Potchefstroom Aerodrome (FAPS) FAR75 at position 30nm from FALA

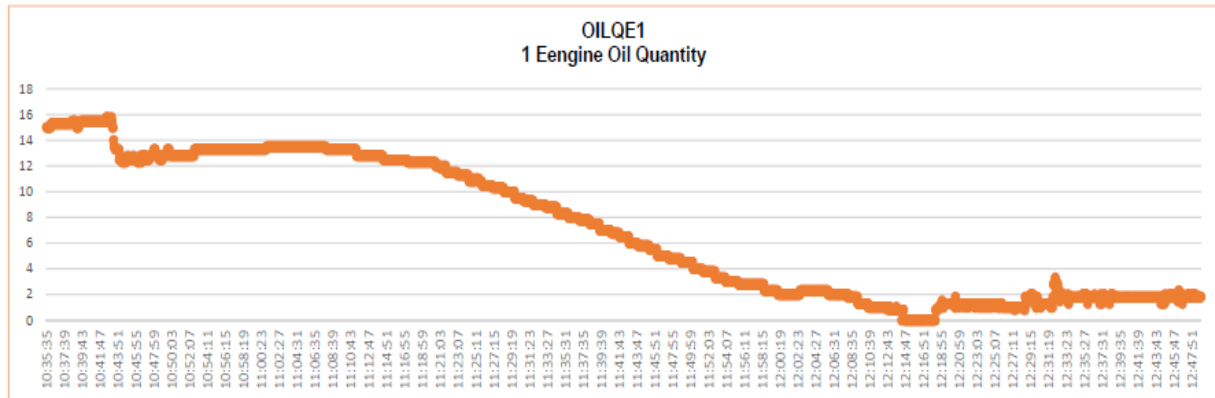
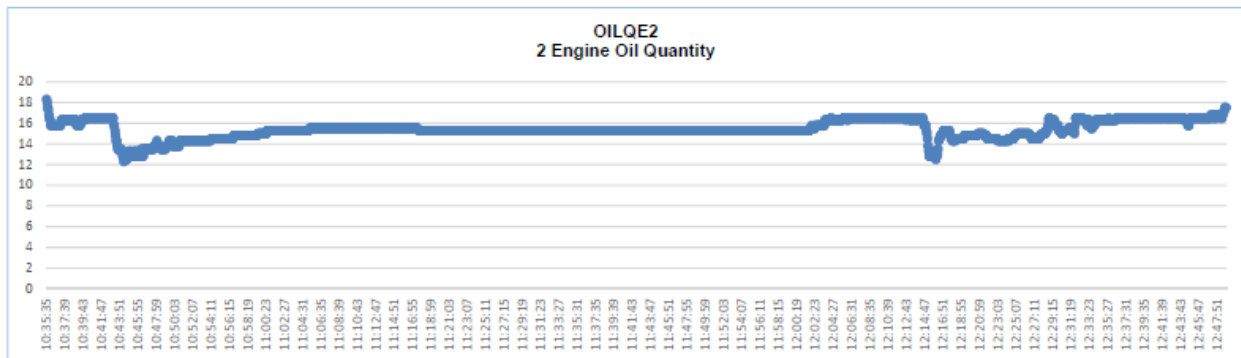
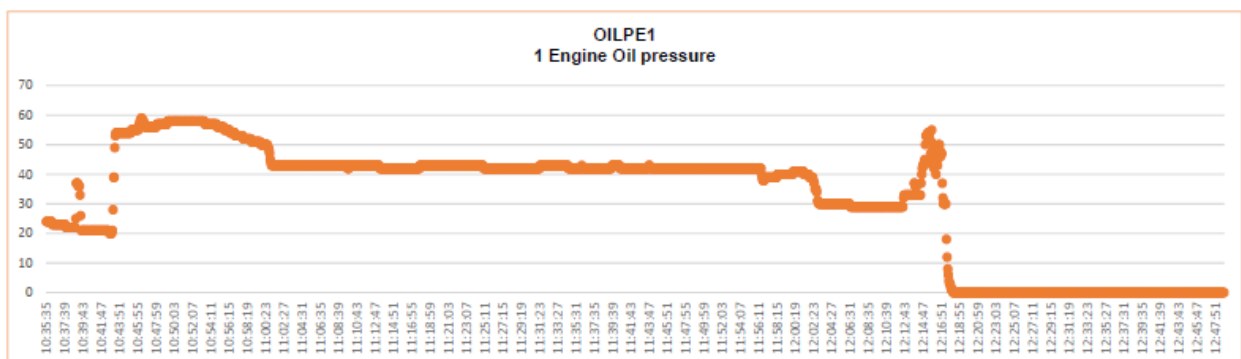
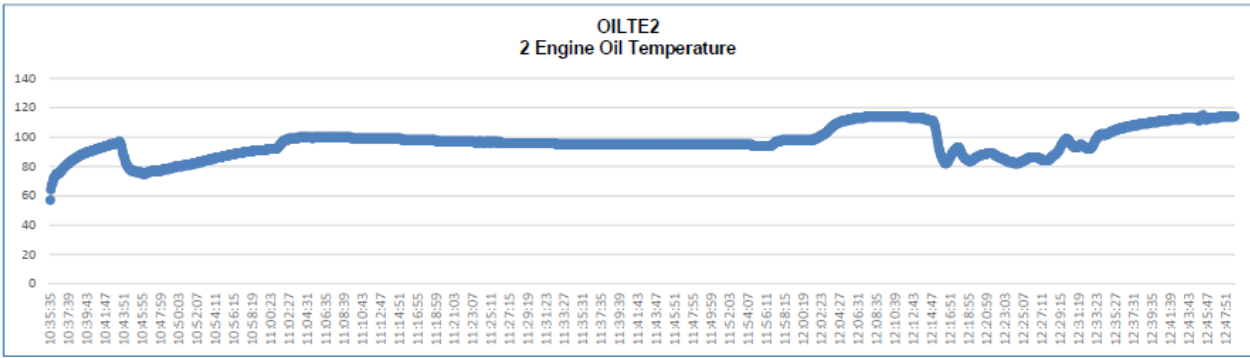
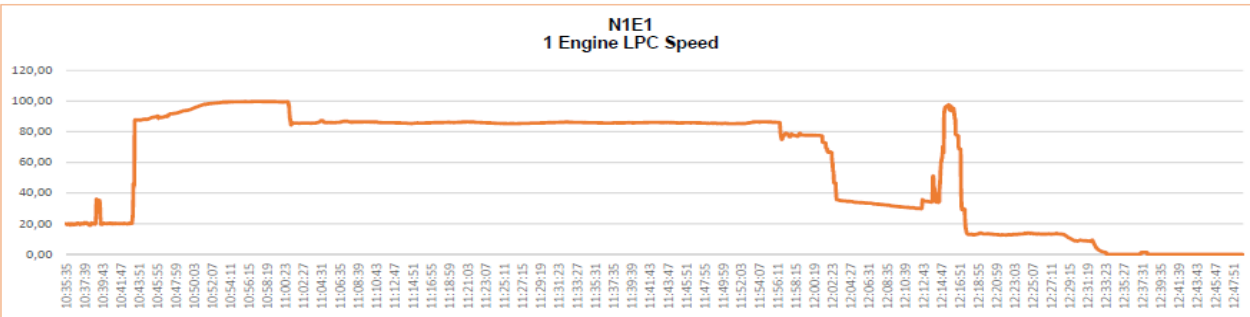
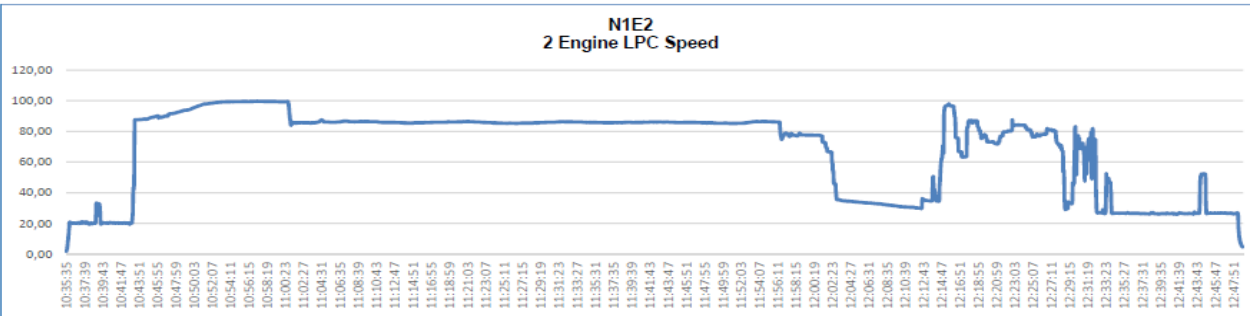
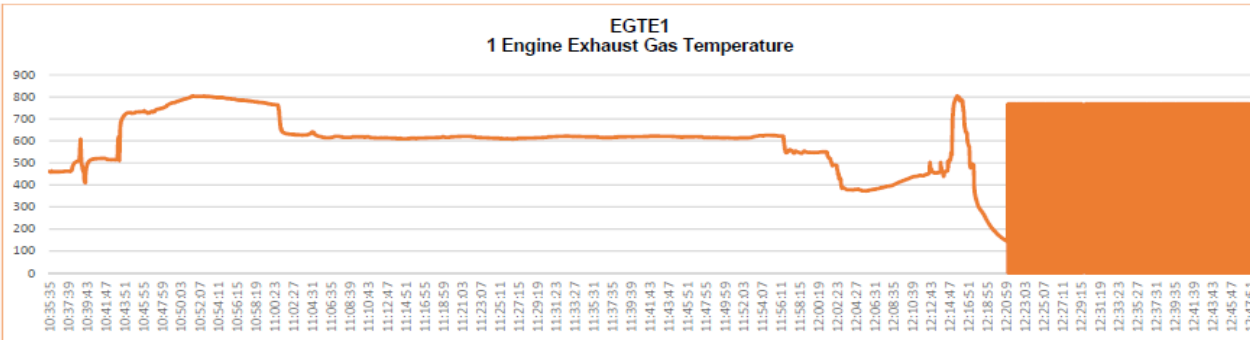
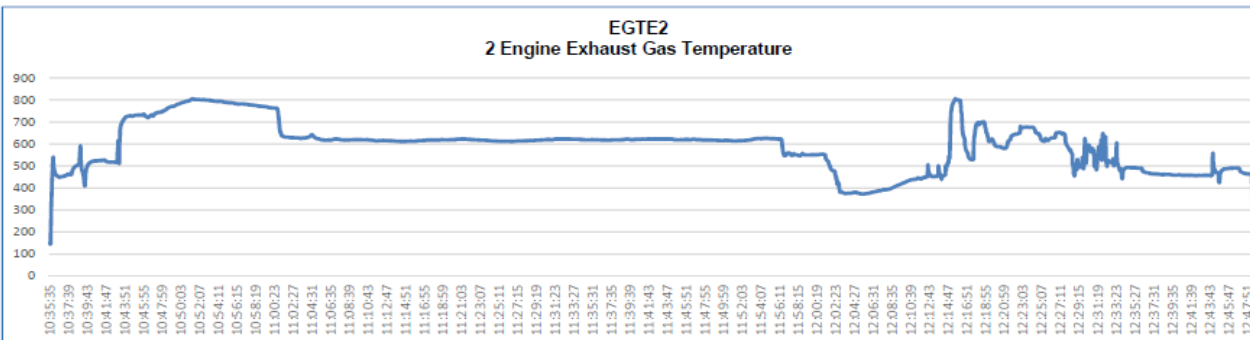
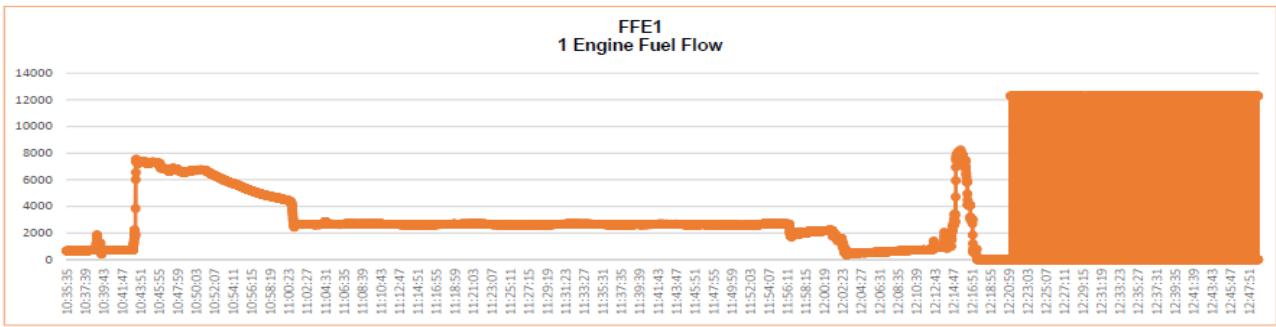
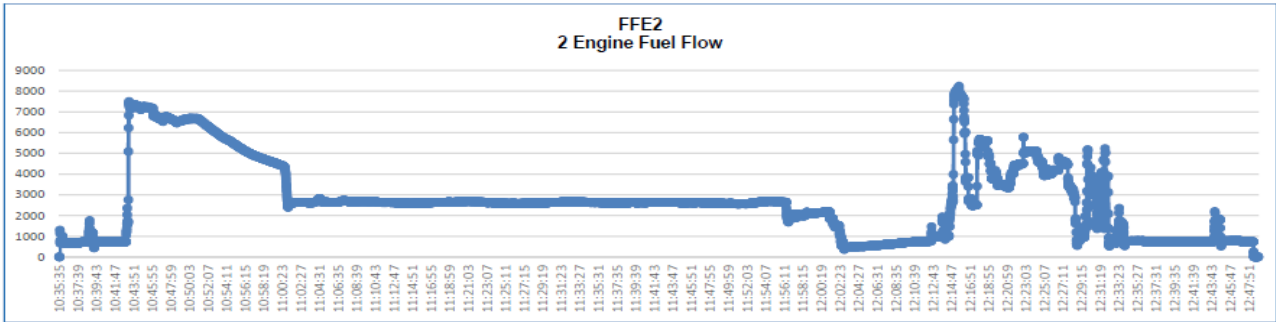
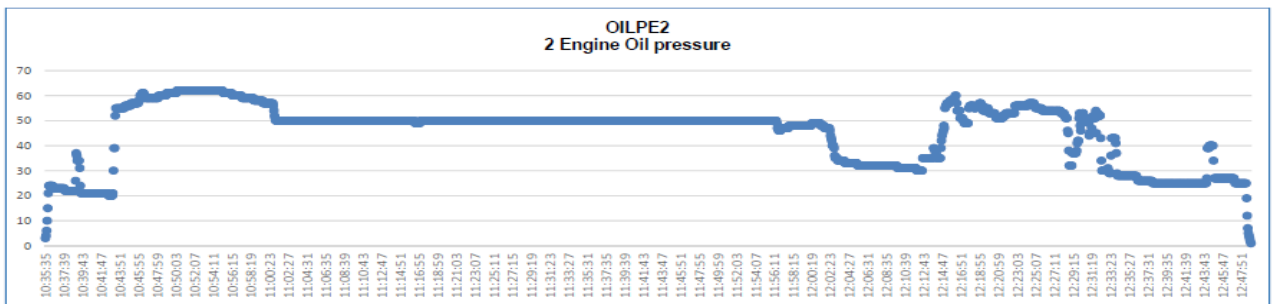
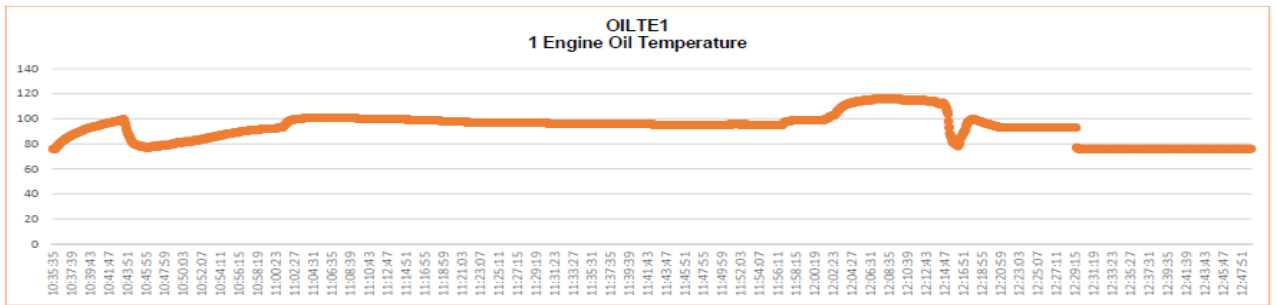
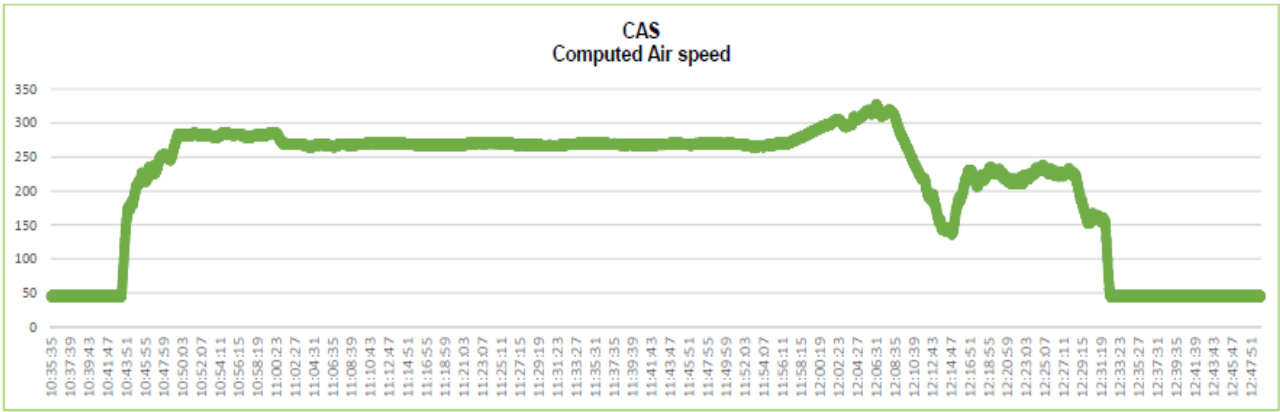
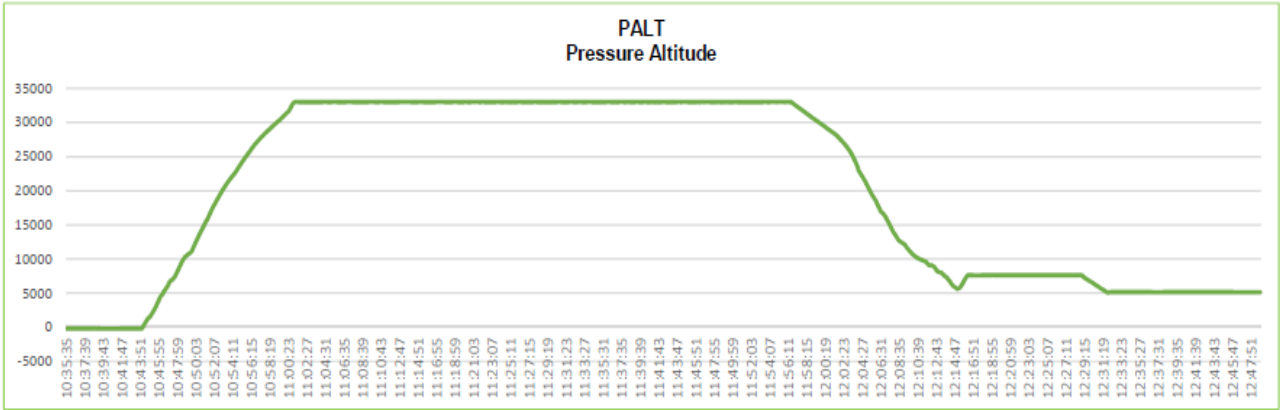
DFDR Graphs – Summary

1. The first indication of a reduction in number 1 engine oil quantity was at 11:11:25, with 12.8 units recorded. The previous recording was at 11:07:53, which was 06min 24sec earlier with 13.3 units of oil recorded.
2. The number 1 engine oil quantity continued to drop at a constant rate during the cruise up to 3 units remaining at 11:54:01. The number 1 engine oil quantity dropped at a slower rate during the descent to 1 unit at 12:10:29.
3. The number 1 engine oil quantity dropped to 0 units during the go-around at 12:14:37. Number 1 engine fuel flow was reduced to 0 at 12:17:32, which was 02min 55sec after the oil quantity was 0 units.
4. The number 1 engine oil pressure dropped to 0 at 12:18:12, which was 40sec after the fuel flow was shut down.
5. The number 1 engine oil drained from 13.3 units to 0 units in 1hr 6min 44sec (from 11:07:53 to 12:14:37).
