AIRCRAFT INCIDENT REPORT AND EXECUTIVE SUMMARY

Reference	CA18/3/2/1278	
Aircraft registration	ZS-JRM	Date of incident	20 August 2019		Time of incident	1825Z
Type of aircraft	Boeing 737-400		Type of operation		Air Transport Operation (Part 121)	
Pilot-in-command licence type	Airline Transport	Age	31	Licence valid	Yes	
Pilot-in-command flying experience	Total flying hours	5 703.2		Hours on type	3 535.7	
Last point of departure	Cape Town International Aerodrome (FACT), Western Cape					
Next point of intended landing	King Shaka International Aerodrome (FALE), Kwa-Zulu Natal					
Location of the incident site with reference to easily defined geographical points (GPS readings if possible)						
En route from FACT to FALE abeam Montagu (GPS position: South 33°46'30.20" East 020°06'56.82")						
Meteorological information	Surface wind: 220°/12kts; temperature: 14°C; dew point: 12°C: CAVOK					
Number of people on-board	2 + 4 + 134	No. of people injured	0	No. of people killed	0

Reference number : CA18/3/2/1278
Name of the Owner : Safair Operations (Pty) Ltd
Name of the Operator : FlySafair
Manufacturer : Boeing Aircraft Company
Model : 737-400
Nationality : South African
Registration mar

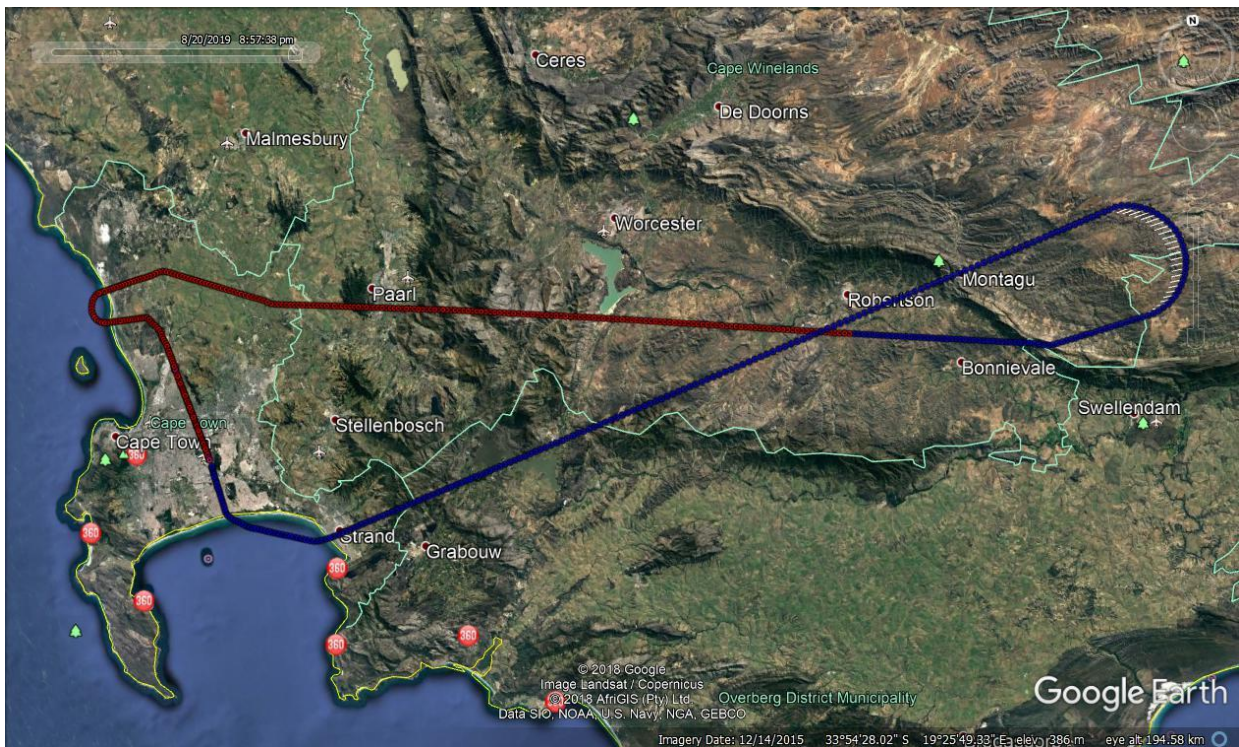
- 1.1.6 From the radar data depicted in Figures 2 and 3, the aircraft could be seen taking off from Runway 19 in a southerly direction (blue line) and was cleared to climb to FL330 en route to FALE. At approximately 1825Z, as they were passing FL310, the crew declared an emergency by broadcasting a Mayday and the emergency descent followed. At approximately 1831Z, the aircraft was observed levelling off at FL100. Shortly after, the Secondary Surveillance Radar (SSR) track changed colour from blue to red. That was when the crew changed the squawk code from the allocated code of 1561 to 7700, which is the emergency code.
- 1.1.7 The crew encountered the decompression incident overhead the town of Montagu, which was at a Geographical Positioning System (GPS) determined to be South 33°46'30.20" East 020°06'56.82", while flying at an altitude of approximately 31 000ft (FL310).

Figure 2: Google Earth overlay of the aircraft flight path after take-off from Runway 19 at FACT.

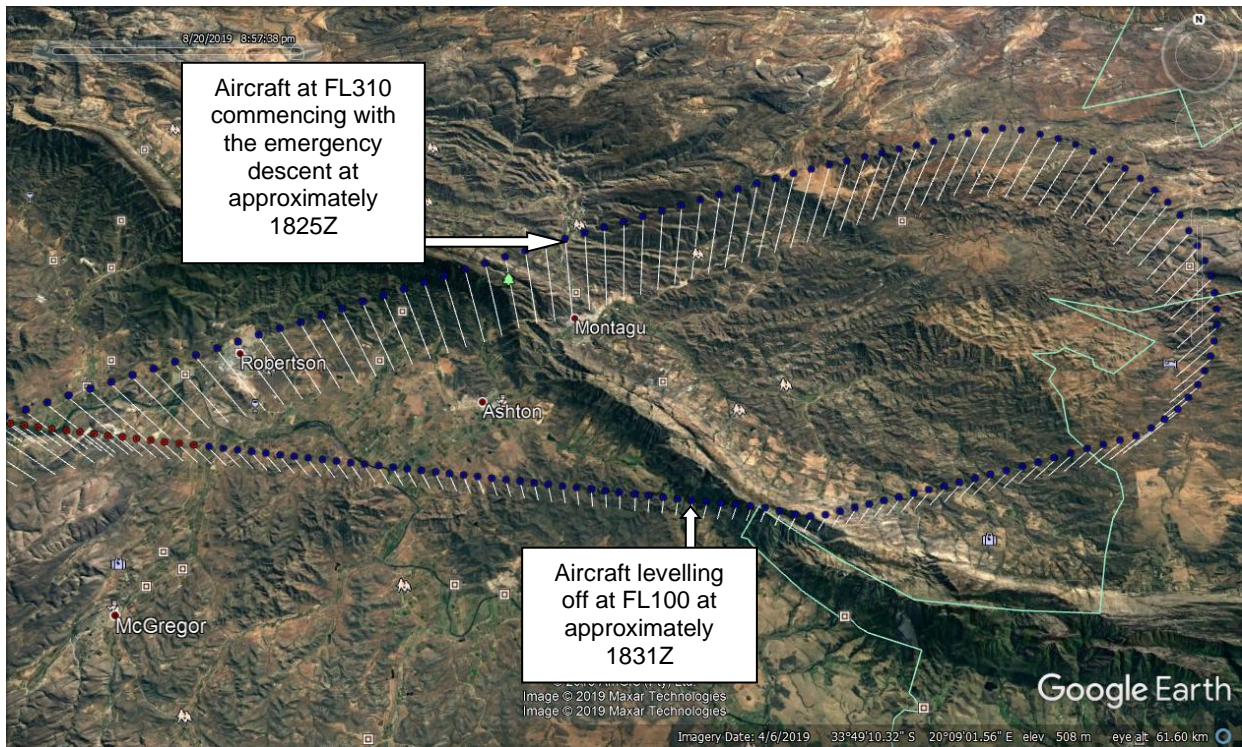
Figure 3: Google Earth overlay (radar data) indicating the emergency descending turn to the right.

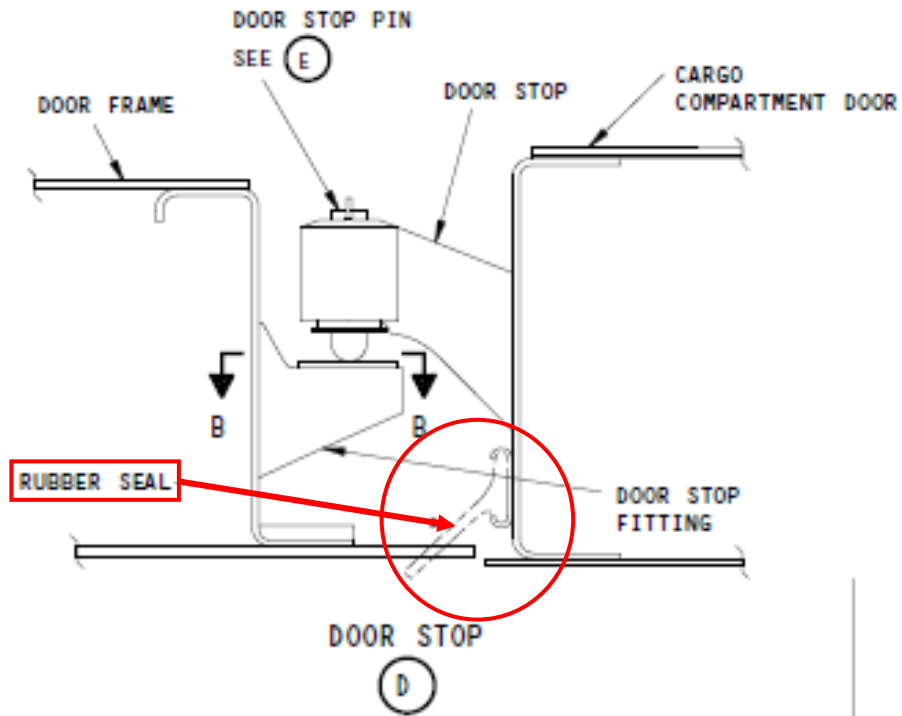
Figure 7: Schematic indicating the position of the cargo door pressure seal.

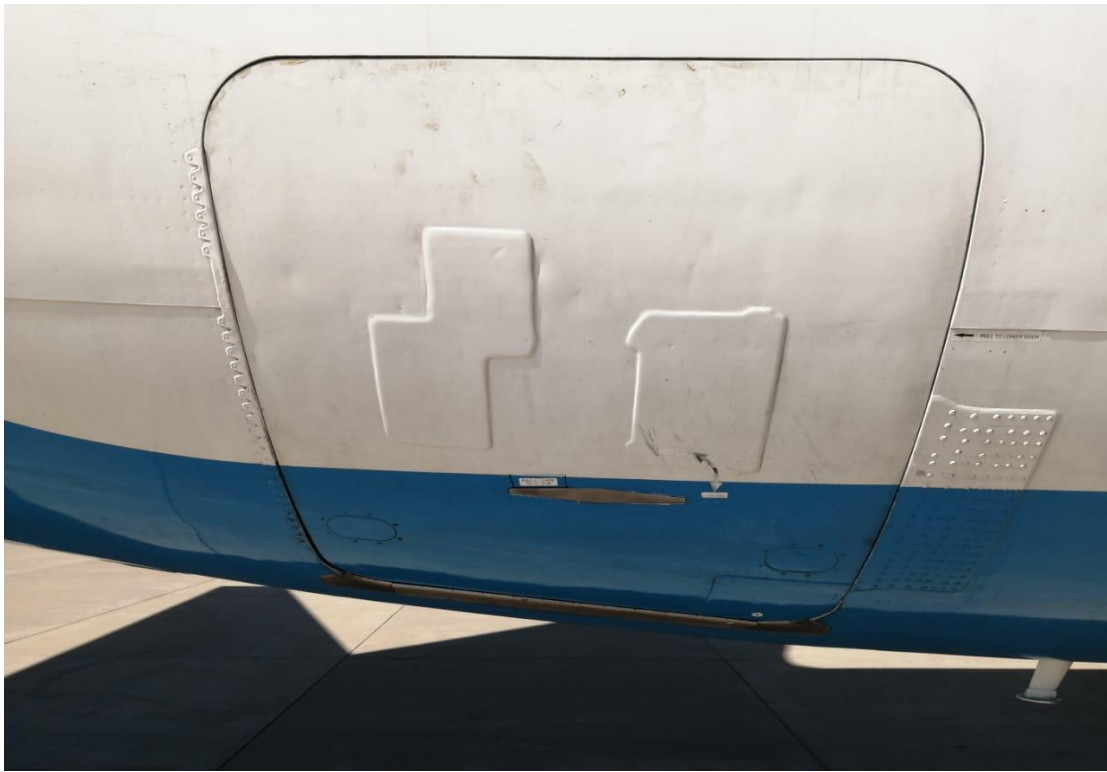
Figure 13: The aft cargo door in the closed position.

Approximately 84 centimetres (cm) of the cargo door pressure seal (entire bottom section – with door in the closed position) had separated during an inspection of the aft cargo door as a section of the seal was found protruding from the door while in the closed position. The ceiling in the cargo hold also displayed evidence of collapse as a result of the air that escaped from the pressurised fuselage when the seal finally failed and the pressure exited (was sucked out) the door structure.

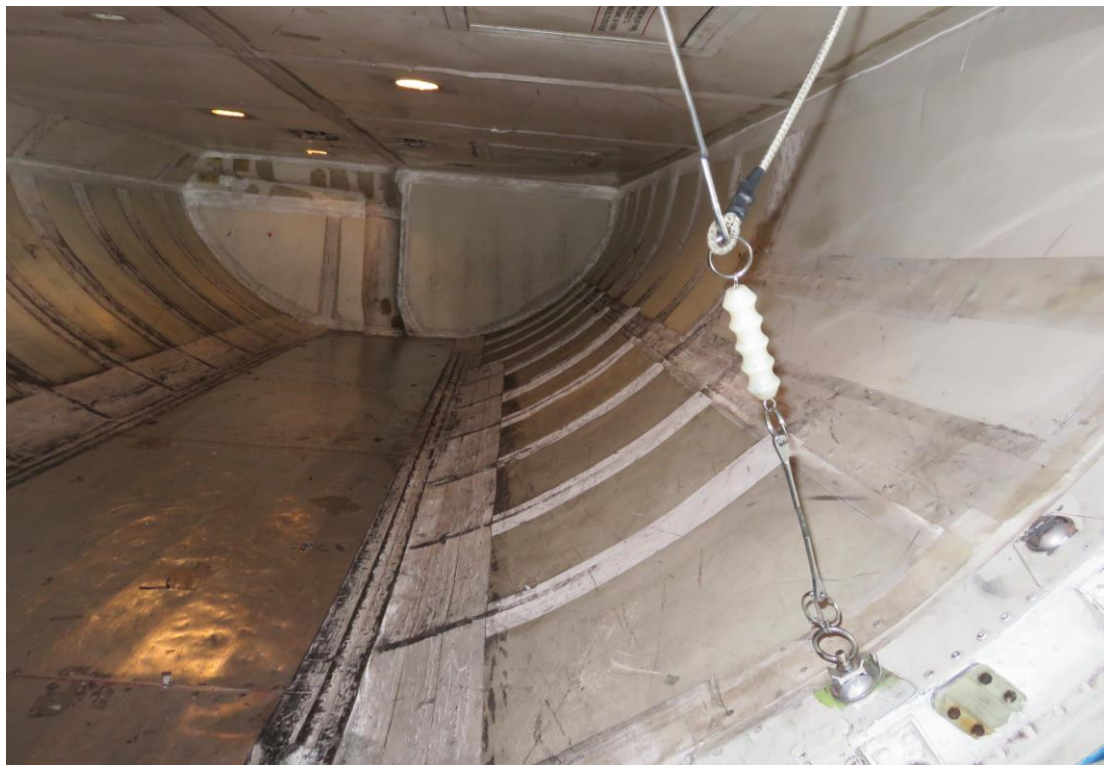
Figure 17: A view of the aft cargo compartment forward section with safety nets removed.

Another way the door pressure seal could potentially be damaged is when the safety nets that are required to be installed in the cargo hold to secure the baggage are in a dilapidated state or when the nets are not properly secured prior to the door being closed and during flight baggage obstructing the cargo door path when being opened. The area in the cargo hold where the door opens (directly behind the cargo door) should be free from any obstructions, and no baggage is to be packed/stored in that area. It is highly unlikely that the cockpit crew will be aware if any of the cargo door pressure seals have been damaged during loading or unloading as they do not leave the cockpit to inspect the aircraft during a turnaround. If there is any damage to the door pressure seal and the baggage handling company personnel does not report it via the correct channels during a routine turnaround flight, it is highly unlikely that anybody will notice unless the aircraft is being subjected to a maintenance inspection. It should be noted that the pressure seal is an on-condition item that needs to be physically inspected for degradation. According to the aircraft manufacturer, there were no SBs or ADs issued on the cargo door pressure seals by the time this incident occurred.
