AIRCRAFT INCIDENT REPORT AND EXECUTIVE SUMMARY

Reference:	CA18/3/2/1282	
Aircraft Registration	ZS-JRM	Date of Incident	16 September 2019		Time of Incident	0743Z
Type of Aircraft	Boeing 737-400		Type of Operation	Commercial (Part 121)		
Pilot-in-command Licence Type	Airline Transport Pilot Licence		Age	50	Licence Valid	Yes
Pilot-in-command Flying Experience	Total Flying Hours	17 673		Hours on Type	709:05	
First Officer Licence Type	Airline Transport Pilot Licence		Age	38	Licence Valid	Yes
First Officer Flying Experience	Total Flying Hours	7 266.02		Hours on Type	137.05	
Last Point of Departure	O.R. Tambo International Aerodrome (FAOR)					
Next Point of Intended Landing	Cape Town International Aerodrome (FACT)					
Location of the incident site with reference to easily defined geographical points (GPS readings if possible)						
FAOR Runway 03L, at GPS co-ordinates S26°07'32.72" E28°16'00.42"						
Meteorological Information	Wind: Variable/4kt; Visibility: 10km, Temperature: 24°C and Dew point: 4°C

Reference Number : CA18/3/2/1282
Name of Owner/Operator : Safair Operations (Pty) Ltd
Manufacturer : Boeing Aircraft Company
Model : 737-400
Nationality : South African
Registration Mar

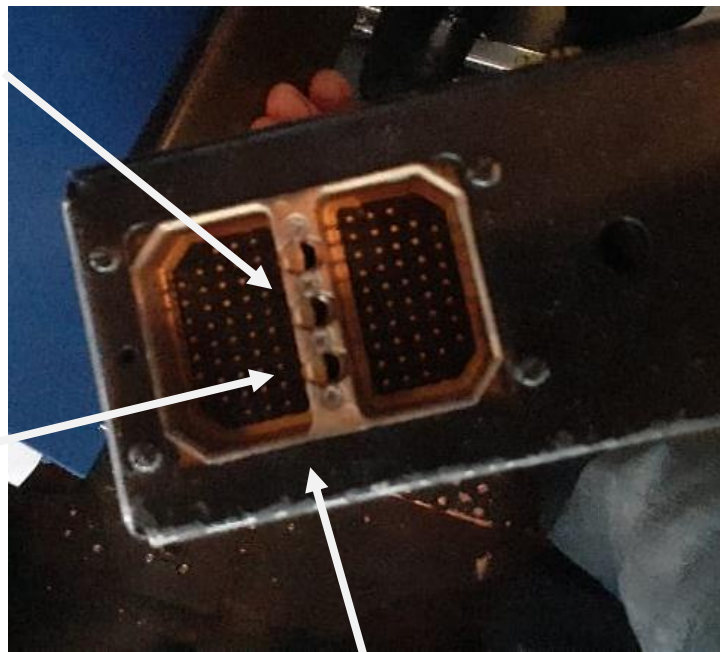
1.16.1 The GCUs are mounted on the electrical equipment rack and are fitted by sliding the unit rearwards into the tray with the handle lever in the open position and ensuring that the guide pins at the back of the component engage in the frame (Figure 2). Once the unit has been pushed in far enough, the hook at the bottom of the handle lever will engage with the fork assembly that is attached to the shelf (Figure 3). The handle lever is then moved into the locking detent securing the box in the tray (Figure 3). The Aircraft Maintenance Manual (AMM) provides further instructions to ensure that the handle and fork assembly have been correctly adjusted (Refer to Appendices 1 and 2).

Figure 2: Arrows showing guide pins on component.

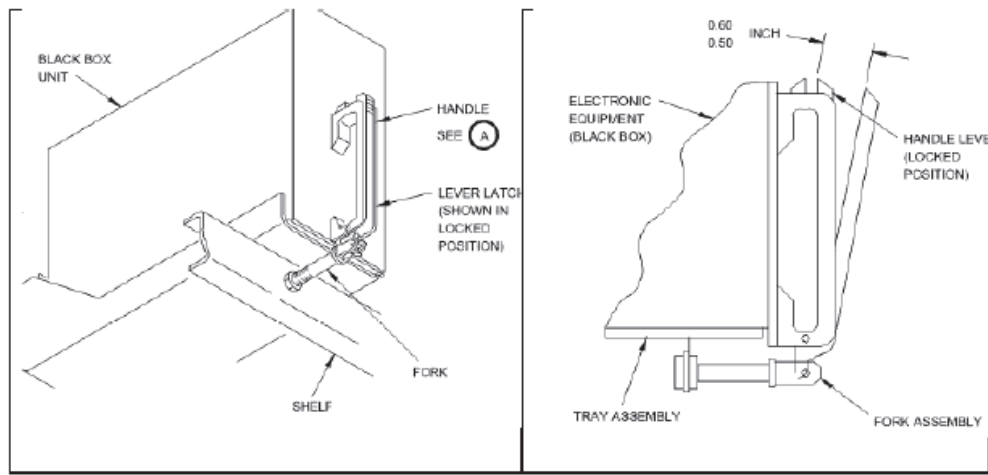
Figure 3: Racking of Generator Control Unit. (Source: AMM Boeing 737-300/400/500)
