**AIRCRAFT INCIDENT REPORT AND EXECUTIVE SUMMARY**

Reference:	CA18/3/2/1288	
<b>Aircraft Registration</b>	ZS-OBD	<b>Date of Incident</b>	16 October 2019		<b>Time of Incident</b>	1402Z	
<b>Type of Aircraft</b>	Cessna 172P		<b>Type of Operation</b>	Training (Part 141)			
<b>Pilot-in-command Licence Type</b>	Commercial Pilot Licence		<b>Age</b>	36	<b>Licence Valid</b>	Yes	
<b>Pilot-in-command Flying Experience</b>	Total Flying Hours		1780.9		Hours on Type	71.4	
<b>Last Point of Departure</b>	Rand Aerodrome (FAGM): Gauteng Province						
<b>Next Point of Intended Landing</b>	Rand Aerodrome (FAGM): Gauteng Province						
<b>Location of the incident site with reference to easily defined geographical points (GPS readings if possible)</b>							
A farm in Kalbasfontein, Randfontein, approximately 24nm south-west of FAGM at the following GPS co-ordinates: 26°38'26.73"S 027°47'12.38"E at an elevation of 4881 feet							
<b>Meteorological Information</b>	Wind: Light & variable, Temperature: 32°C, Visibility: CAVOK

SRP Date	13 October 2020		Publication Date	16 October 2020

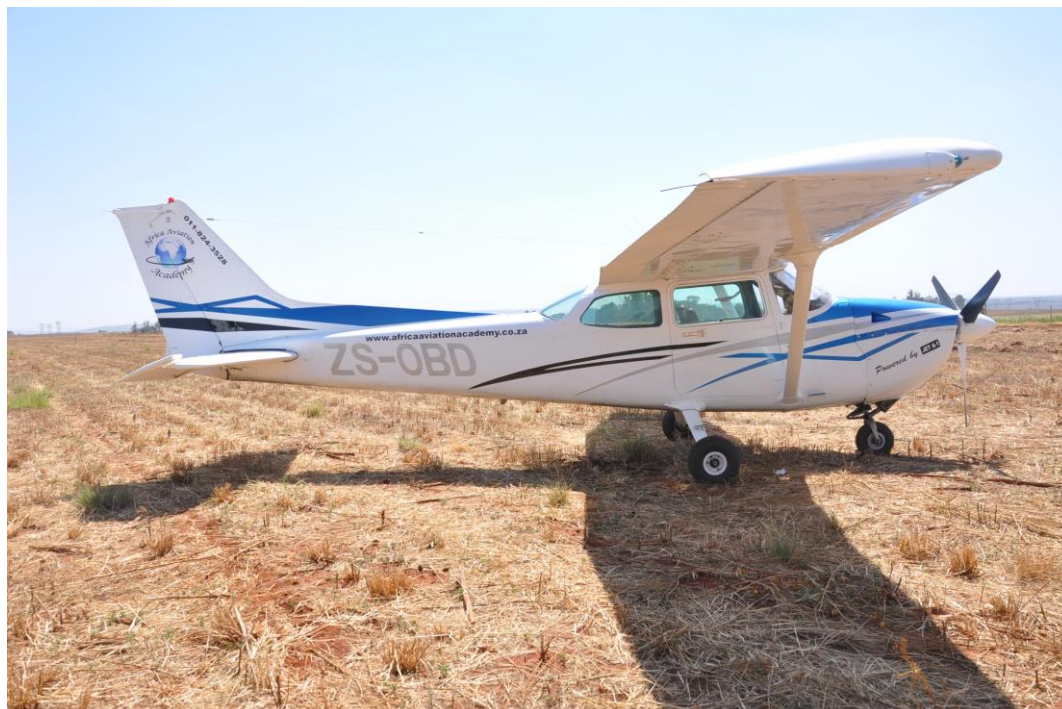
1.3.1 The aircraft was not damaged in the incident sequence.

Figure 1: The aircraft after the forced landing on a farm.

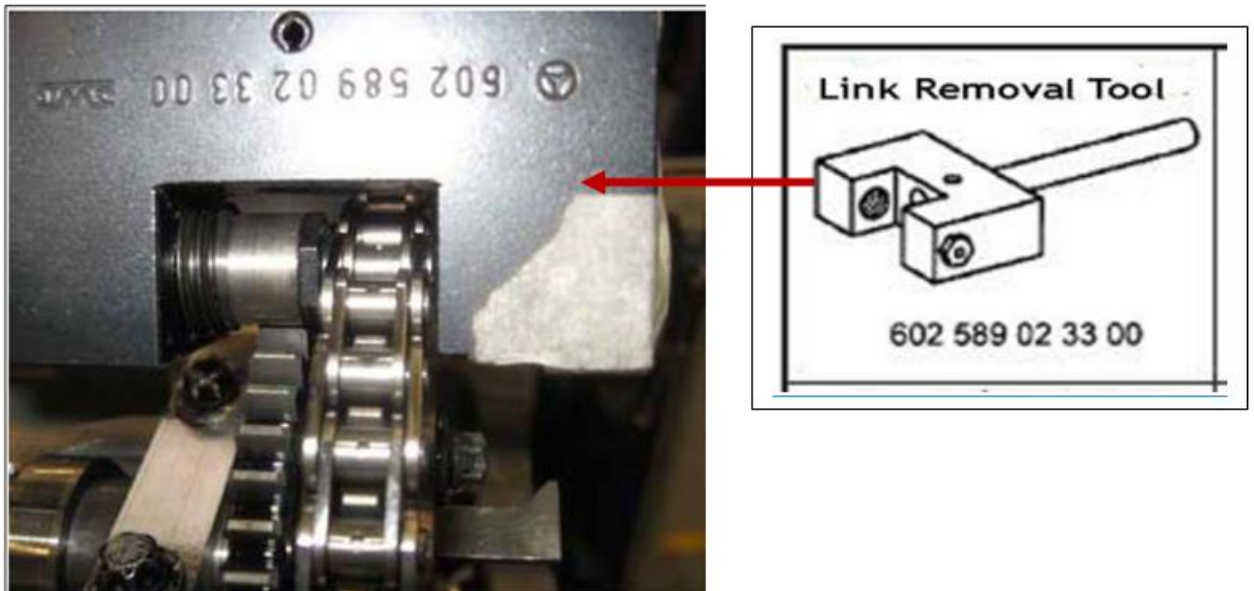
**Figure 8:** A special tool recommended by the manufacturer for the removal of the timing chain.

- It is possible to disconnect the timing chain using a special tool. But if the timing chain has been disconnected, it would not be possible to reconnect the same timing chain again. In that case, one would need to install a new timing chain. The new timing chain comes open with a special new pin which is closed by being pressed using a special tool. According to the AMO, a new pin was used to re-connect the timing chain, and part number VR 00308-00-01 and VR 00308-00-02 tools were used for the removal and assembly. (See Figures 6, 7, 8 and 9)

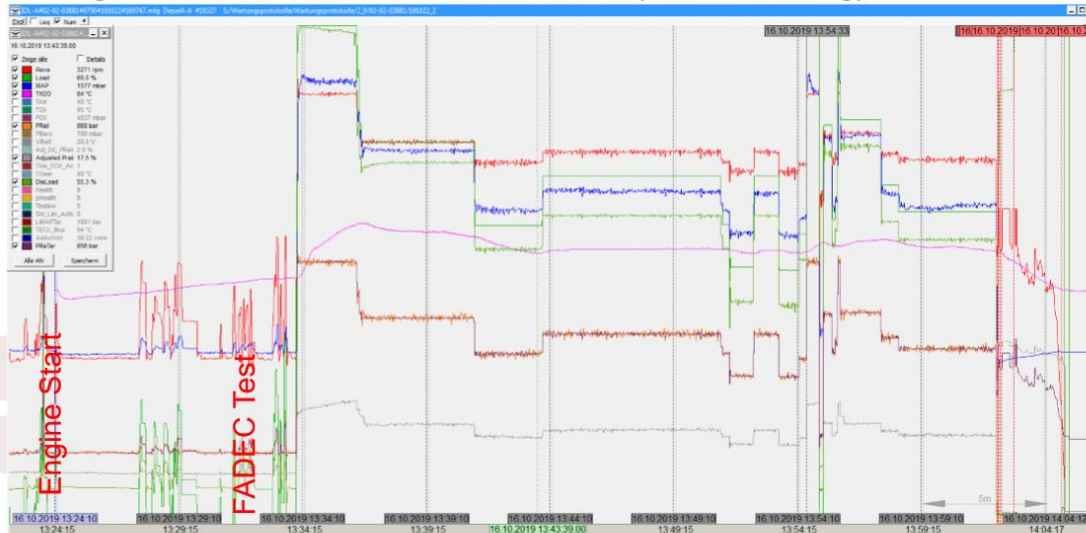
1.16.1 The FADEC was sent to Continental Aerospace Technologies in Germany, which is the engine manufacturer, for data downloading. The FADEC downloading had determined that there were several failed entries of the computer-aided manufacturing (CAM) sensor. The FADEC was missing the CAM sensor of the crankshaft and the rail pressure had dropped from 880-bar down to 2-bar in 157.6 seconds. (See report attached as Appendix A)

- FADEC A
- Engine has been started at 13:24:10 o'clock (FADEC A timing)

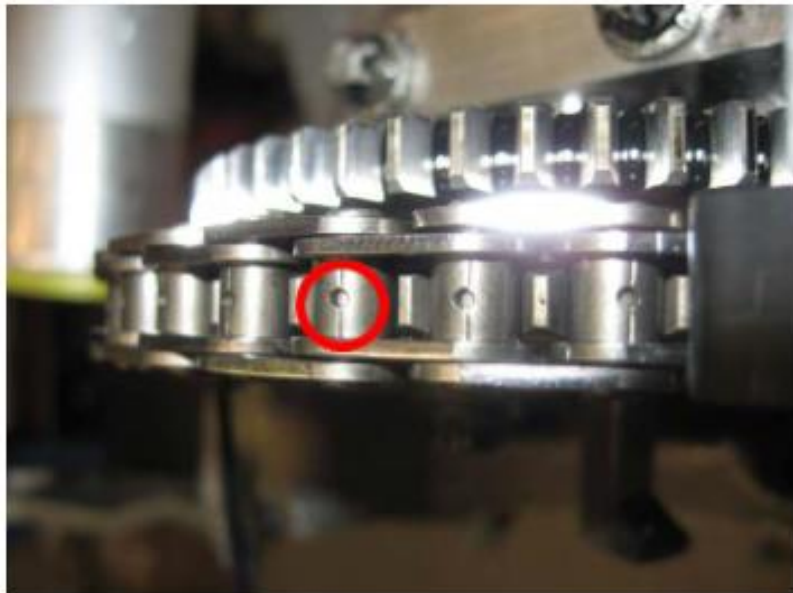
Figure 2: Original assembly of the time chain, holes in the bushings visible

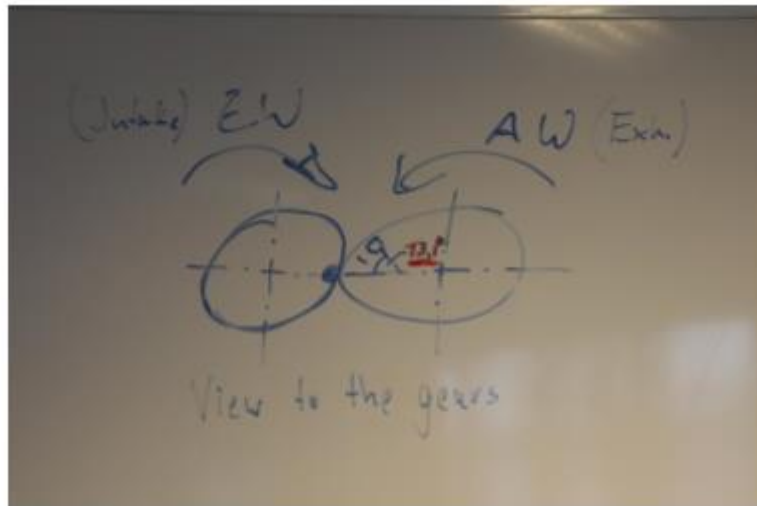
Germany for the engine strip. The engine strip was overseen by an Accredited Representative from the Federal Bureau of Aircraft Accidents Investigation. Synchronisation of the camshaft was found to be fitted incorrectly with gears moved two-teeth clockwise (see Figures 4 & 5) and the timing chain was found broken. The report concluded that the cause of the engine failure was due to a crack on the timing chain which led to its failure as well as caused damage to the valve timing system. (See engine strip report attached as Appendix B)

**Figures 4 & 5:** Picture and a diagram for synchronisation of the camshaft drive gears which had shifted two-teeth clockwise (~13°).

Figure 3: Drawing, Synchronisation of the cam shaft drive gears
