AIRCRAFT SERIOUS INCIDENT REPORT AND EXECUTIVE SUMMARY

Reference:		CA18/3/2/1291	
Aircraft Registration	ZS-CAR	Date of Incident	8 November 2019	Time of Incident	0720Z
Type of Aircraft	Cessna 550	Type of Operation	Flight Calibration (Part 135)		
Pilot-in-command Licence Type	Airline Transport Pilot Licence	Age	48	Licence Valid	Yes
Pilot-in-command Flying Experience	Total Flying Hours	5200	Hours on Type	1300	
Co-Pilot Licence Type	CPL	Age	33	Licence Valid	Yes
Co-Pilot Flying Experience	Total Flying Hours	1046.4	Hours on Type	250.5	
Last Point of Departure	Lanseria International Airport (FALA), Gauteng Province				
Next Point of Intended Landing	Polokwane International Airport (FAPP), Limpopo Province				
Location of the serious incident site with reference to easily defined geographical points (GPS readings if possible)					
On Runway 07 at FALA at the following GPS co-ordinates: S23°50'43.2" E029° 27'30.7" with an elevation of 4521ft AGL					
Meteorological Information	Wind: 260°/ 3kt; Visibility: >10km; Cloud: Nil, QNH 1022

SRP Date	13 October 2020	Publication Date	21 October 2020

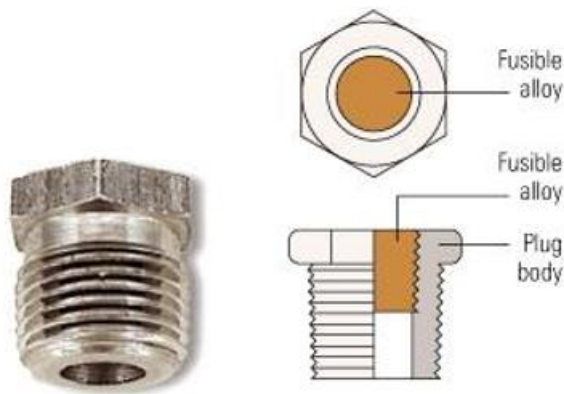
Figure 6: A fuse plug. (Source Sinomas)

1.12.2.1 A fuse plug is a threaded cylinder made of brass or bronze. This type of plug is drilled right through, and the hole is filled with a metal of lower melting point. This metal will melt at a predetermined temperature, thus deflating the aircraft tyre.

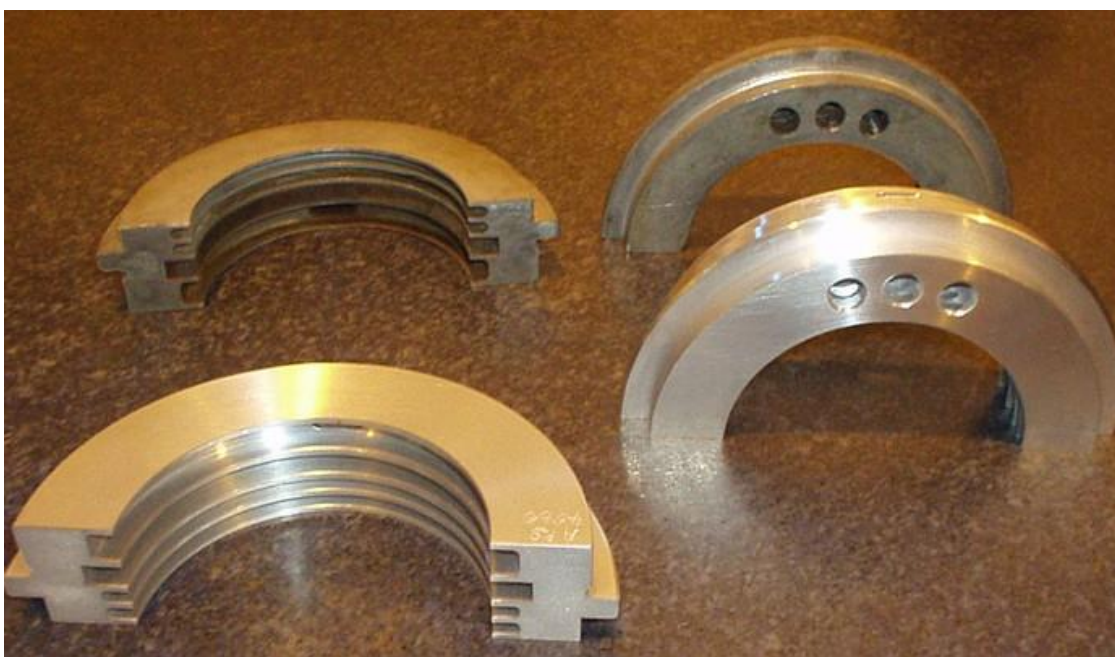
Figure 7: The labyrinth seal halves. (Source: Slideplayer.com)

The impeller back face air is used to prevent oil from leaking into areas where it is not required or where it would be detrimental to the engine operation. A Labyrinth Air Seal consists of two separate parts, one multi-groove ring rotating with the shaft and one stationary ring with a straight surface see figure 8. A small clearance is maintained between the two parts and pressure air is allowed to leak between them to create the required sealing. Air flows into the bearing compartments and is evacuated by oil scavenge system. The breather impeller located in the Accessory Gearbox allows the air to be discharged overboard.

Labyrinth seals are normally maintenance free items. Premature wear would be an indication of severe unbalance or bearing distress, which would be evident to the crew. A malfunction of the oil system even though improbable, may cause flooding of certain cavities and possible smoke at the exhaust or oil smell in the cabin. No repair can be carried out at the field level, the engine must be taken back to the manufacturer.

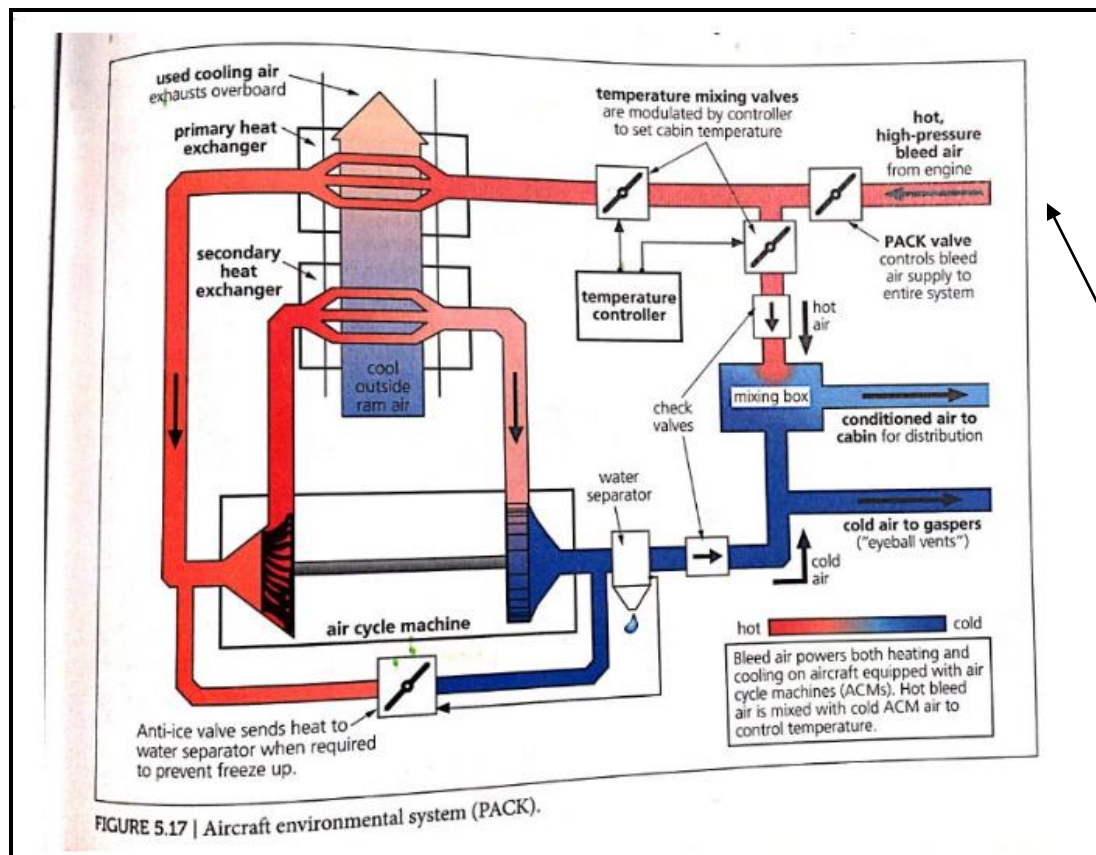
Figure 9: Arrow showing entry of P3 air of Citation 550 air conditioning system. (Source: <https://i.stack.imgur.com/JhCt7.jpg>)

Internal passages in the engine guide P3 air and impeller back face air pressure for cooling of various hot sections and components like the combustion chamber liner and stators. P3 air is also tapped from the gas generator for various application around the airframe such as environmental control. See figure 9.

- 1.16.6 The aircraft environmental system is dependent on the P3 air that is generated by the engines. The P3 air is generated by air being sucked in through the engine intake, this air then gets compressed by N2 compressor/impeller. As the air gets compressed it heats up thus allowing hot air to be tapped from the engine. If by some means of inadequate sealing of oil from Bearing number 3 there you will find the oil being vaporized in this stream of air that has been compressed and heated by the N2 compressor, and that's how you can find smoke being introduced to the environmental system and into the cabin and cockpit.

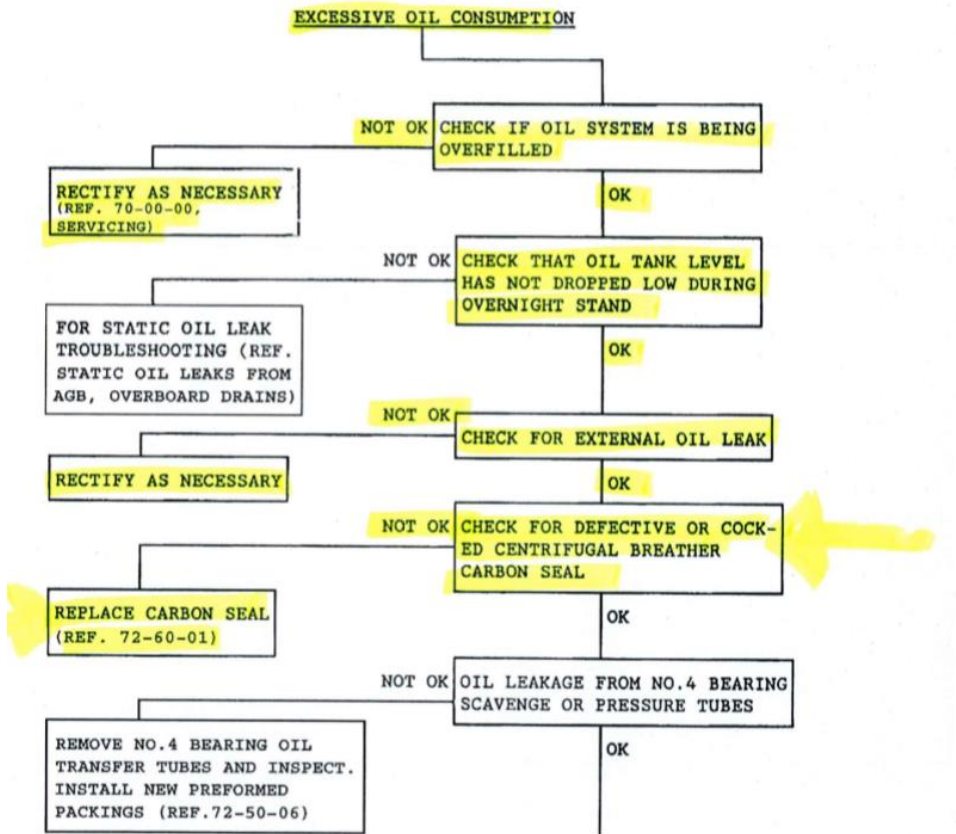
Figure 11: Excessive oil consumption troubleshooting flow diagram (a).

- 1.16.7 The operations procedure of the pressurisation/environmental system is attached to this report as Appendix D.
- 1.16.8 During troubleshooting of the number 1 engine oil leak and smoke in the cockpit, the AMO told the investigation team that they had followed the manufacturer's "Fault Isolation" as contained in the maintenance manual chapter 72-00-00. Figures 10, 11 and 12 are extracts from the maintenance manual chapter 72-00-00.
