AIRCRAFT SERIOUS INCIDENT SHORT REPORT

CA18/3/2/1294: The propeller separated from the crank shaft flange in-flight and the pilot executed a forced landing on a farm.

Aircraft registration : ZU-CUN

Aircraft manufacturer and model : Zenith Air, Zodiac CH-601 XL

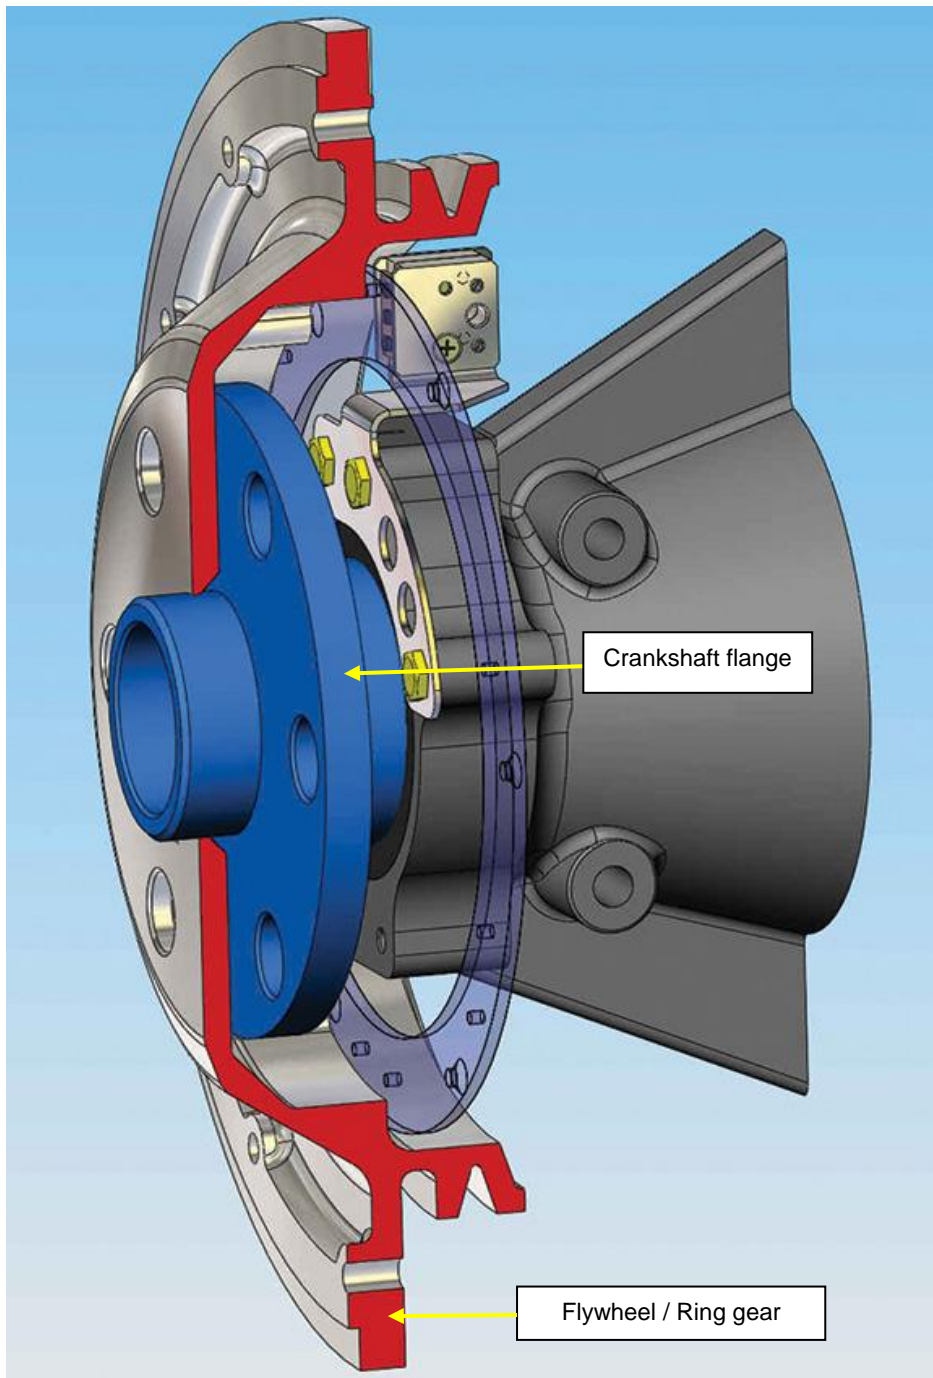
Figure 4: A view of the crankshaft flange with some of the drive bushes indicated by yellow arrows.

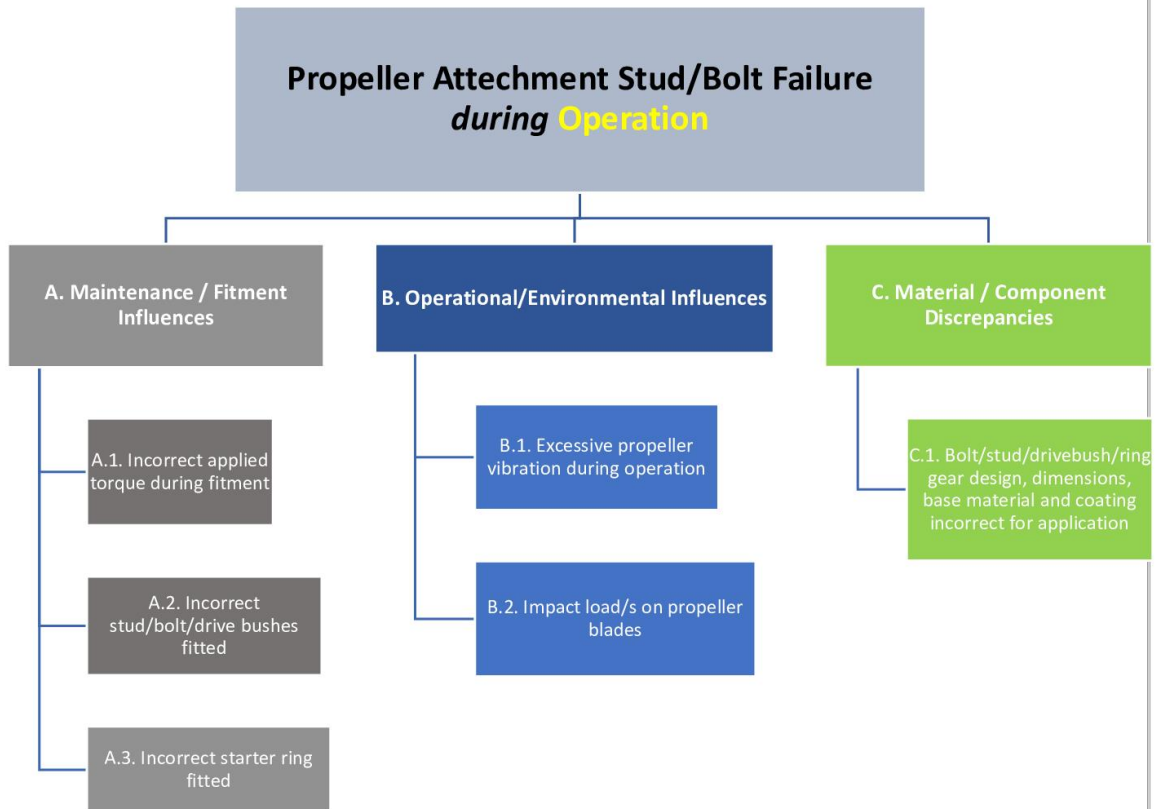
UNIVERSITEIT VAN PRETORIA UNIVERSITY OF PRETORIA YUNIBESITHI YA PRETORIA	LABORATORY FOR MICROSCOPY & MICROANALYSIS PAGE 8 OF 9
COMPILED FOR: SACAA (AID)	FAILURE ANALYSIS REPORT: PROPELLER ASSEMBLY, ZODIAC CH601, AIRCRAFT No ZU-CUN	DOCUMENT NUMBER FA-003-04-20 DATE 2020-04-01 ISSUE 1
<p>The extent of the elongation damages at the locating drive bush location again suggest under-torque as the primary contributing factor while the damages at the remaining 5 positions suggest a combination of under-torque and bush/flywheel hole dimensional variations. <i>The reason for the latter discrepancy could not be ascertained by this investigation (see Recommendations).</i></p> <p>Contributing to the above is the use of a singular locating drive bush thus allowing for radial movement of the remaining 5 bushes within the rotational plane under load.</p> <p>The resultant detrimental influence on propeller vibration due to the loosened attachment bolt and drive bush movement undoubtedly enhanced the fatigue fracture initiation and progression rate.</p> <p>A.2. Could not be affirmed by this investigation (see Recommendations).</p> <p>A.3. Could not be affirmed by this investigation (see Recommendations).</p> <p>7.2. B: Operational/Environmental Influences (Fault Tree)</p> <p>B.1. Could not be affirmed by this investigation.</p> <p>B.2. Could not be affirmed by this investigation.</p> <p>7.3. C: Material/Component Discrepancies (Fault Tree)</p> <p>C.1. No specifications were supplied towards comparison.</p> <p>7.4. Conclusion: The 6x attachment bolts revealed a time-dependant fatigue failure mode with undeterminable sequence.</p> <p>The most probable contributory causes are (a) incorrectly applied torque during fitment (under-torque) and/or (b) selecting incorrect non-locating drive bush sizes (non-locating types - 5x).</p>

8. RECOMMENDATIONS

8.1. Considering the detrimental effects on Flight Safety of a propeller assembly failure during operation, it is strongly recommended that all OEM specifications relating to drive bush sizes, flywheel/starter ring dimensions and fitment are revisited prior to concluding.
