AIRCRAFT SERIOUS INCIDENT REPORT AND EXECUTIVE SUMMARY

Reference:		CA18/3/2/1298	
Aircraft Registration	ZS-MIN	Date of Incident	4 December 2019		Time of Incident	1035Z
Type of Aircraft	Beechcraft King Air B200		Type of Operation		Commercial (Part 135)	
Pilot-in-command Licence Type	Airline Transport Pilot Licence	Age	48		Licence Valid	Yes
Pilot-in-command Flying Experience	Total Flying Hours	9 140		Hours on Type	2 388	
Last Point of Departure	Virginia Aerodrome (FAVG): Kwa-Zulu Natal Province					
Next Point of Intended Landing	Hoedspruit Aerodrome (FAHT): Limpopo Province					
Location of the incident site with reference to easily defined geographical points (GPS readings if possible)						
En-route from FAVG to FAHT at flight level (FL) 250, at position R025 DME50nm from King Shaka International Aerodrome (FALE)						
Meteorological Information	Wind: Westerly at 70kts; Temperature: -15°C, Visibility: 9999m, Cloud: Overcast and Layered at FL250

Reference Number : CA18/3/2/1298
Name of Owner : Mkhombe Investments (PTY) LTD
Name of Operator : KZN Aviation (PTY) LTD
Manufacturer : Beechcraft Aircraft Corporation
Model : B200
Nationality : South African
Registration Marks : ZS-MIN
P

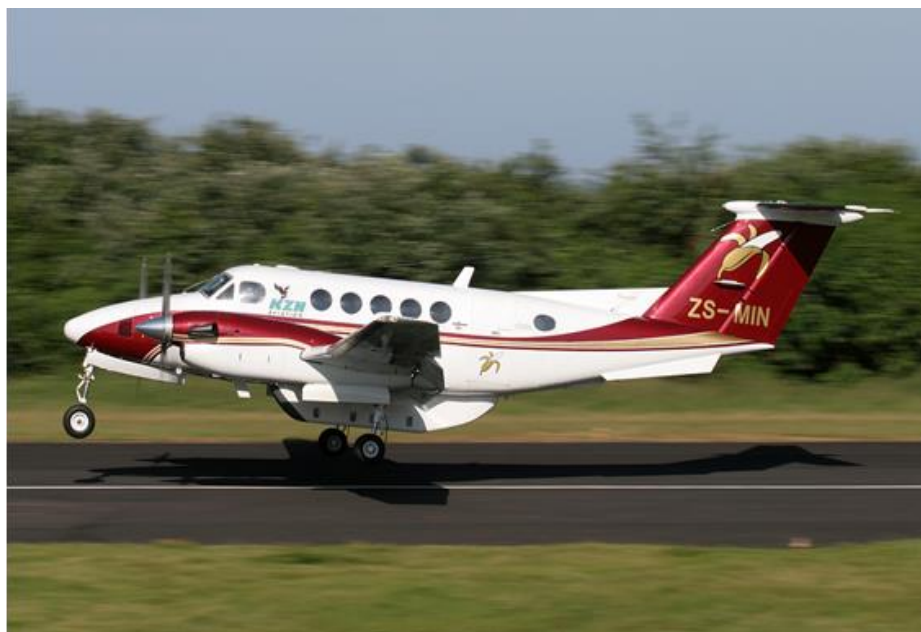
Figure 1: The aircraft ZS-MIN. (Source: www.airliners.com)

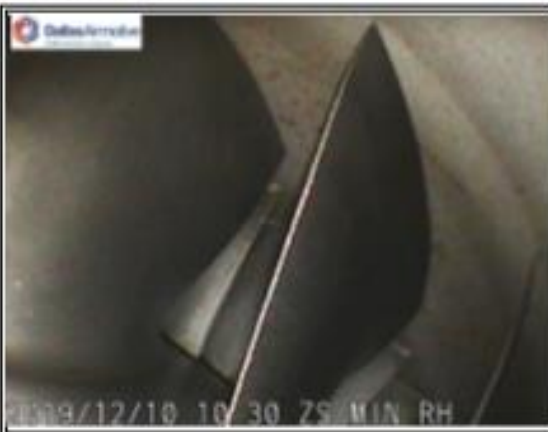
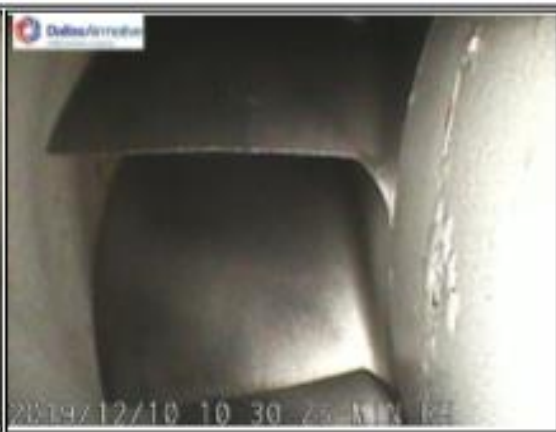
Compressor Blades

- Cold Section: No oil leakages, noted minor paint flaking from the inlet, no foreign object and/or debris (FOD) noted on the compressor blades.
- Hot Section: No major heat erosion or cracks noted on the compressor turbine vane ring (CTVR) and small exit duct (SED), shroud intact with no major rub observed between compressor turbine (CT) blades and shrouds, low carbon content in combustion chamber (CC) liner with no visible cracks noted, no FOD or heat erosion noted on the power turbine (PT) blades, open cracks noted on the CT blade tips. (See full report attached as Appendix B)
