AIRCRAFT SERIOUS INCIDENT REPORT AND EXECUTIVE SUMMARY

Reference:		CA18/3/2/1325	
Aircraft Registration	ZS-OAF	Date of Accident	22 November 2020		Time of Accident	0820Z	
Type of Aircraft	Boeing 737-400			Type of Operation	Air Transport Operations, Passengers (Part 121)		
Pilot-in-command Licence Type	Airline Transport Pilot		Age	37	Licence Valid	Yes	
Pilot-in-command Flying Experience	Total Flying Hours		7 924.0		Hours on Type	3 383.0	
Last Point of Departure	Cape Town International Aerodrome (FACT), Western Cape						
Next Point of Intended Landing	East London Aerodrome (FAEL), Eastern Cape						
Damage to Aircraft	Minor						
Location of the incident site with reference to easily defined geographical points (GPS readings if possible)							
Runway 29 at George Aerodrome (GPS position: 34°00'24.13" South 022°22'27.41" East), elevation 648ft							
Meteorological Information	Surface wind: 210°/10kt; temperature: 19°C; dew point: 14°C; clouds: Scattered at 3300ft

Reference Number : CA18/3/2/1325
Name of Owner : Safair Operations (Pty) Ltd
Name of the Operator : FlySafair
Manufacturer : Boeing Aircraft Company
Model : 737-400
Nationality : South African
Registration markings : ZS-O

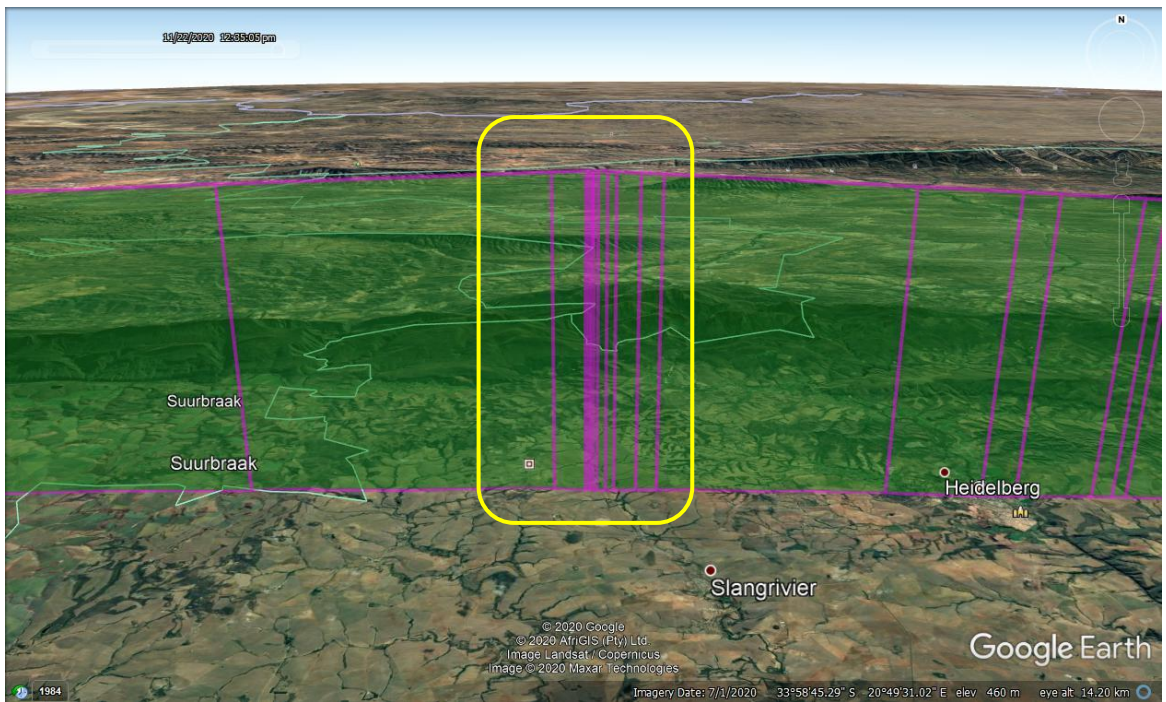
Figure 5: Google Earth overlay indicating events where the Cabin Altitude, as well as the engine low idle warning activated.

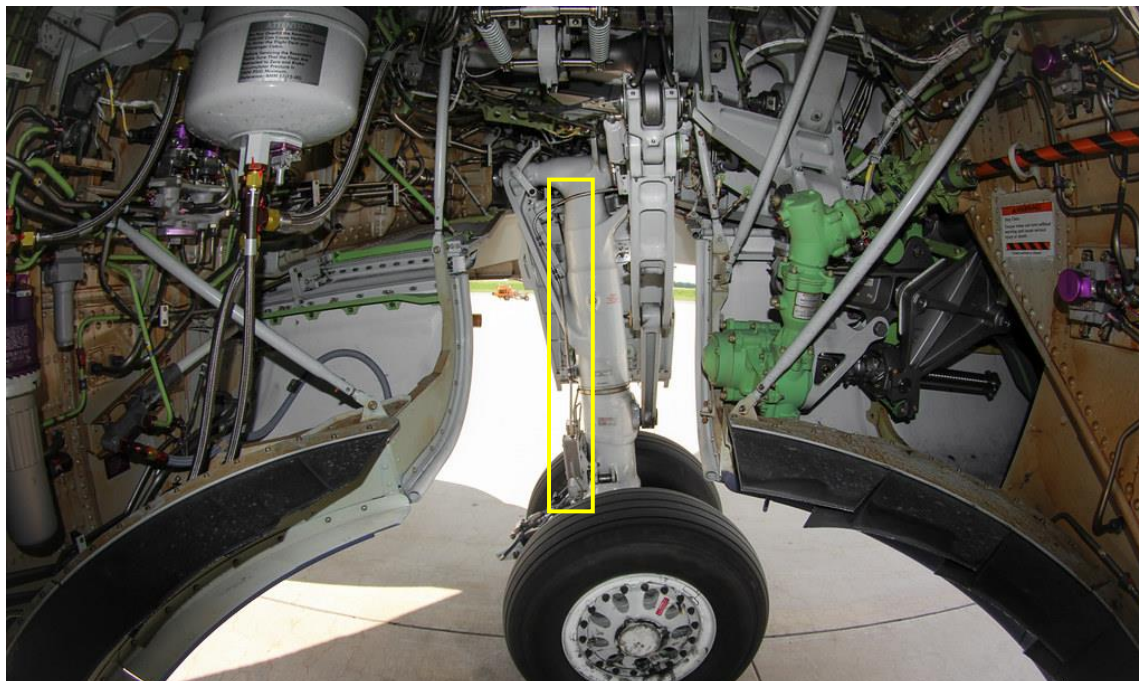
The Air/Ground squat switch is only fitted to the right main gear and consists of a Teleflex cable, which will compress or extend as the weight of the aircraft comes on

or off the right main gear. This Teleflex cable is connected to the Air/Ground sensor, which activates the switch by sensing if the aircraft is in air or ground mode.

Figure 16: The photograph was taken from within the right main gear wheel well.

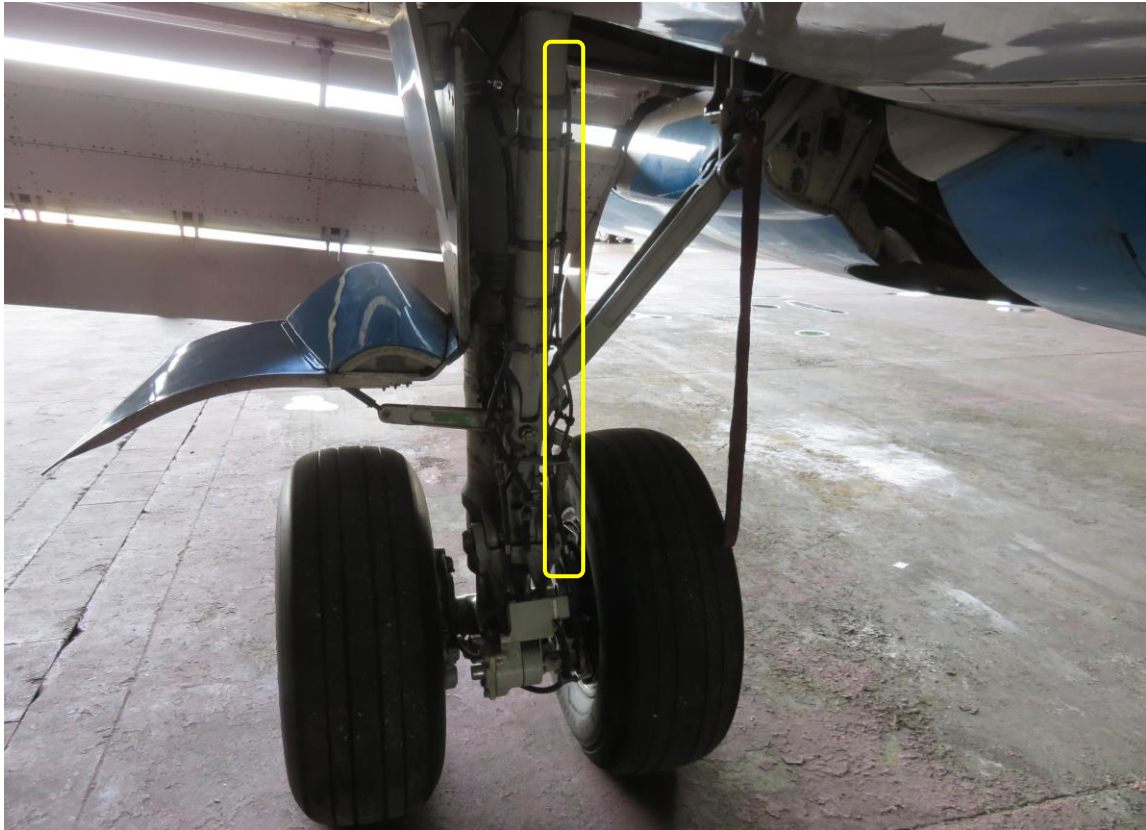
Figure 17: Right main gear (view from the front) with the Teleflex cable visible in the yellow window.

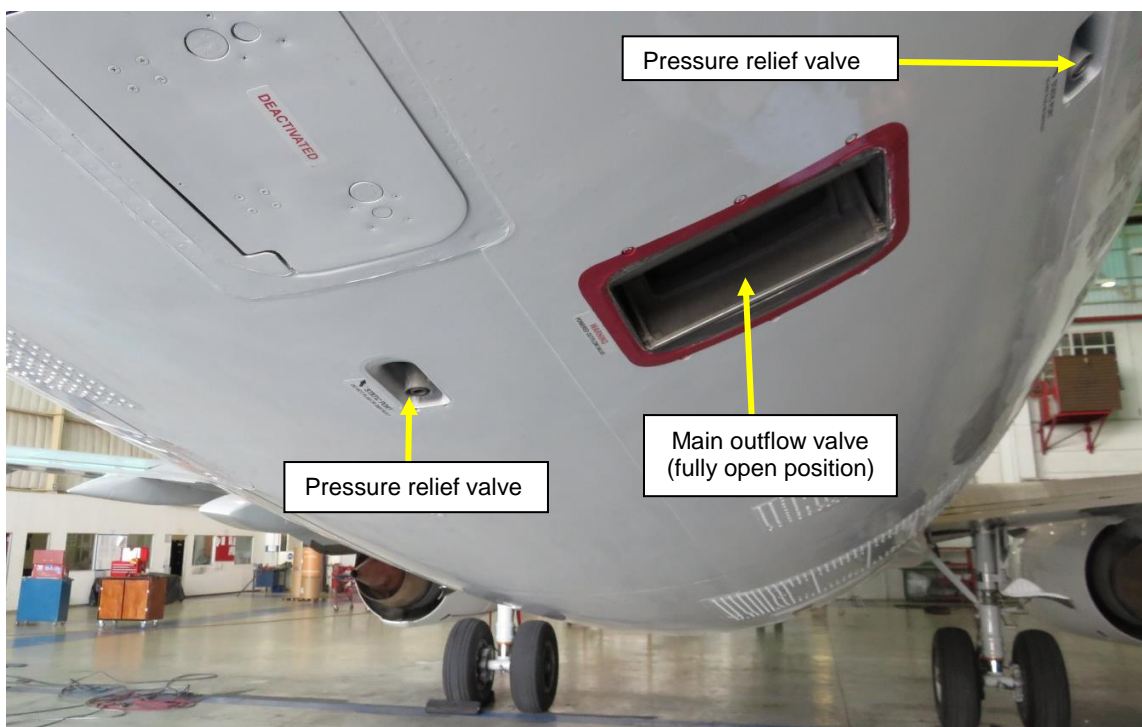
Figure 19: Main outflow valve and two pressure relief valves. (Not the incident aircraft)

After landing at FAGG, the crew noticed a very high cabin pressure. It was not possible to open the doors, which could have delayed an evacuation if it were required. The outflow valve as illustrated in Figure 19 was in the closed position. This valve was then slowly opened manually by the crew to ensure the cabin was fully depressurised to allow the doors to be opened; if the air ground sensor was operational, the aircraft would have automatically dumped the excess cabin pressure on touchdown.
