## AIRCRAFT SERIOUS INCIDENT REPORT AND EXECUTIVE SUMMARY

<b>Reference:</b>		CA18/3/2/1336	
<b>Aircraft Registration</b>	ZS-SJF	<b>Date of Serious Incident</b>	25 January 2021		<b>Time of Serious Incident</b>	1232Z	
<b>Type of Aircraft</b>	Boeing 737-800		<b>Type of Operation</b>		Commercial (Part 121)		
<b>Pilot-in-command Licence Type</b>	Airline Transport Pilot Licence		<b>Age</b>	50	<b>Licence Valid</b>	Yes	
<b>Pilot-in-command Flying Experience</b>	<b>Total Flying Hours</b>		11 261.4		<b>Hours on Type</b>	1 841.2	
<b>Last Point of Departure</b>	O.R. Tambo International Airport (FAOR), Gauteng Province						
<b>Next Point of Intended Landing</b>	King Shaka International Airport (FALE), KwaZulu-Natal Province						
<b>Damage to Aircraft</b>	None						
<b>Location of the serious incident site with reference to easily defined geographical points (GPS readings if possible)</b>							
En route from FAOR to FALE abeam Dundee (GPS position: South 28°07'.6" East 030°22'.2")

**Reference Number** : CA18/3/2/1336  
**Name of Owner/Operator** : Mango Airlines SOC (Ltd)  
**Manufacturer** : Boeing Aircraft Company  
**Model** : Boeing 737-800  
**Nationality** : South African  
**Registra

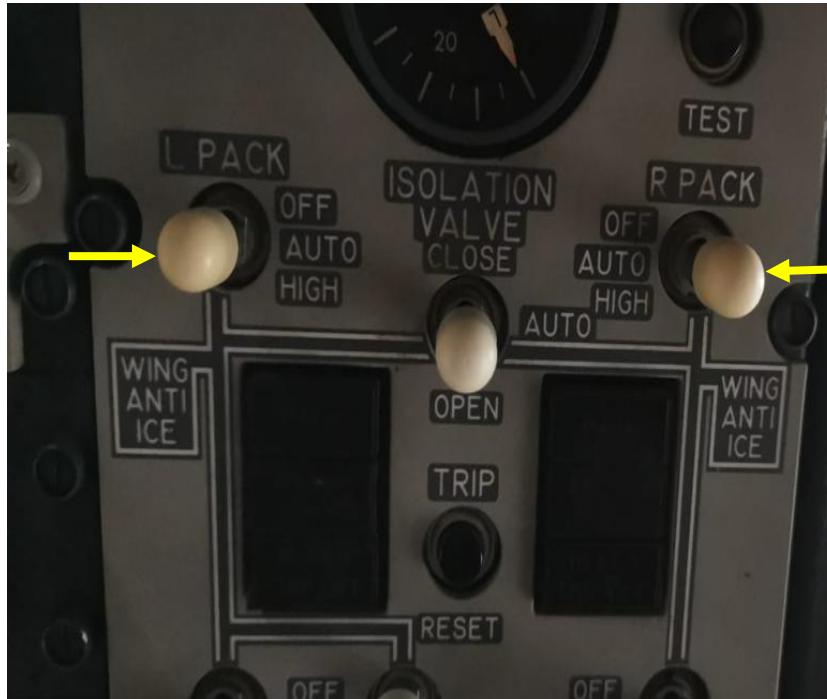
**Figure 8:** The aircraft pneumatic panel showing the pre-flight set position of the air-conditioning packs toggle switches (Bleed 1 & 2) on AUTO.

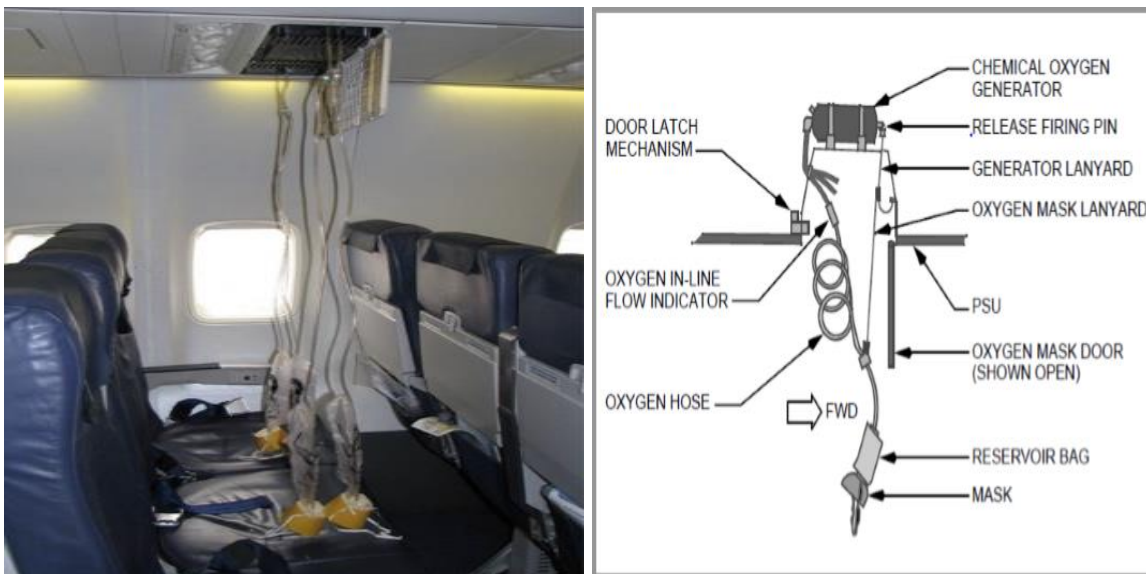
The passenger oxygen is supplied by individual oxygen generators located at each passenger service unit (PSU). A generator with two masks is located above each cabin attendant station. The system is activated automatically when the cabin altitude climbs above 14 000ft, or when the switch on the overhead panel is positioned to ON by the flight crew. When the system is activated manually, the masks will drop, so the passenger has to pull the mask, put it on his/her face and start breathing. Once any of the four masks of a PSU is pulled, a continuous flow of oxygen begins. It lasts approximately 12 minutes and it cannot shut off. When the passenger oxygen system is activated, the following amber indicator lights illuminate on the flight deck: “MASTER CAUTION” and “OVERHEAD” on the pilot’s glareshield and “PASS OXY ON” on the overhead panel. The cabin oxygen masks were manually deployed and were utilised without struggle.

**Figures 12 & 13:** On the left is a picture of the cabin oxygen mask deployed and on the right is the passenger oxygen system schematic. (Source: Boeing)
