AIRCRAFT SERIOUS INCIDENT REPORT AND EXECUTIVE SUMMARY

Reference:		CA18/3/2/1371	
Helicopter Registration	ZS-HEW	Date of Incident	23 September 2021		Time of Incident	1400Z
Type of Helicopter	Schweizer 269C		Type of Operation		Game Capture (Part 137)	
Pilot-in-command Licence Type	Commercial Pilot Licence (CPL) Helicopter		Age	47	Licence Valid	Yes
Pilot-in-command Flying Experience	Total Flying Hours	10092.5		Hours on Type	377.6	
Last Point of Departure	Camdeboo Game Reserve in Graaf-Reinet, Eastern Cape Province					
Next Point of Intended Landing	Camdeboo Game Reserve in Graaf-Reinet, Eastern Cape Province					
Damage to Helicopter	Substantial					
Location of the incident site with reference to easily defined geographical points (GPS readings if possible)						
Camdeboo Game Reserve in Graaf Reinet, Eastern Cape province at Global Position System (GPS) co-ordinates S 32°13'11.10", E 024°32'28.61" at a field elevation of 2624ft.						
Meteorological Information	Wind direction: 220°; Wind Speed: 5kts; Visibility: Good; Air temperature: 18°C

Reference Number : CA18/3/2/1371
Occurrence Category : Category 2
Type of Operation : Game Capture Part 137
Name of Operator : E'scape Airtou

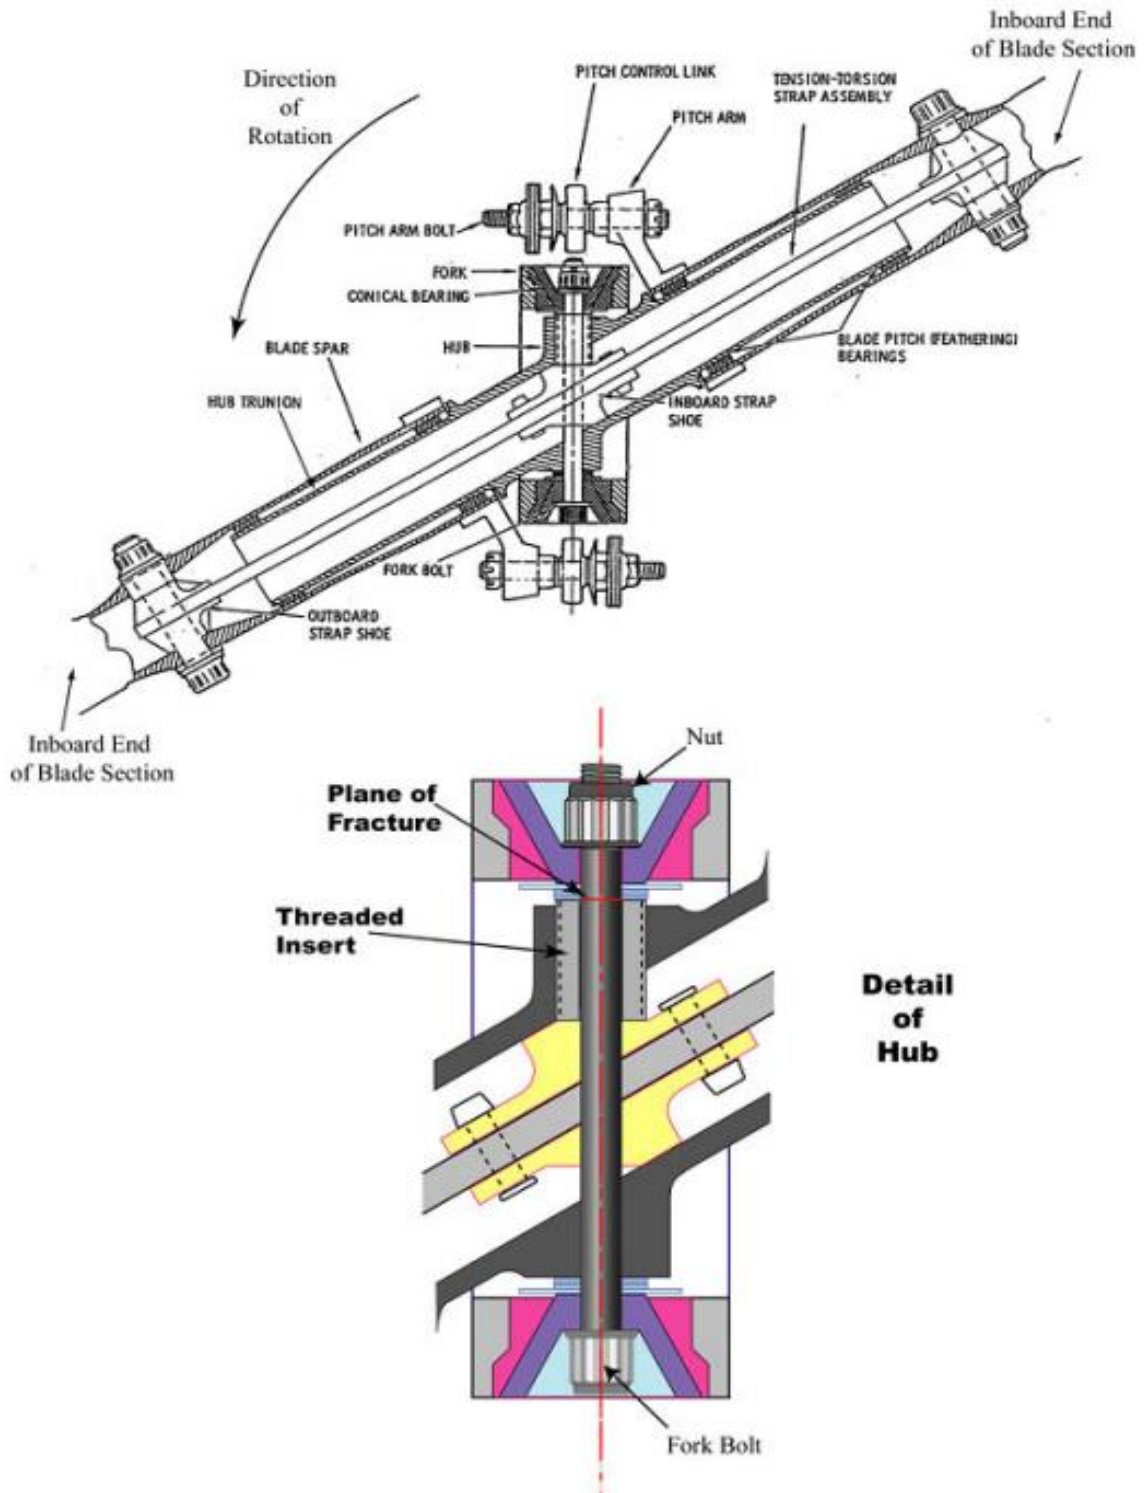
Diagram 2: Layout and details of tail rotor hub components.

There is no information relating to the inspection of the fork hinge bolt.

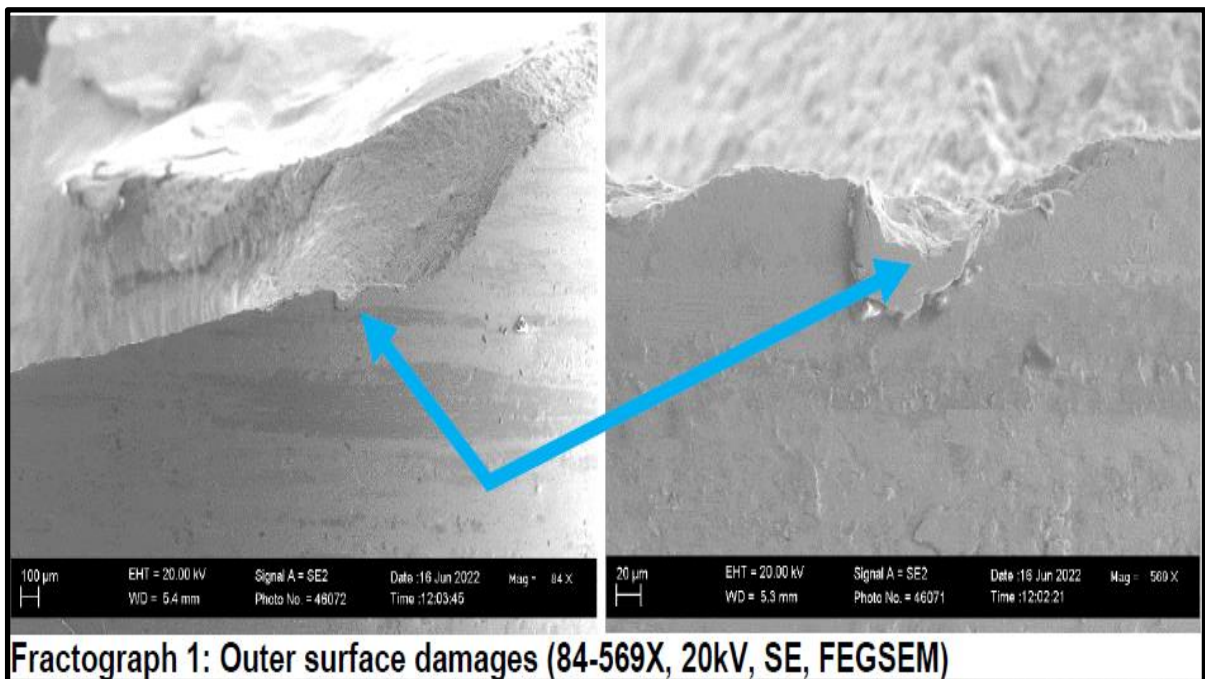
The fracture surface revealed indications towards a predominant fatigue fracture mode with the initiation point (Figure 4, blue arrow; also refer to Fractography 1 and 3, blue arrows) and directions of progression as indicated with red arrows.
