| LIMITED SERIOUS INCIDENT INVESTIGATION REPORT |

| Reference Number | CA18/3/2/1384 | | | | | | |
| Registration | ZU-NDP | | | | | | |
| Make/Model | Jabiru J430 (Serial Number: 353) | | | | | | |

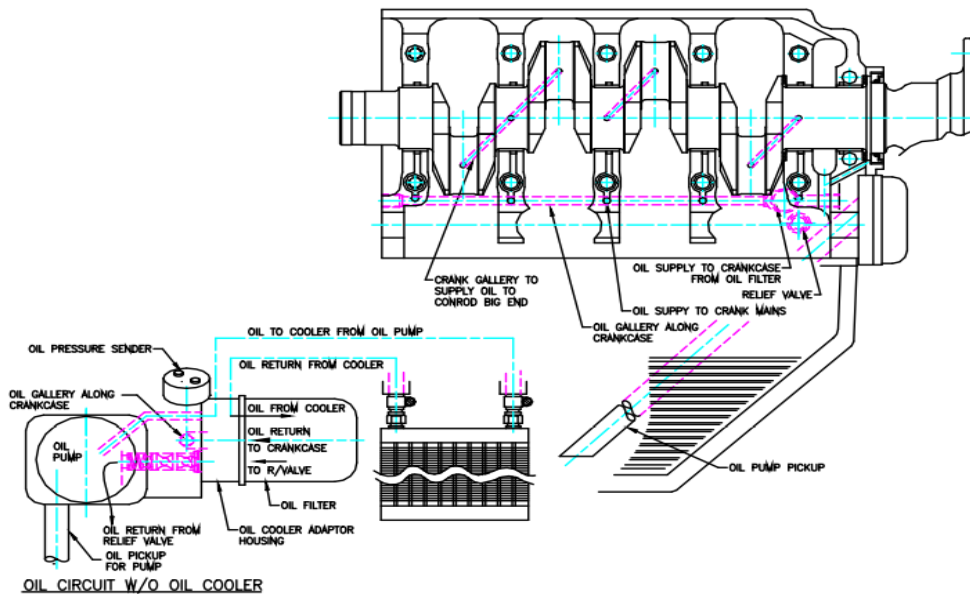
Diagram 1: Oil system schematic. (Source: Manufacture)

The visual inspection revealed a fractured crank shaft at the No. 1 Conrod Big End (BE) position (Photos 2 and 3, red arrows; Diagrams 1 and 2, red arrow).
