<b>AIRCRAFT ACCIDENT REPORT AND EXECUTIVE SUMMARY</b>
---

Reference:	CA18/2/3/9682	
<b>Aircraft Registration</b>	ZU-TEF	<b>Date of Accident</b>	23 January 2018		<b>Time of Accident</b>	11:10Z
<b>Type of Aircraft</b>	Savannah S		<b>Type of Operation</b>	Test Flight		
<b>Pilot-in-command Licence Type</b>	National Pilot		<b>Age</b>	59	<b>Licence Valid</b>	Yes
<b>Pilot-in-command Flying Experience</b>	Total Flying Hours	1580.5		Hours on Type	1266.6	
<b>Last point of departure</b>	Robertsvale Aerodrome, Gonubie (Eastern Cape)					
<b>Next point of intended landing</b>	Robertsvale Aerodrome, Gonubie (Eastern Cape)					
<b>Location of the accident site with reference to easily defined geographical points (GPS readings if possible)</b>						
Private farm 3nm West of Kei Mouth at the GPS: S32° 41'33.67" E028° 19'30.59" Elevation: 40 feet						
<b>Meteorological Information</b>	Surface wind: 220° at 17 knots. Temperature 24°C. Visibility: 9999m					
<b>Number of people on board</b>	1 + 1	<b>No. of people injured</b>	0	<b>No. of people killed</b>	2

## AIRCRAFT ACCIDENT REPORT

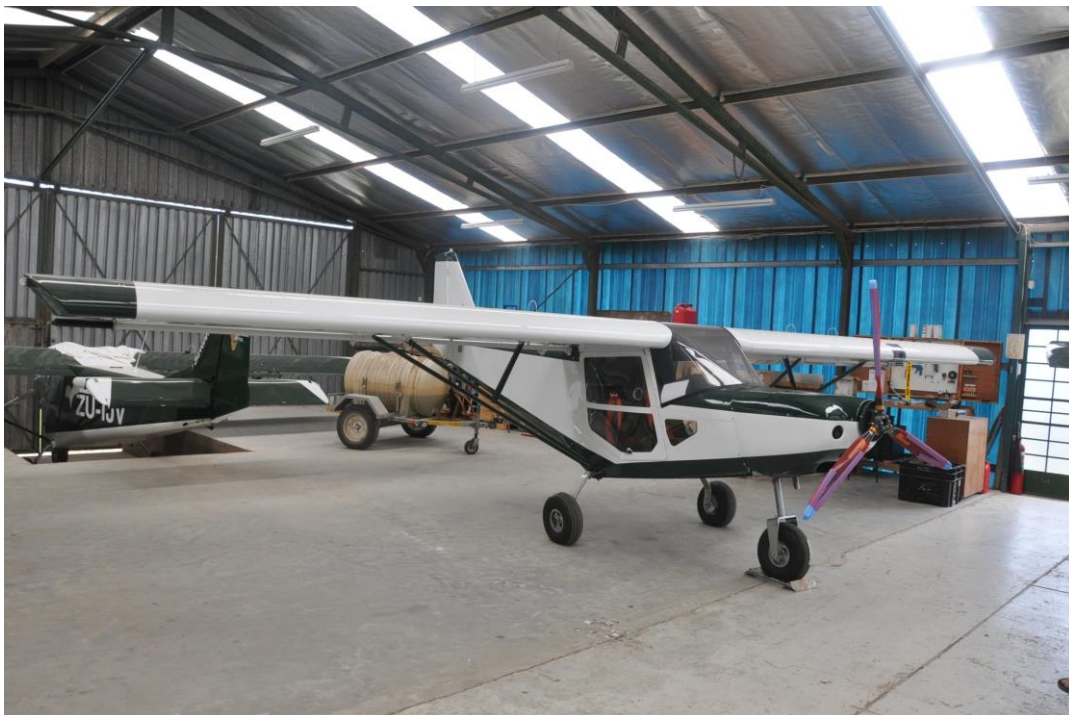
Figure 1: Aircraft prior to the accident

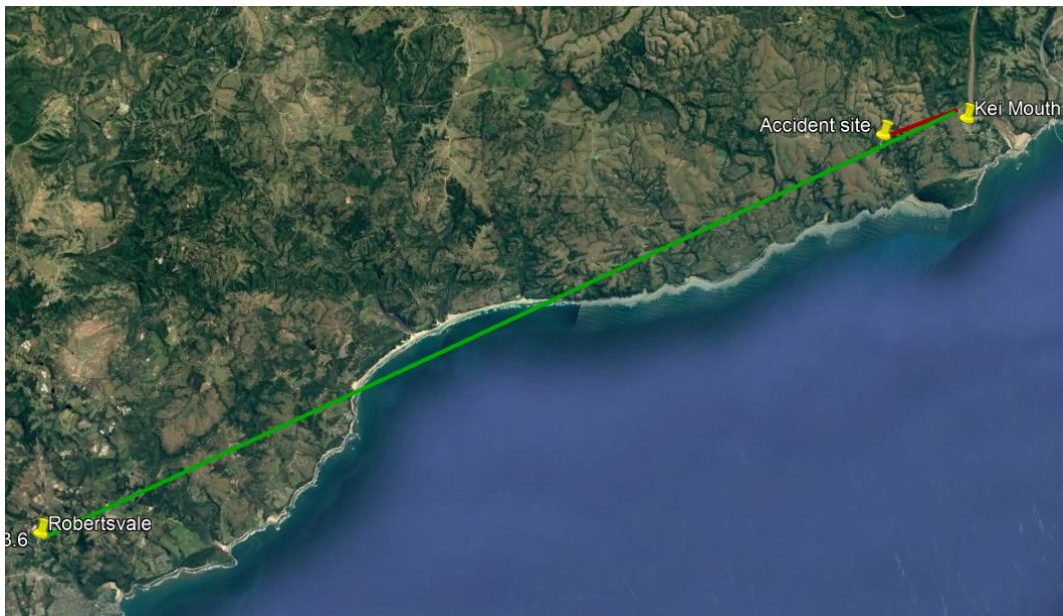
and from Kei Mouth to the accident site was approximately 3 nautical miles. The aircraft did not reach Robertsvale private airstrip and it was reported missing the following day on the 24th January 2018. An official search for the missing aircraft was initiated on the same day the aircraft was reported missing. The search was co-ordinated by the Aeronautical Rescue Coordination Centre (ARCC).

Figure 2: Approximate flight path
