AIRCRAFT ACCIDENT REPORT AND EXECUTIVE SUMMARY

Reference:	CA18/2/3/9687	
Aircraft registration	ZS-KOM	Date of accident	24 February 2018		Time of accident	1047Z
Type of aircraft	Cessna T210N (Aeroplane)		Type of operation		Private (Part 91)	
Pilot-in-command licence type		Student pilot	Age	73	Licence valid	Yes
Pilot-in-command flying experience		Total flying hours	Unknown		Hours on type	Unknown
Last point of departure		Mossel Bay Aerodrome (FAMO), Western Cape Province				
Next point of intended landing		Graaff-Reinet Aerodrome (FAGR), Eastern Cape Province				
Location of the accident site with reference to easily defined geographical points (GPS readings if possible)						
Oudtshoorn Military Area (GPS position; 33°30.748' South 022°10.893' East), Elevation 1 922 feet AMSL						
Meteorological information		Surface wind: 060°/5 kts, Temperature: 27°C, overcast with light rain visibility: 4000m				
Number of people on-board	1 + 1	No. of people injured	0	No. of people killed	2

Name of Owner : Jangen Air Investments (Pty) Ltd
Name of Operator : Private (Part 91)
Manufacturer : Cessna Aircraft Company
Model : T210N
Nationality : South African
Registration markings : ZS-KOM
Place : Ou

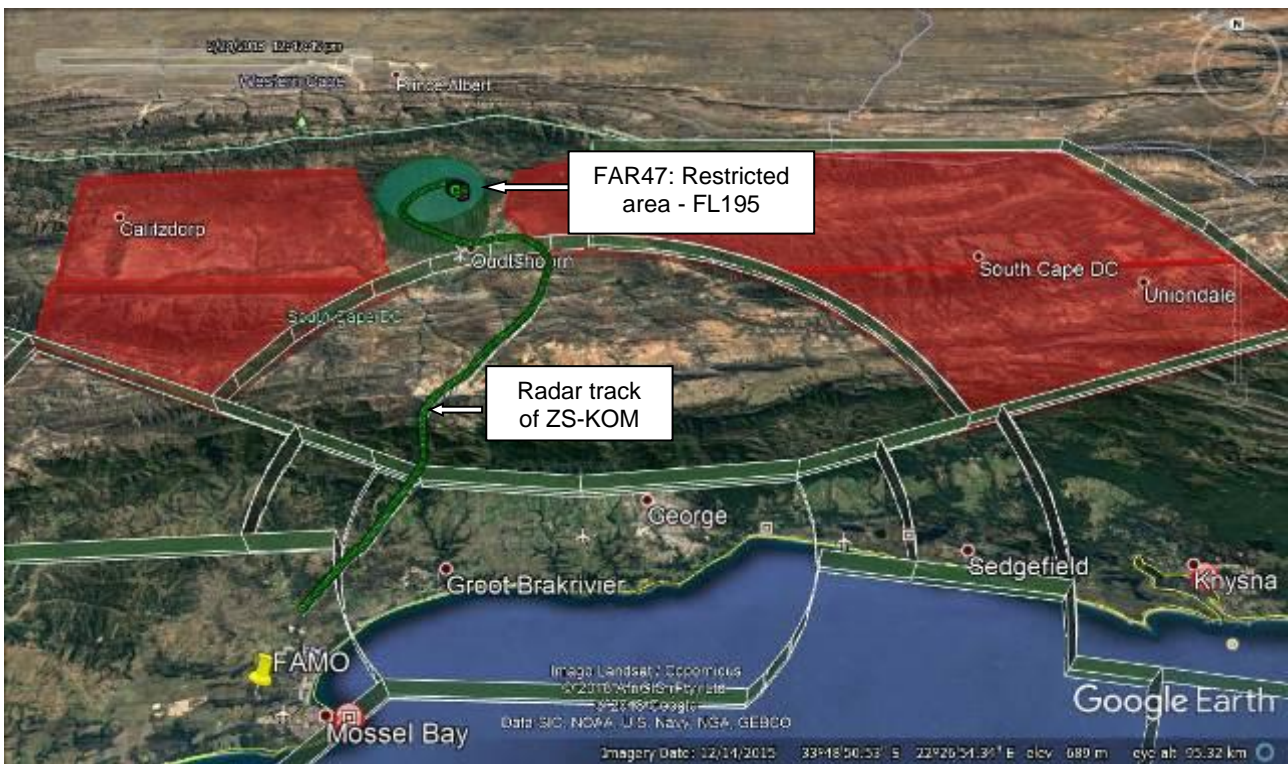
- 1.1.3 The aircraft was observed on radar flying in a north-north-easterly direction after becoming airborne from FAMO. At 1037Z, the aircraft turned left, and at 1040Z it passed to the north of the extended centreline of runway 04 at Oudtshoorn Aerodrome (FAOH) while flying in a westerly direction towards Calitzdorp. The aircraft proceeded to fly in a north-westerly direction, then turned right. At 1041Z, the aircraft entered FAR47, which was a restricted area from ground level up to flight level 195 (19 500 feet AMSL) while flying in a northerly direction. FAR47 is depicted as the green cylinder in Figure 2. At 10:46:59 (radar time) the aircraft was observed flying at an altitude of 8 600 feet AMSL, which was the maximum altitude of the aircraft while it was being tracked on radar.

Figure 2: Google Earth overlay indicating the radar track of ZS-KOM (Radar data courtesy of ATNS)

- 1.1.4 At 10:47:14Z, the aircraft was at 8 600 feet AMSL when it was observed descending past 7 900 feet in approximately 10 seconds. It further descended past 7 100 feet AMSL and disappeared from the radar screen.

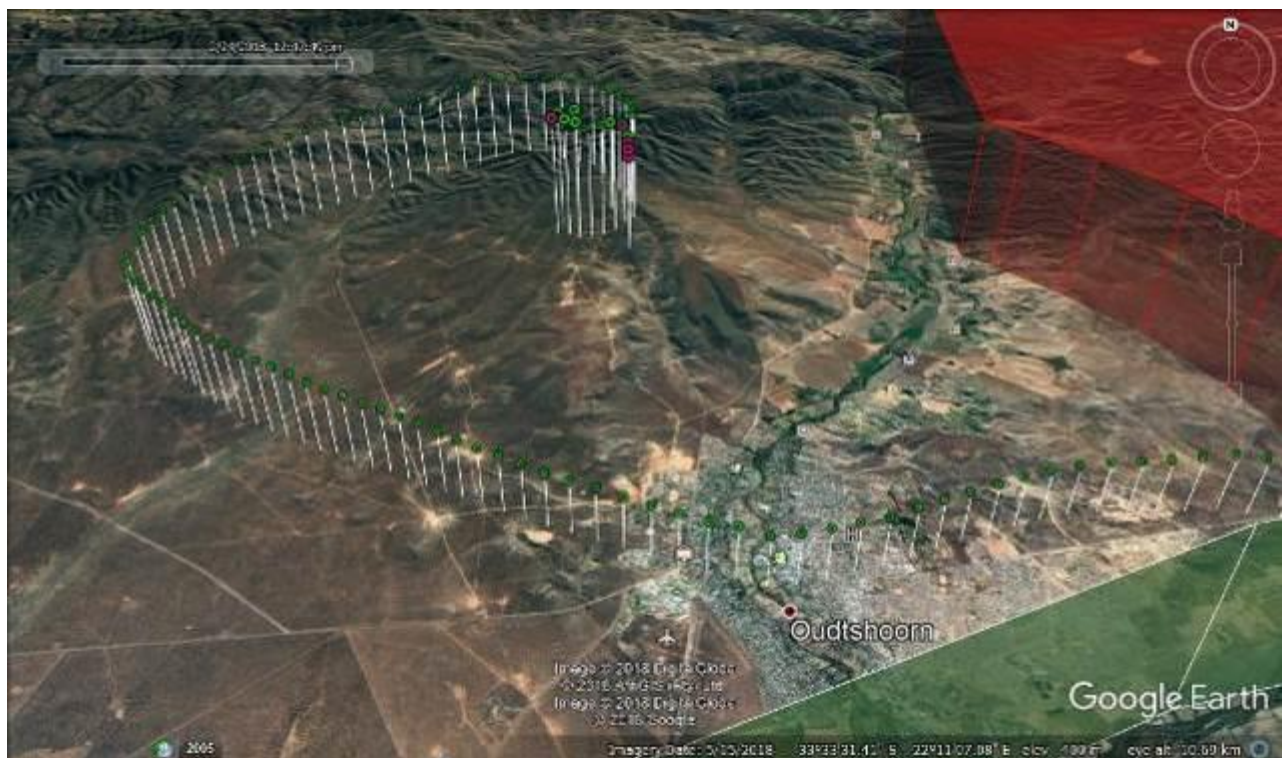
Figure 7: Google Earth overlay indicating the flight profile over Oudtshoorn until the aircraft disappeared from radar
