AIRCRAFT ACCIDENT REPORT AND EXECUTIVE SUMMARY

Reference:	CA18/2/3/9699	
Aircraft registration	ZS-HHI	Date of accident	9 April 2018		Time of accident	1115Z
Type of aircraft	AS350B3 (Helicopter)		Type of operation		Private (Part 91)	
Pilot-in-command licence type		Private	Age	47	Licence valid	Yes
Pilot-in-command flying experience		Total flying hours	546.3		Hours on type	18.2
Last point of departure		Private helipad near Nigel, Mpumalanga Province				
Next point of intended landing		Private helipad near Nigel, Mpumalanga Province				
Location of the accident site with reference to easily defined geographical points (GPS readings if possible)						
Transnet railway service road near Frutuna (GPS position; 26°36'42.10" South 028°32'39.70" East)						
Meteorological information		Surface wind: variable 20–25 kt, Temperature: 20°C, Visibility: CAVOK				
Number of people on board	1 + 4	No. of people injured	1 + 1	No. of people killed	0	
Synopsis

Probable cause						
<p>The pilot executed a non-standard manoeuvre (referred to as a pedal turn) in strong wind conditions, which resulted in a loss of tail rotor effectiveness and subsequent loss of control.</p>						
SRP date	12 February 2019

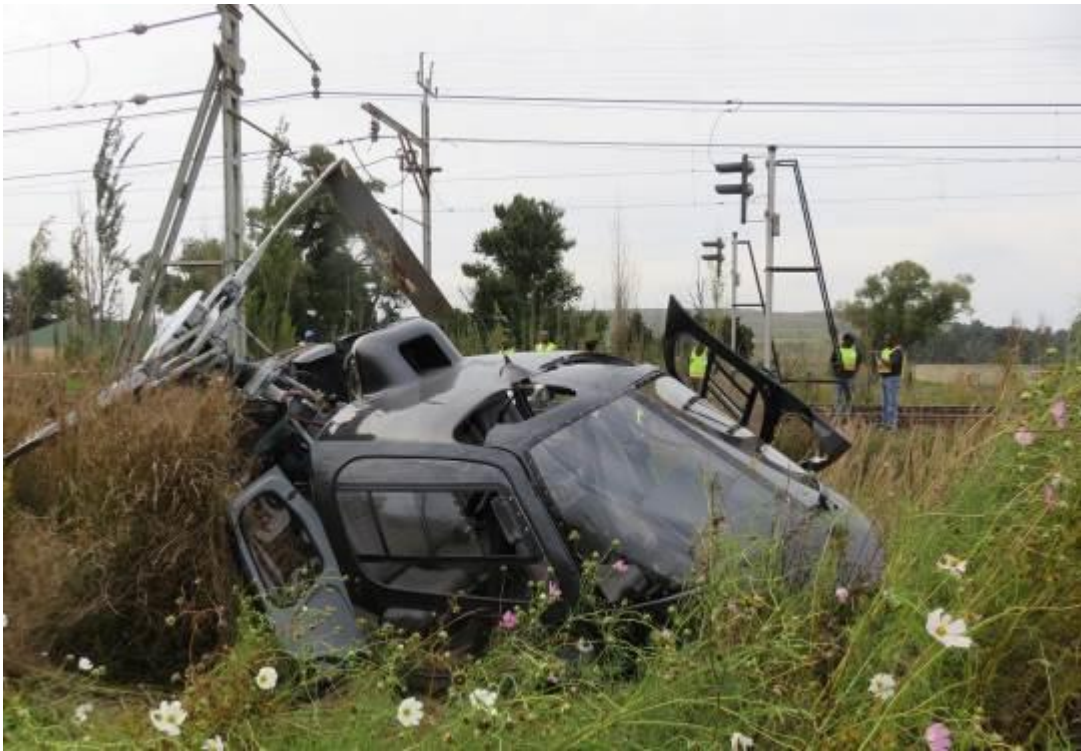
Figure 6: A view of the cabin of the helicopter with the farmstead visible in the background

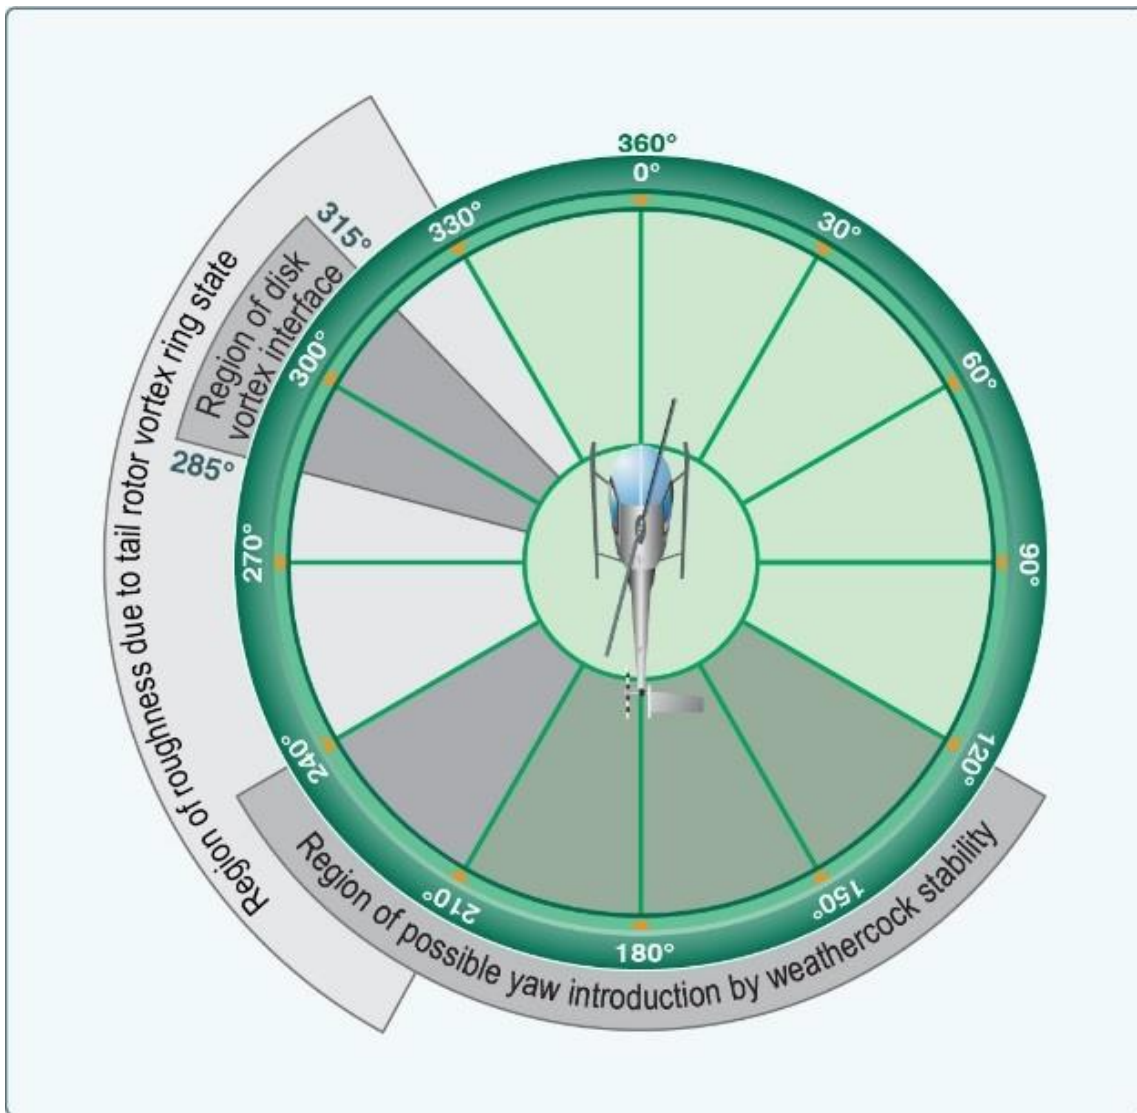
Various factors can contribute to LTE, including: varying airflow from the main rotor blades (particularly at high power settings) or from the environment, which can affect the airflow entering the tail rotor; operating at airspeeds below translational lift; operating at high altitudes and high gross weights; operating near large buildings or ridgelines, which can cause turbulence; and the relative wind direction (see Figures 1 and 2).

Figure 1. Relative wind directions that can contribute to LTE for anti-clockwise main rotor helicopters

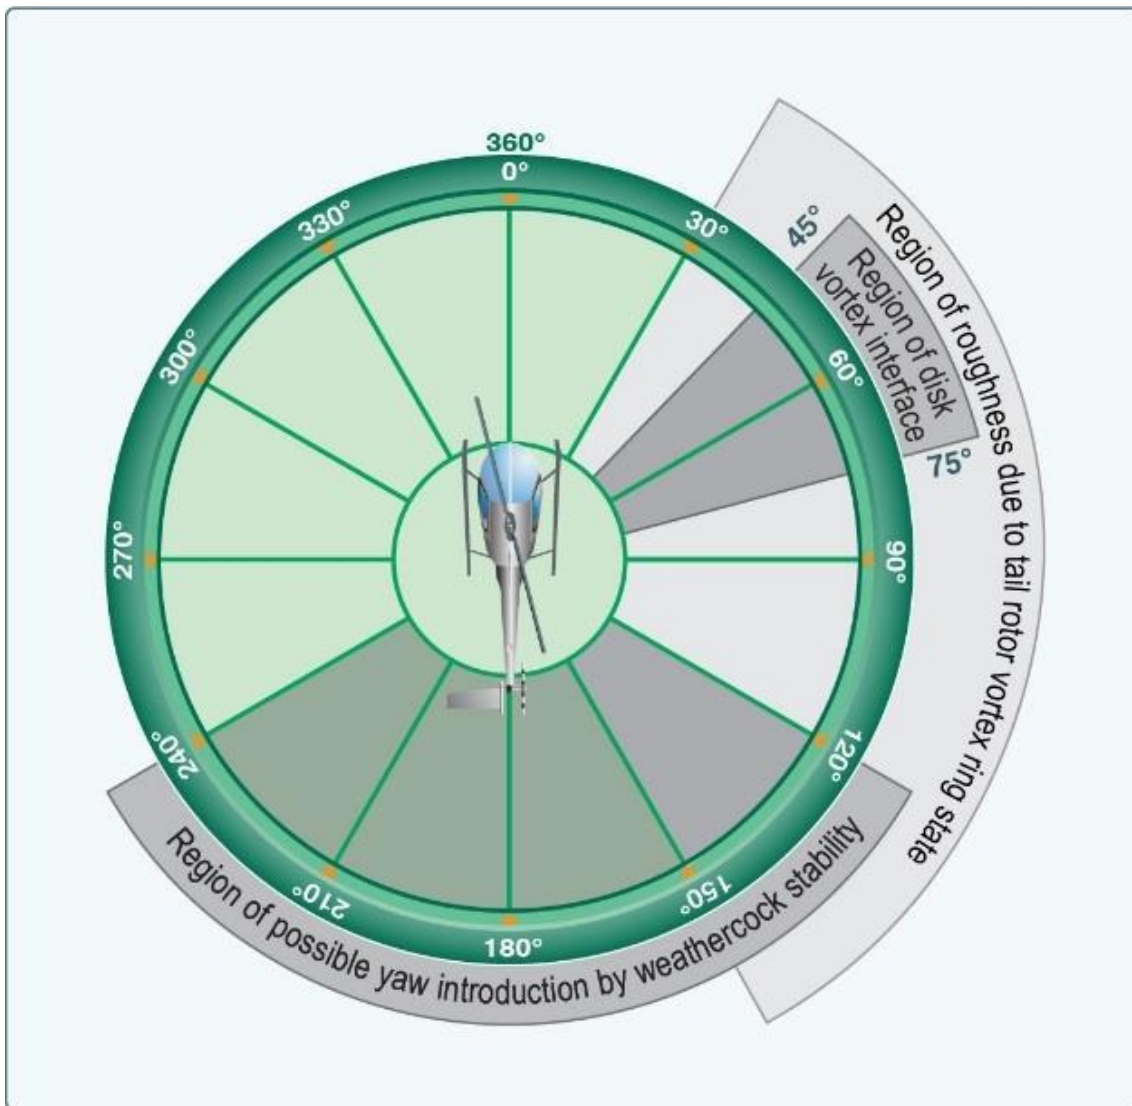
Figure 2. Relative wind directions that can contribute to LTE for clockwise rotating main rotor helicopters

On US-manufactured single-rotor helicopters, the main rotor rotates anti-clockwise as viewed from above. The torque produced by the main rotor causes the fuselage of the helicopter to rotate in the opposite direction (nose right). On some European- and Russian-manufactured helicopters, the main rotor rotates clockwise as viewed from above. In those helicopters, the torque produced by the main rotor causes the fuselage to rotate nose left. Operating with the relative wind direction within $\pm 15^\circ$ of the 10-o'clock position (for anti-clockwise main rotor helicopters) or the 2-o'clock position (for clockwise rotating main rotor helicopters) generates vortices that directly blow into the tail rotor. Also, tailwinds from 120° to 240° can cause high workloads. Finally, crosswinds can create roughness due to tail rotor vortex ring state (wind from 210° to 330° on anti-clockwise rotating main rotor helicopters or from 30° to 150° on clockwise rotating main rotor helicopters).
