AIRCRAFT ACCIDENT REPORT AND EXECUTIVE SUMMARY

Reference:	CA18/2/3/9702	
Aircraft Registration	ZS-REG	Date of Accident	28 April 2018		Time of Accident	0547Z
Type of Aircraft	Bell Helicopter Textron 206L-4		Type of Operation		Private (Part 91)	
Pilot-in-command Licence Type		PPL (Helicopter)	Age	43	Licence Valid	Yes
Pilot-in-command Flying Experience		Total Flying Hours	176,6		Hours on Type	41,0
Last point of departure		Farm Snymansdrift, East of Kuschke Nature Reserve (S24°0'35,90" E029°18'22,04"), Limpopo				
Next point of intended landing		Farm Snymansdrift, East of Kuschke Nature Reserve (S24°0'35,90" E029°18'22,04"), Limpopo				
Location of the accident site with reference to easily defined geographical points (GPS readings if possible)						
Farm Snymansdrift, East of Kuschke Nature Reserve (S24°01'26,5" E029°19'06,1") Elevation: 4800 ft						
Meteorological Information		Surface wind: Nil, Temperature: 13 °C, Pressure altitude: 1015 hPa, Dew point: 11 °C, visibility: 5000 m, Cloud: Overcast, and broken at 1000 ft AGL mist present

Name of Owner : Breaker Flight (Pty) Ltd
Name of Operator : Private (Part 91)
Manufacturer : Bell Helicopters
Model : 206L-4
Nationality : South Af

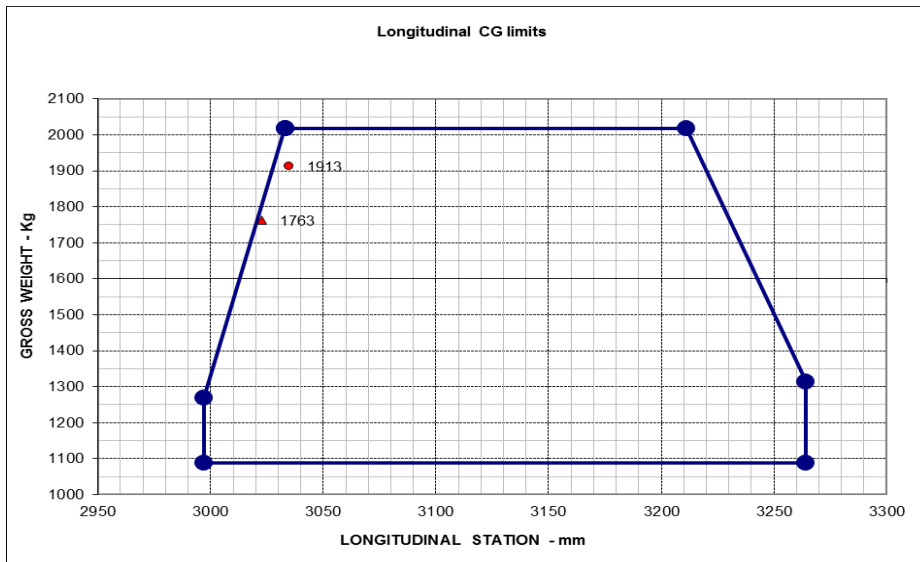
Graph 1: Mass & balance longitudinal CG limits

The above calculation shows the helicopter was within its mass limitations.

The helicopter was operated within the allowable longitudinal and lateral CG limit.
