AIRCRAFT ACCIDENT REPORT AND EXECUTIVE SUMMARY

Reference:	CA18/2/3/9704	
Aircraft Registration	ZS-DEX	Date of Accident	3 May 2018		Time of Accident	0608Z
Type of Aircraft	Falcon 900EX (Aeroplane)		Type of Operation	Private (Part 91)		
Pilot-in-command Licence Type	Airline Transport	Age	46		Licence Valid	Yes
Pilot-in-command Flying Experience	Total Flying Hours	6 362.2		Hours on Type	186.8	
Last Point of Departure	Cape Town International Aerodrome (FACT), Western Cape Province					
Next Point of Intended Landing	Rand Aerodrome (FAGM), Gauteng Province					
Location of the accident site with reference to easily defined geographical points (GPS position)						
Upon landing on Runway 17 at FAGM (GPS position: S26°14'14.00" E028°08'55.44"), elevation 5 448ft						
Meteorological Information	Wind: 190°C at 12 kts; Temperature: 12°C; Visibility: CAVOK and Dew Point 7°C					
Number of people On-board	2 + 10	No. of People Injured	0	No. of People Killed	0

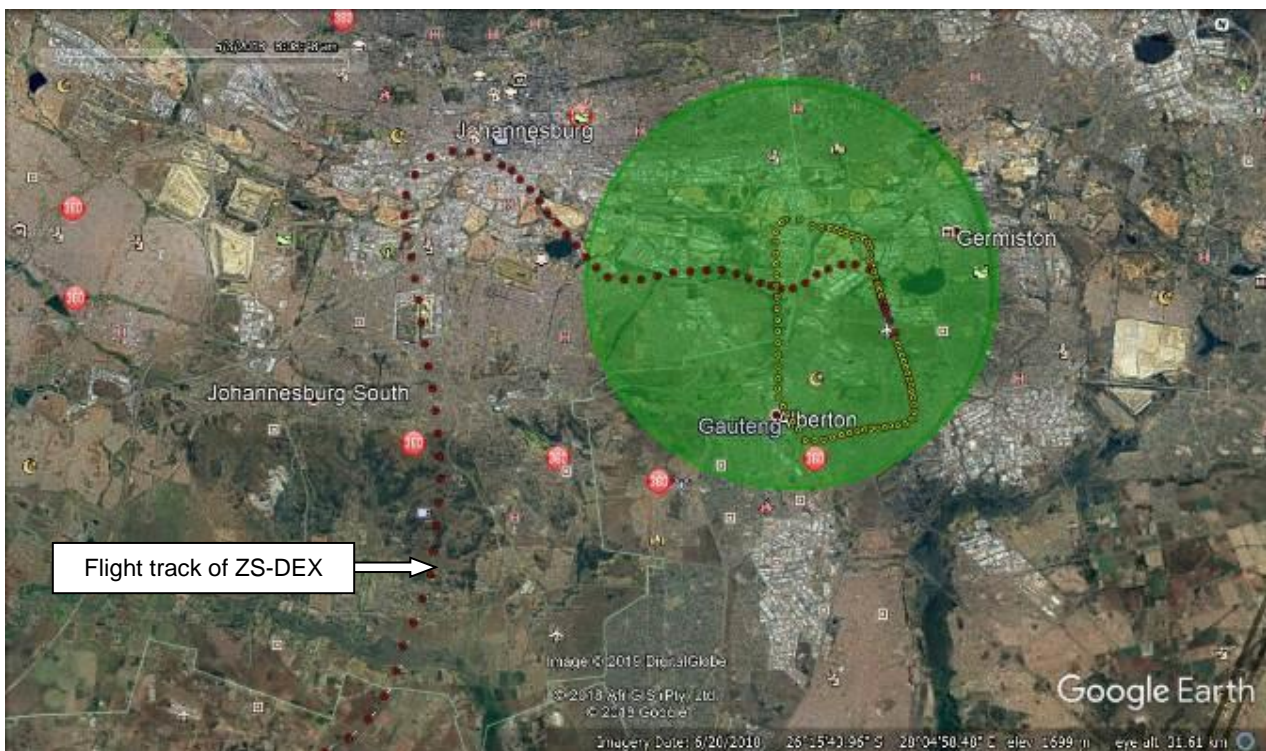
1.1.11 The aircraft ZS-DEX's flight track in Figures 1 and 2 can be seen as indicated by the red dotted line as it approached FAGM from the south-west. The green circle is the FAGM air traffic zone (ATZ), and the yellow dotted line within the green circle is the track flown by the Cessna 172 that was in the circuit at the time. The crew members of the ZS-DEX flew a very wide right downwind for Runway 17, which took the aircraft in proximity to the Johannesburg central business district (CBD) from where the PF executed several turns before the aircraft touched down on Runway 17. The downwind leg was flown outside of FAGM's controlled airspace in terms of the special rules, South Sector.

Figure 1: Overlay of the approach path that was flown by ZS-DEX (red dotted line)

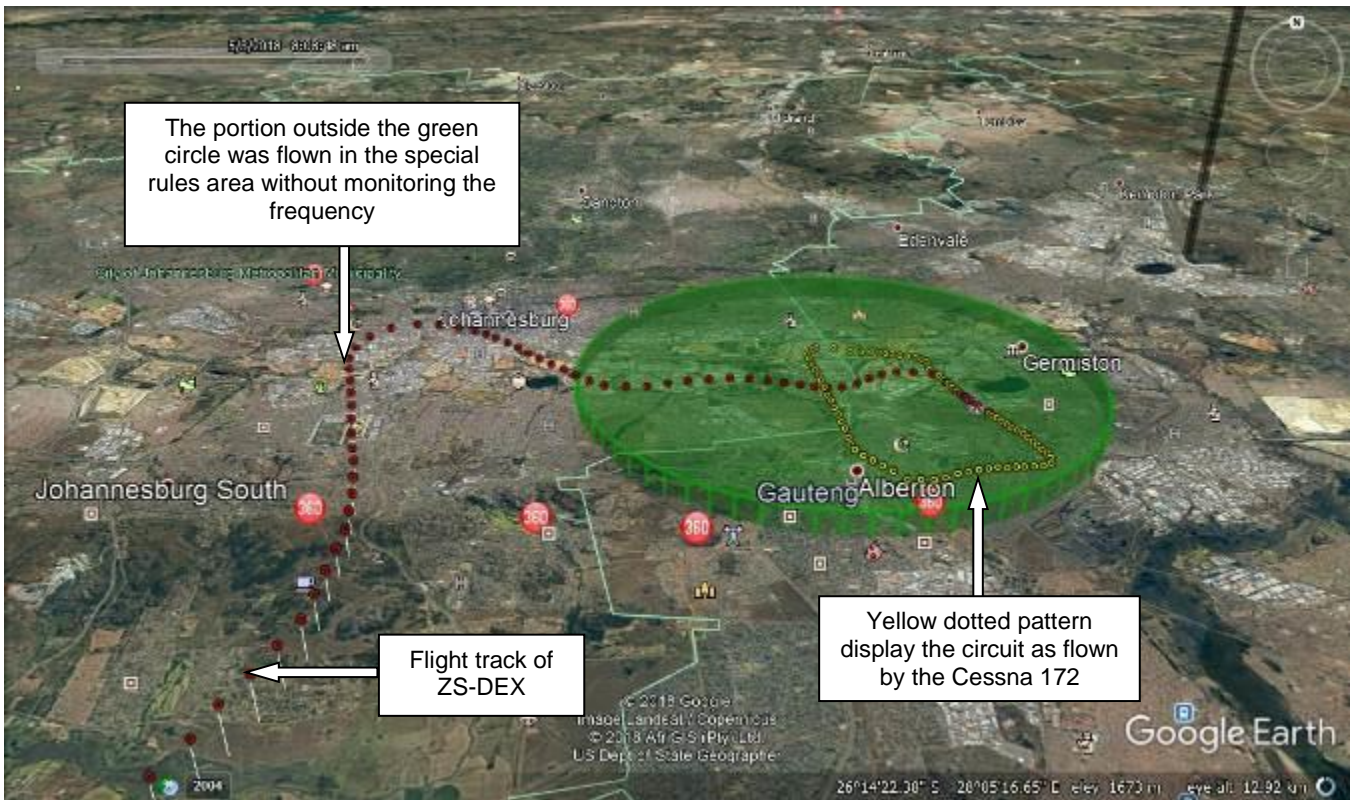
Figure 2: Overlay of the approach path that was flown by ZS-DEX (red dotted line) (Source: Google Earth)

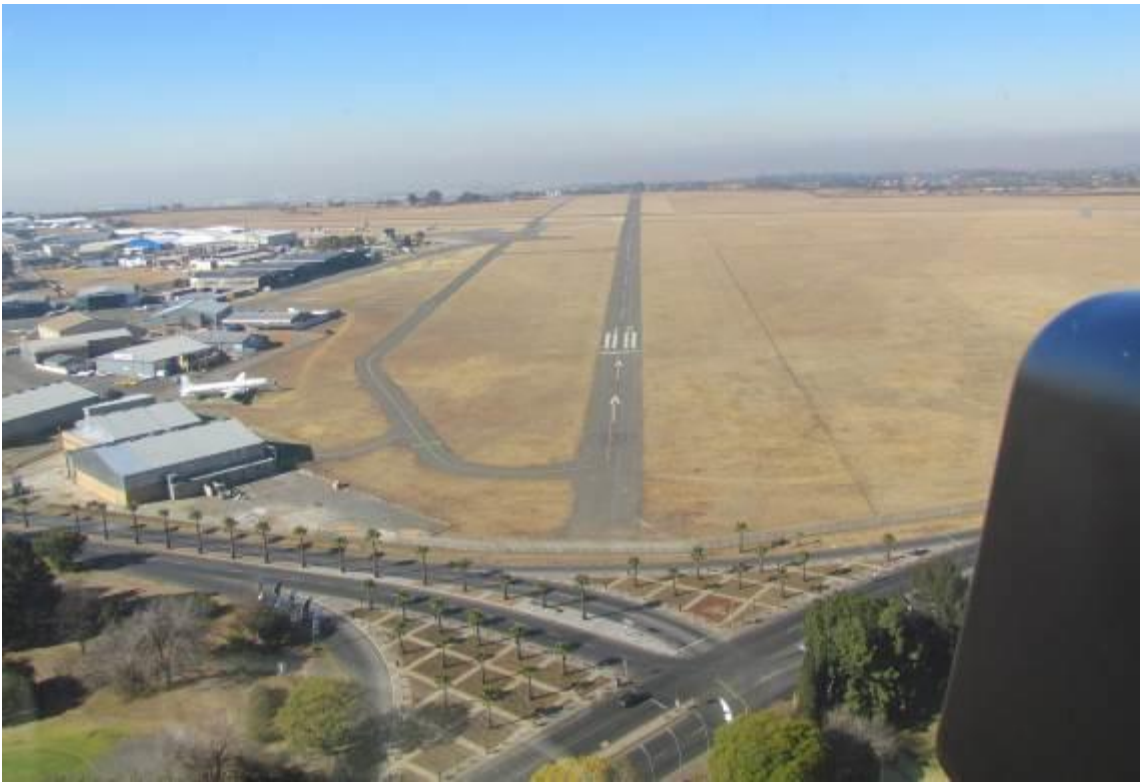
Figure 4: On short final approach for Runway 17 at FAGM

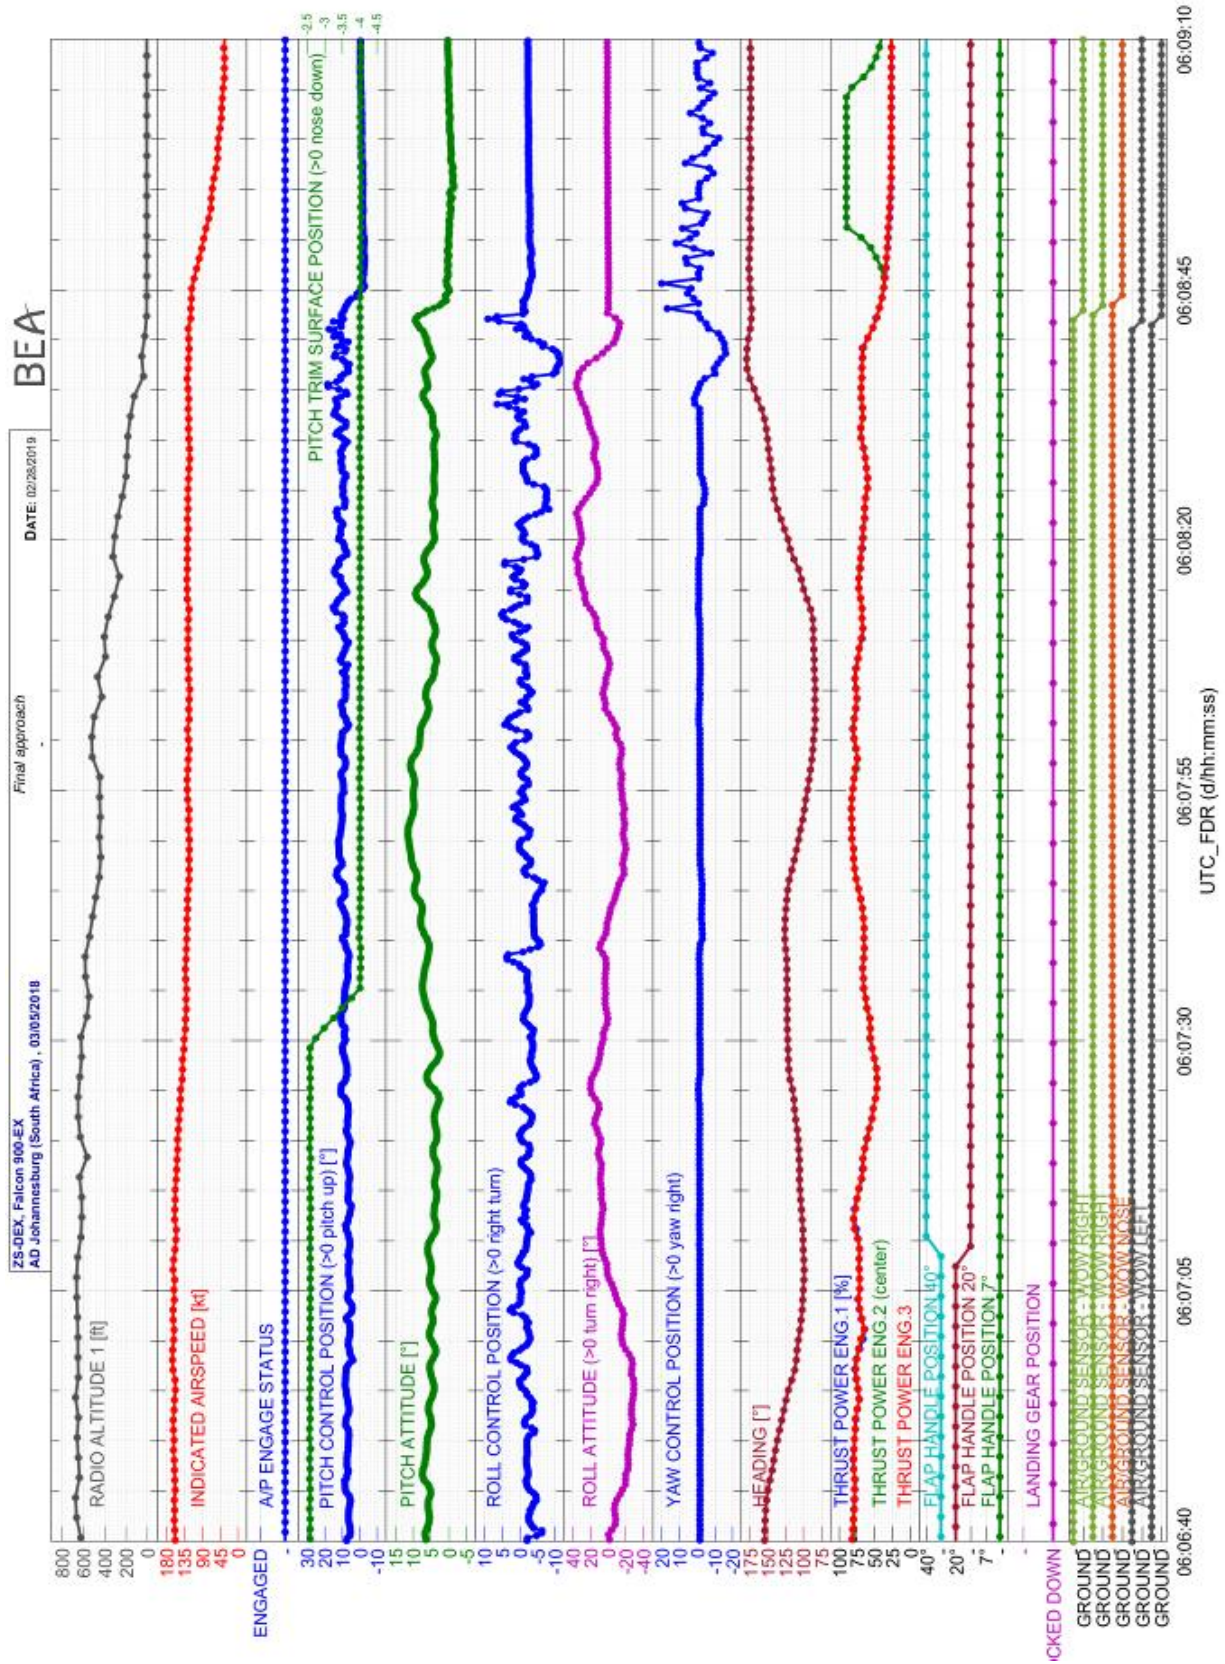
- 1.16.3 The orange line (Figure 15b below) displays the aileron input during the flight. During the final approach phase of the flight, these control surfaces displayed substantial inputs, which included several noticeable deflections of 11° and more.

Figure 15a: FDR data for the last 2 minutes of the flight
