## AIRCRAFT ACCIDENT REPORT AND EXECUTIVE SUMMARY

Reference:	CA18/2/3/9711	
<b>Aircraft Registration</b>	ZU-FFA	<b>Date of Accident</b>	12 May 2018		<b>Time of Accident</b>	0730Z
<b>Type of Aircraft</b>	Zodiac CH601 HD (Aroplane)		<b>Type of Operation</b>		Private (Part 94)	
<b>Pilot-in-command Licence Type</b>		National Pilot Licence	<b>Age</b>	43	<b>Licence Valid</b>	No
<b>Pilot-in-command Flying Experience</b>		Total Flying Hours	265,12		Hours on Type	20,8
<b>Last point of departure</b>		Panorama AerodromeAerodrome, Gauteng Province				
<b>Next point of intended landing</b>		Rand Aerodrome (FAGM) Germiston, Gauteng Province				
<b>Location of the accident site with reference to easily defined geographical points (GPS readings if possible)</b>						
260 meters from the threshold of runway 11 at FAGM, (GPS position 26°14'33.06" South 028°8'16.84" East at an elevation of 5383 ft AMSL.						
<b>Meteorological Information</b>		Surface wind 350° variable between 330° and 030° at 10 kt, temp 17 °C, dew point 3 °C,CAVOK

**Name of Owner** : Coenraad de Beer  
**Name of Operator** : Jaco Neethling  
**Manufacturer** : Zenith Aircraft  
**Model** : Zodiac CH 601 HD  
**Nationality** : So

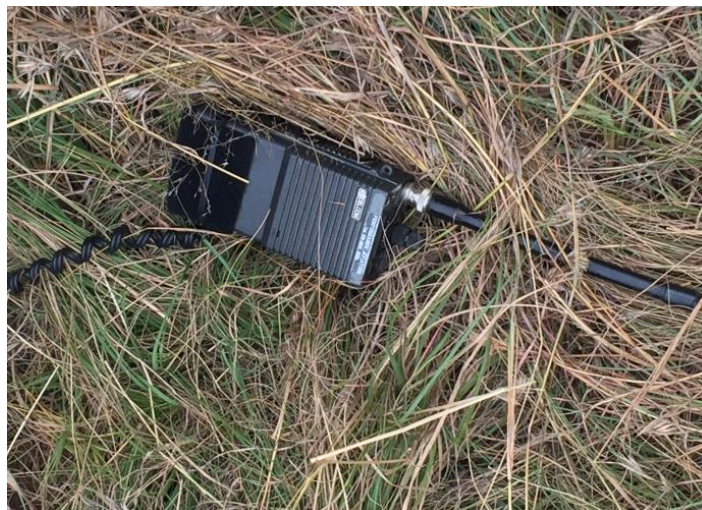
1.9.1 The aircraft was equipped with one VHF (very high frequency) radio, as approved by the regulator. According to the pilot statement, he reported that he was having radio problems en route to FAGM. He diverted to Panorama aerodrome in order to get the radio problem sorted out. The AP arrived from Vereeniging and gave the pilot a hand-held radio. The pilot took off and continued to FAGM using a hand held radio. According to available records (transcripts), the pilot contacted the tower when he was overhead Silver Ball. The tower cleared the aircraft to join left base runway 35. It was noted that the aircraft was fitted with a transponder, but the pilot failed to enter the code 7600, which is international standard to indicate that you are experiencing a communication failure on board the aircraft.

Figure 6: The hand-held radio that was used by the pilot during the flight.
