Accident and Incident Investigations

HELICOPTER ACCIDENT REPORT AND EXECUTIVE SUMMARY

Reference:	CA18/2/3/9714	
Aircraft Registration	ZS-MZS	Date of Accident	1 June 2018		Time of Accident	0940Z
Type of Aircraft	Robinson R44 Raven II		Type of Operation	Private (Part 91)		
Pilot-in-command Licence Type	Private Pilot (Helicopter)		Age	36	Licence Valid	Yes
Pilot-in-command Flying Experience	Total Flying Hours		±406.8		Hours on Type	±68.6
Last point of Departure	Rustenburg Aerodrome (FARG), North West Province					
Next Point of Intended Landing	Zebula Golf Estate & Spa Aerodrome, Limpopo Province					
Location of the accident site with reference to easily defined geographical points (GPS readings if possible)						
Lumarie Game Farm, 8 nautical miles south-west of Zebula Golf Estate & Spa Aerodrome at GPS co-ordinates S24°52'07.71" E027°52'27.97" at an elevation of 3 920ft						
Meteorological Information	Wind: 280°/10 kts, visibility: >10km, temperature: 21°C, dew point: 15°C

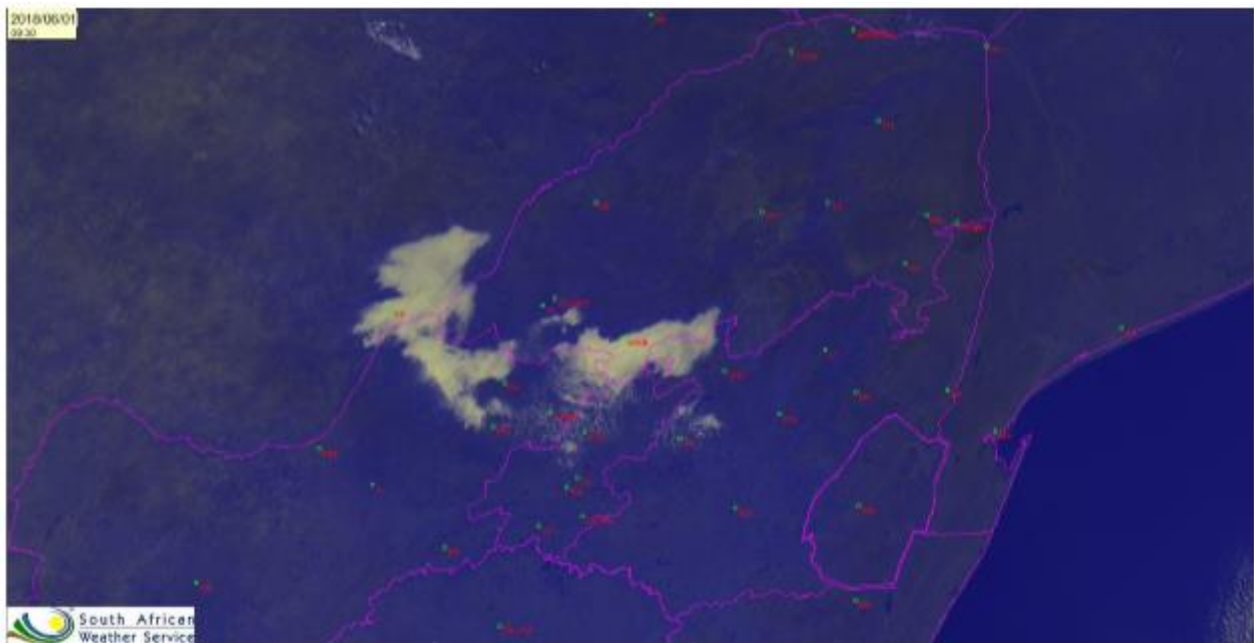
Figure 4: HRV cloud enhance satellite image at 0930Z on 1 June 2018.

Figure 4 is the Heat Recovery Ventilation (HRV) satellite image as at 0930Z, 10 minutes before the accident. It attests to the clear weather conditions at the accident location at the approximate time of the accident, notwithstanding banks of clouds to the south extending to Rustenburg.

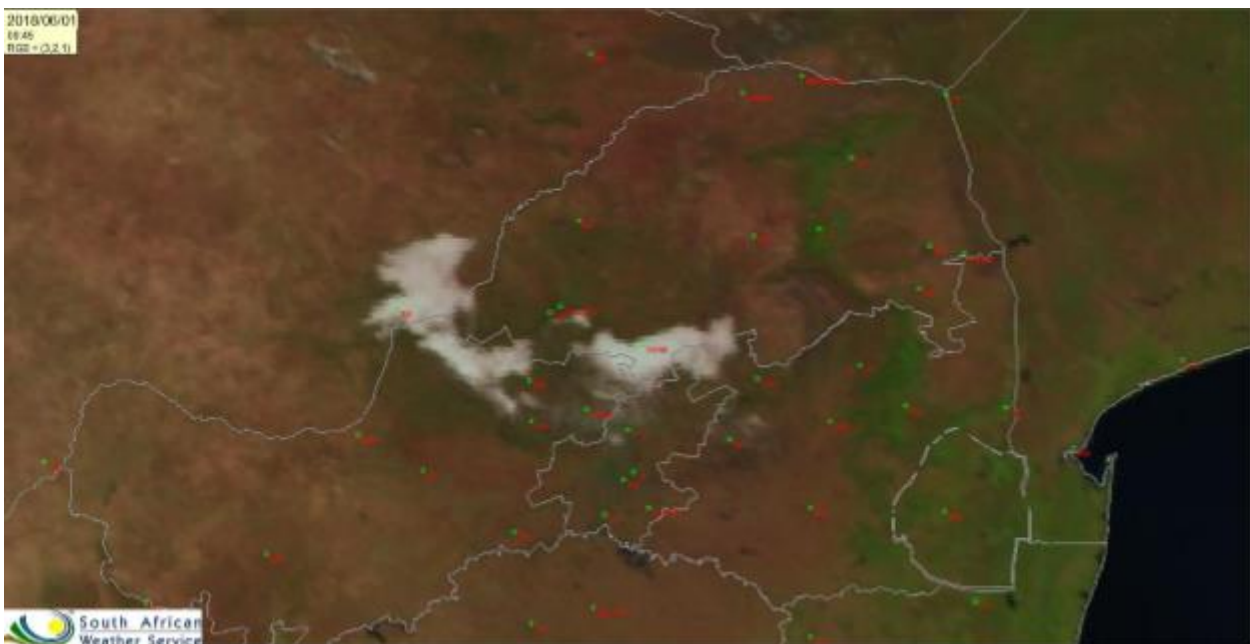
Figure 5: Day natural colour satellite image at 0945Z on 1 June 2018, showing dissipating stratus clouds.

A loop of satellite images from 0900Z to 1000Z clearly indicate the rapid clearance of this low-level cloud such that by 0945Z, just 5 minutes after the accident, the accident location shows no presence of cloud or any other significant weather (Figure 5).

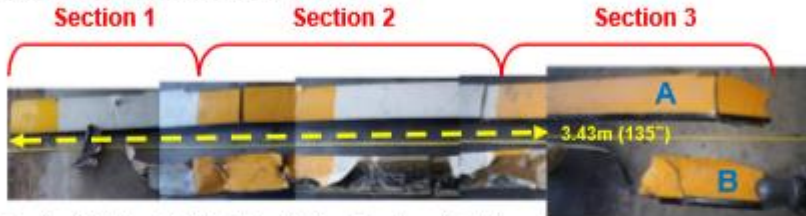
Combined Picture 1: Main Rotor Blades, Top view (digital)

The visual inspection revealed the Main Rotor Blades (Blade A Serial No 5699, Blade B Serial No 5688, Part No's C016-5) to be in a conspicuously contrasting post-impact condition (Combined Pictures 1 and 2, Photo 5).

Note: For ease of reference, the MR blades were divided in Sections 1, 2 and 3 coinciding with the change in paint scheme (Combined Picture 1, red brackets; Diagrams 2 and 4).

Section 2, Top Side: No clear indications of LE impact damages or scraping marks were noted (Combined Picture 1).

Section 2, Bottom Side: No indications of blade skin debonding were noted at the skin/main spar bond-line up to the 135°/3.43m position (Combined Picture 1, RHC SB-72).

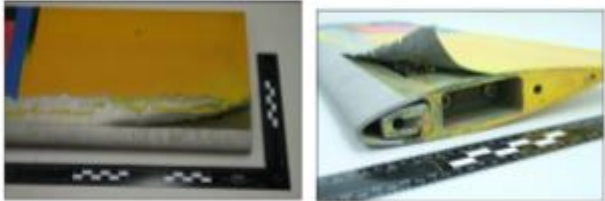
Extract 1: Historic indications of delamination⁵

- The noted impact damages to the blade skins and inner honeycomb structure of the outer segment (Section 1) of Blade B suggest the absence of the Main Spar 'protection' at the LE boundary during impact.

- Research results from similar Robinson Helicopter (R22 and R44) MR blade damages following impacts with hard ground or other objects infer that the Main Spar rarely separates from the blade skins in total, as with the unit under investigation. In the majority of cases the MR blade segmented as an assembly during impact.
