AIRCRAFT ACCIDENT REPORT AND EXECUTIVE SUMMARY

Reference:	CA18/2/3/9732	
Aircraft registration	ZU-EVW	Date of accident	18 September 2018		Time of accident	0820Z
Type of aircraft	Ikarus C42B (Micro-light)		Type of operation		Commercial (Part 96)	
Pilot-in-command licence type	Commercial		Age	24	Licence valid	Yes
Pilot-in-command flying experience	Total flying hours		294.2		Hours on type	47.7
Last point of departure	Bethlehem Aerodrome (FABM), Free-State Province					
Next point of intended landing	Bethlehem Aerodrome (FABM), Free-State Province					
Location of the accident site with reference to easily defined geographical points (GPS readings if possible)						
Bethlehem Aerodrome (GPS position; 28°14'52.25" South 028°20'08.33" East) elevation 5 536 feet AMSL						
Meteorological information	Surface wind; 328°/7.4kt gusting 10.7kt, temperature; 24.5°C, CAVOK					
Number of people on board	1 + 1	No. of people injured	0	No. of people killed	2

Synopsis	<p>On Wednesday morning, 19 September 2018, the pilot accompanied by a passenger departed from Kroonstad Aerodrome (FAKS) on an agricultural survey flight and landed at Bethlehem Aerodrome (FABM) after being airborne for three hours

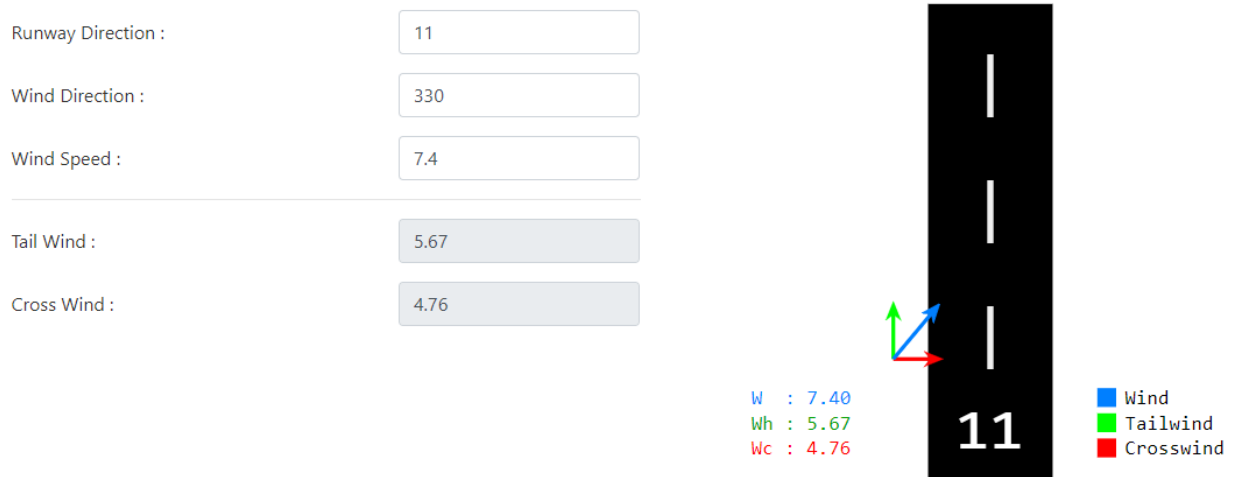
Figure 4: The wind component (Source: <https://www.e6bx.com>)

The data captured in the table on the next page was obtained from the Bethlehem weather station for 19 September 2018. The data was available in five-minute intervals. The weather information at the time of the accident (0820Z) has been highlighted in bold in the table. *NOTE: The wind data as contained in the table below were measured in true north, a variation of 20° should be added to convert it to magnetic north. This was done to the wind direction that was captured at 0820Z.

Time (Zulu)	Wind speed m/sec (knots)	Wind direction from True North (Magnetic North)	Wind gust m/sec (knots)	Temperature °C	Humidity %	Rain mm
0810	3.1	310.7	4.5	23.7	13.4	0
0815	3.1	316.7	4.8	24.2	12.7	0
0820	3.8 (7.4)	308.4 (328.4)	5.5 (10.7)	24.5	13	0
0825	3.4	320.3	5	25	12.8	0
0830	2.7	310.9	4.1	15.5	12.9	0

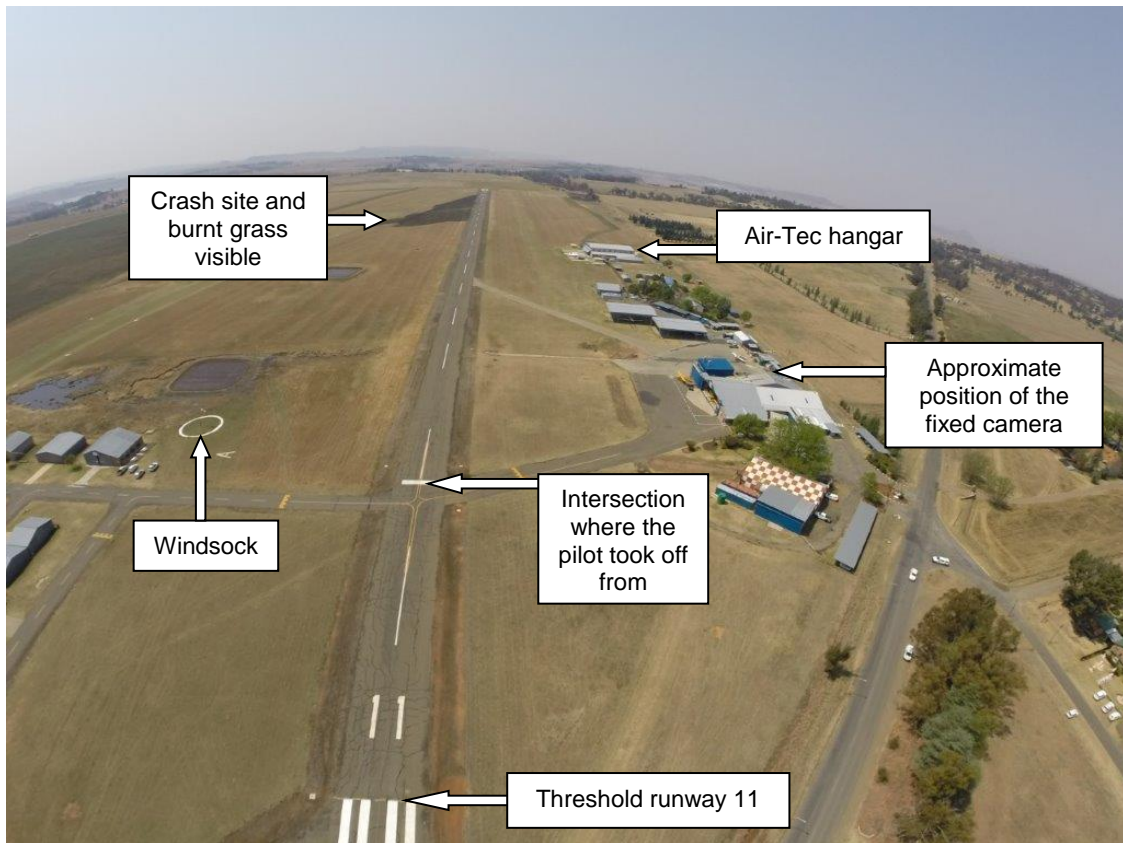
Figure 6: An aerial view of the Bethlehem aerodrome (photograph courtesy of Kobus Smit)

- 1.1.2 The pilot, accompanied by an observer/passenger, then boarded the aircraft ZU-EVW for their second surveillance flight of the day. They taxied onto runway 11, where the pilot commenced with an intersection take-off as illustrated in Figure 6. The intersection was 82m before the threshold of runway 11. The intention of the flight was to continue with the agricultural survey in the Frankfort, Reitz and Bethlehem area. The prevailing weather conditions, according to the meteorological aerodrome report (METAR) for FABM on 19 September 2018 at 0800Z, was 33005KT CAVOK 22/M07 Q1022=. The wind was from the northwest at 330°/5 knots, with the temperature 22°C, the dew point was -7°C and the pressure altitude setting was 1022 hPa.

Prior to take-off the pilot taxied from the apron area on the northern side of the aerodrome where the aircraft was refuelled via the taxiway to the runway intersection as depicted in Figure 6 on page 17 of this report. In order to get to the runway intersection, the pilot had to taxi past the aerodrome windsock, which was located approximately 45m from the taxiway centreline. This would have given him a clear indication of what the prevailing wind conditions was at the time.

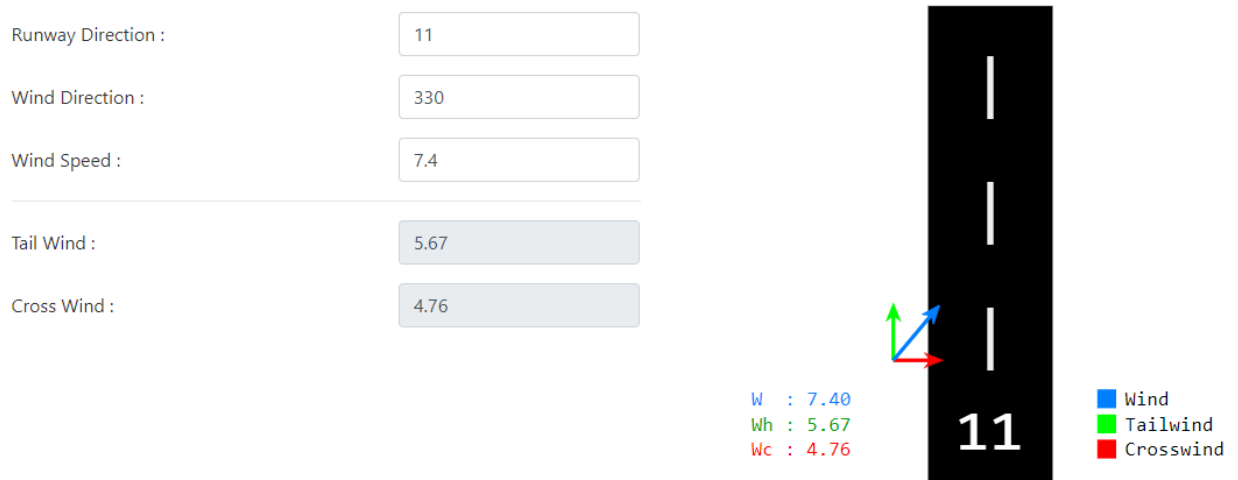
Figure 18: Schematic of the prevailing winds at the time of the accident flight

The wind correction angle (WCA) for take-off is illustrated in Figure 16 was calculated to be -10° (100°), which was then subtracted from the take-off course, which was 110° . A wind speed of 10.7 knots was used during the calculation as it was evident from the video footage that the wind was gusting at the time.

In the calculations to determine the WCA a true airspeed of 40 knots was used, which equated to a ground speed of 48 knots if the wind correction was taken into account. This speed was 2 kt above the value as captured on the airspeed indicator that was found on the accident site as displayed in Figure 13 of this report.

Taking into consideration the information that is depicted in Figure 16 on page 27 of this report, which provides the orientation of the two runways at FABM and the prevailing wind conditions at the time. From this illustration it could be seen that if the pilot had planned the flight better, he would have most probably opted to make use of runway 31, which would have allowed for an into wind take off. The pilot that was flying ZS-LUW, which was the first aircraft that took-off from FABM following the accident in question, did opt to use runway 31 due to the prevailing wind conditions, which was still from the northwest (unchanged) at the time. Taking off into wind increases lift, and also assist the aircraft in becoming airborne at a lower ground speed and a shorter take-off roll is required.
