Accident and Incident Investigations Division

<b>AIRCRAFT ACCIDENT REPORT AND EXECUTIVE SUMMARY</b>
---

Reference:		CA18/2/3/9735		
<b>Aircraft Registration</b>	ZU-CBR	<b>Date of Accident</b>	6 October 2018	<b>Time of Accident</b>	0645Z	
<b>Type of Aircraft</b>	Windlass Aquilla		<b>Type of Operation</b>	Private (Part 94)		
<b>Pilot-in-command Licence Type</b>	NPL (National Pilot Licence)		<b>Age</b>	32	<b>Licence Valid</b>	Yes
<b>Pilot-in-command Flying Experience</b>	Total Flying Hours		60	<b>Hours on Type</b>	60	
<b>Last Point of Departure</b>	Mlala Game Farm Private Airstrip in Limpopo Province					
<b>Next Point of Intended Landing</b>	Mlala Game Farm Private Airstrip in Limpopo Province					
<b>Location of the accident site with reference to easily defined geographical points (GPS readings if possible)</b>						
Mlala Game Farm is 5.4nm north-east of Marble Hall at GPS co-ordinates S24°54'56,8" E029°21'34,2", at an field elevation of 2 815ft						
<b>Meteorological Information</b>	Wind: 135° at 05kt; Visibility: 9999m; Temperature: 17°C

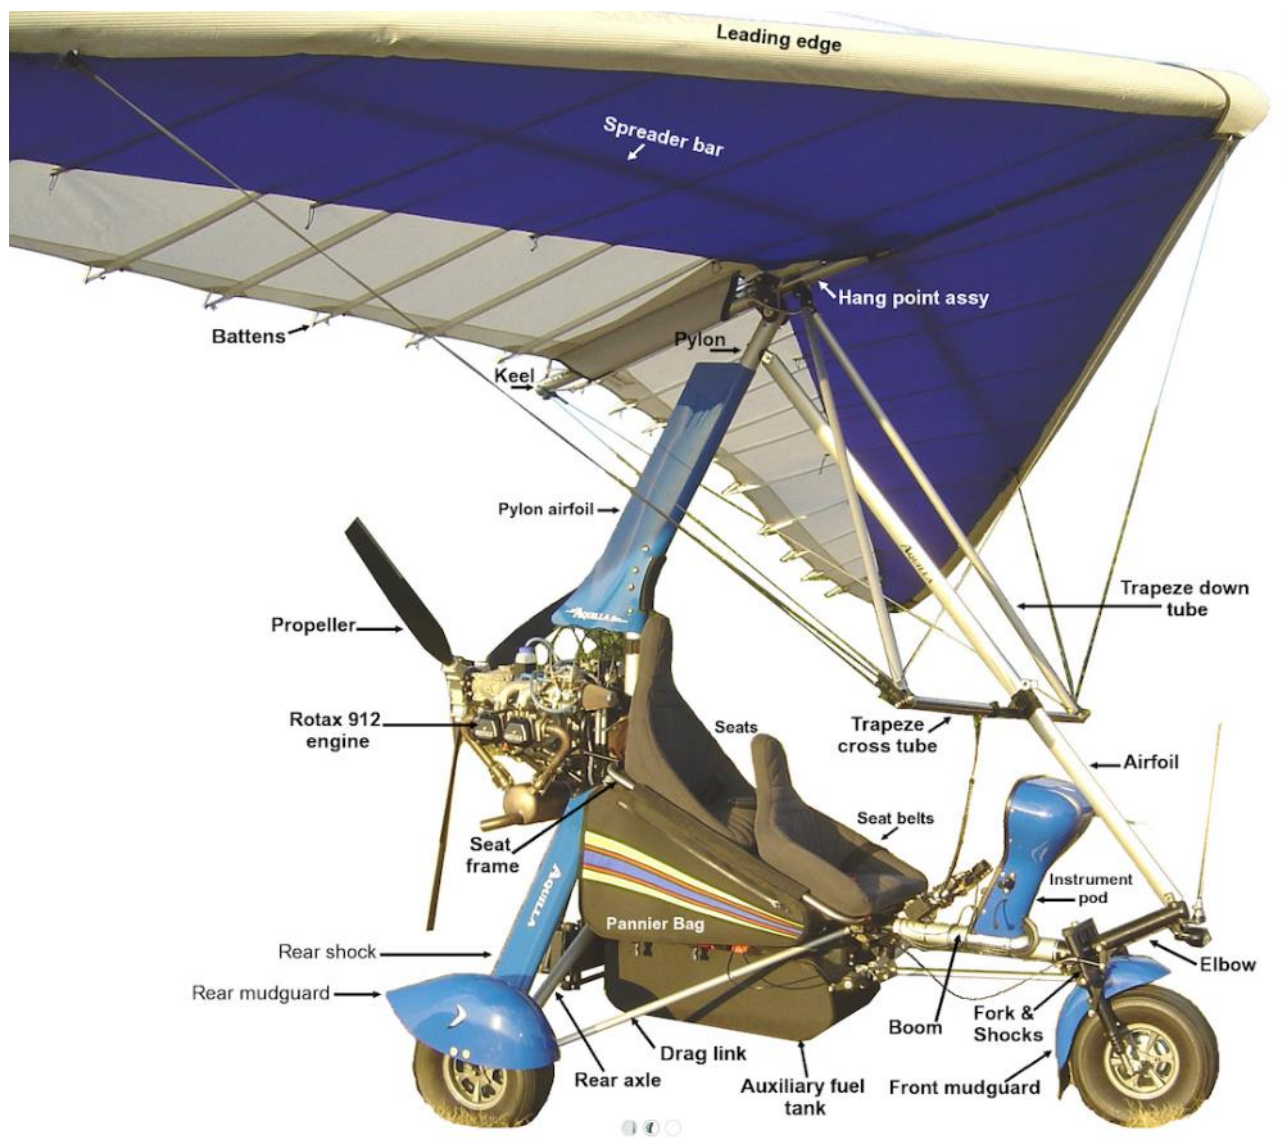
**Figure 5:** Windlass Aquila similar to the accident aircraft.

1.12.2 An eyewitness stated that he saw the microlight approaching from the south going north after he heard a strange noise which alerted him to it. He then saw the wing separating from the body and the body rotating forward three times on its longitudinal axis before impacting the ground. The wing came to rest 75m from the airframe impact.

1.12.3 The fuselage, the engine and the propeller were significantly damaged during the impact sequence.
