AIRCRAFT ACCIDENT REPORT AND EXECUTIVE SUMMARY

Reference:	CA18/2/3/9736	
Aircraft Registration	ZS-PZT	Date of Accident	8 October 2018		Time of Accident	0920Z
Type of Aircraft	Cessna C172L		Type of Operation	Training (Part 141)		
Pilot-in-command Licence Type	Student Pilot		Age	21	Licence Valid	Yes
Pilot-in-command Flying Experience	Total Flying Hours		37.7		Hours on Type	37.7
Last Point of Departure	Grand Central Aerodrome (FAGC), Gauteng					
Next Point of Intended Landing	Grand Central Aerodrome (FAGC), Gauteng					
Location of the accident site with reference to easily defined geographical points (GPS readings) if possible						
Residential property, Vorna Valley (S26°00'02" E028°06'25")						
Meteorological Information	FAGC 080900Z; Temperature: 17°C; Dew Point: 02°C; Wind: 300°/6 kts; CAVOK QNH: 1028 hPa					
Number of People On Board	1 + 0	No. of People Injured	0	No. of People Killed	1 (On board) and 1 (On ground)	
Synopsis	<p>On Monday 8 October 2018 at 0833Z, the pilot departed Grand Central Aerodrome (FAGC) on a solo training flight with the intention of remaining in the circuit to practise touch-and-go landings.</p> <p>Following the pilot's fifth touch-and-go, while the

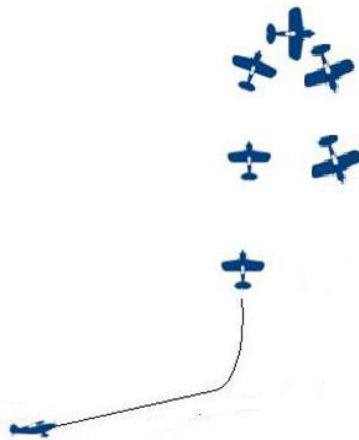
- 1.1.5 A second eyewitness stated that the aircraft had banked abruptly to the right after it had entered the orbit. The aircraft continued to fly with a high bank angle up until the eyewitness lost sight of the aircraft.
- 1.1.6 A third eyewitness, who was in proximity to the Accident site, stated that the aircraft had flown in front of his car at a low level and had rapidly pitched up. The witness described the aircraft as performing a manoeuvre similar to a hammerhead turn, after which the right wing lost lift and the aircraft impacted the ground.

Figure 2: According to the third eyewitness, the aircraft entered a turn similar to the illustration above (hammerhead turn) and impacted the ground (source: <http://www.aerobatica.pt>)

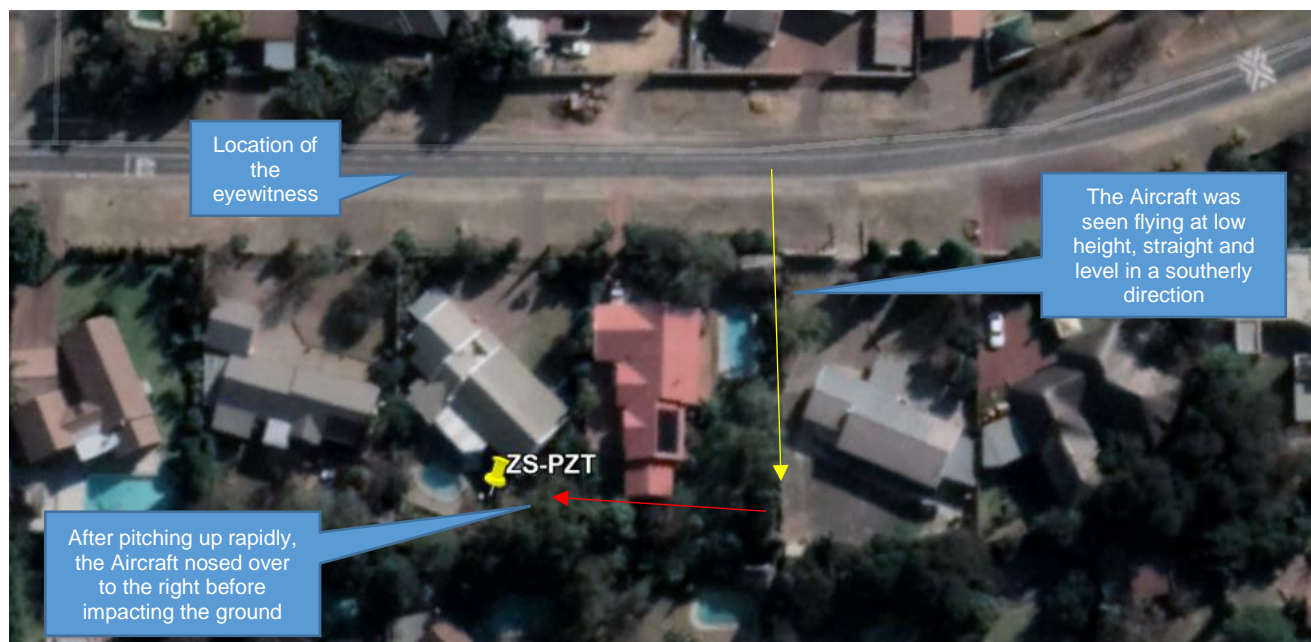
1.12.1 The aircraft was seen flying at a low level in a southerly direction. After crossing Albertyn Street, the aircraft pitched up to a near vertical position. The aircraft lost momentum, stalled and nosed over to the right. The final heading before coming to rest was in a westerly direction.

1.12.2 The pitch angle prior to impact was approximately between 30° and 60° as the aircraft still possessed sufficient forward momentum to continue on its ground trajectory for a further 23m.

Figure 8: The direction of the aircraft leading up to the Accident
(Source: Google Earth)

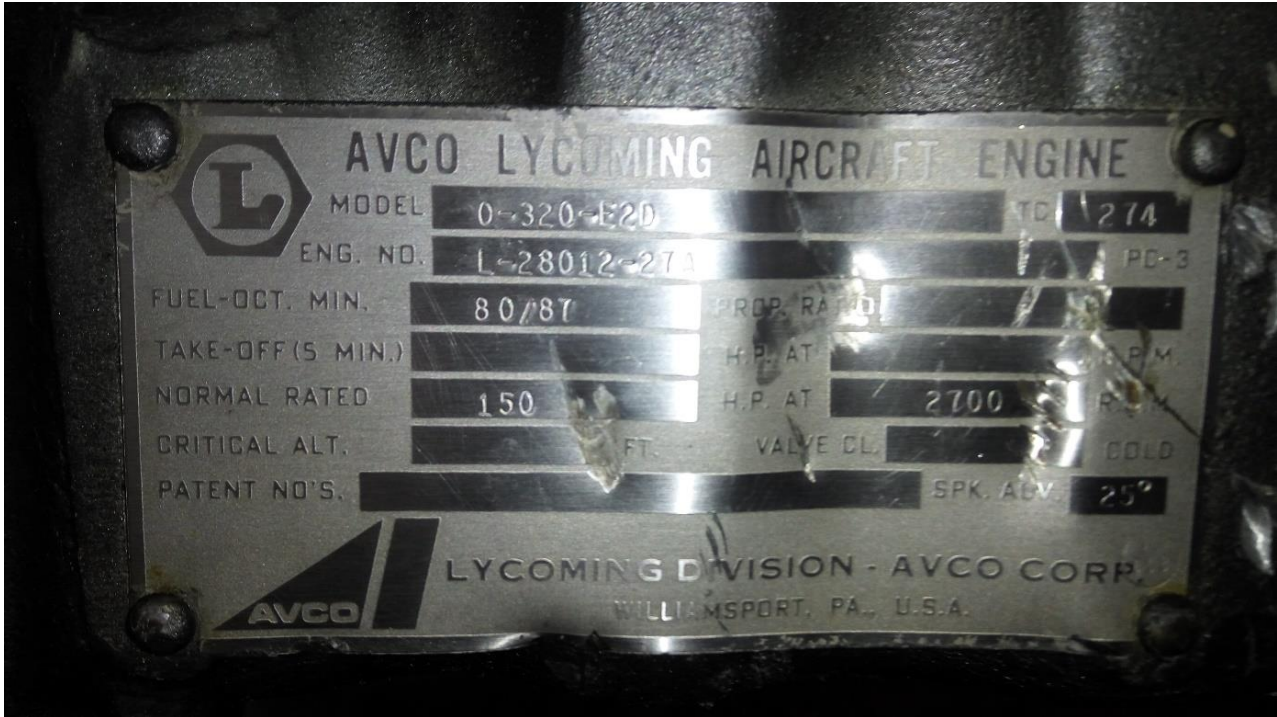
The Engine Data Plate

Engine Model	Avco Lycoming Aircraft Engine O-320-E2D
Engine Serial Number	L-28012-27A
