AIRCRAFT ACCIDENT REPORT AND EXECUTIVE SUMMARY

Reference:	CA18/2/3/9748	
Aircraft Registration	ZS-PBR	Date of Accident	9 November 2018		Time of Accident	1620Z	
Type of Aircraft	Partenavia P68C-TC		Type of Operation		Test flight (Part 43)		
Pilot-in-command Licence Type	Commercial Licence		Age	34		Licence Valid	Yes
Pilot-in-command Flying Experience	Total Flying Hours		1514.7		Hours on Type	4.9	
Last point of departure	Lanseria Aerodrome (FALA) Gauteng Province						
Next point of intended landing	Lanseria Aerodrome (FALA) Gauteng Province						
Location of the accident site with reference to easily defined geographical points (GPS readings if possible)							
Hartebeesfontein Road at GPS 25°51'14.15" South 027°37'25.41" East, at an elevation of 4 206 feet							
Meteorological Information	Wind: Variable at 5kt, Temp 26°C, Dew point 6°C, Visibility 10km.						
Number of people on board	1+0	No. of people injured	0	No. of people killed	0		
Synopsis	<p>On 9 November 2018 at 1320Z, a pilot took off from Lanseria International Airport (FALA) following a mandatory periodical inspection (MPI), the flight was conducted as a maintenance check flight with the intention to land back at FALA.

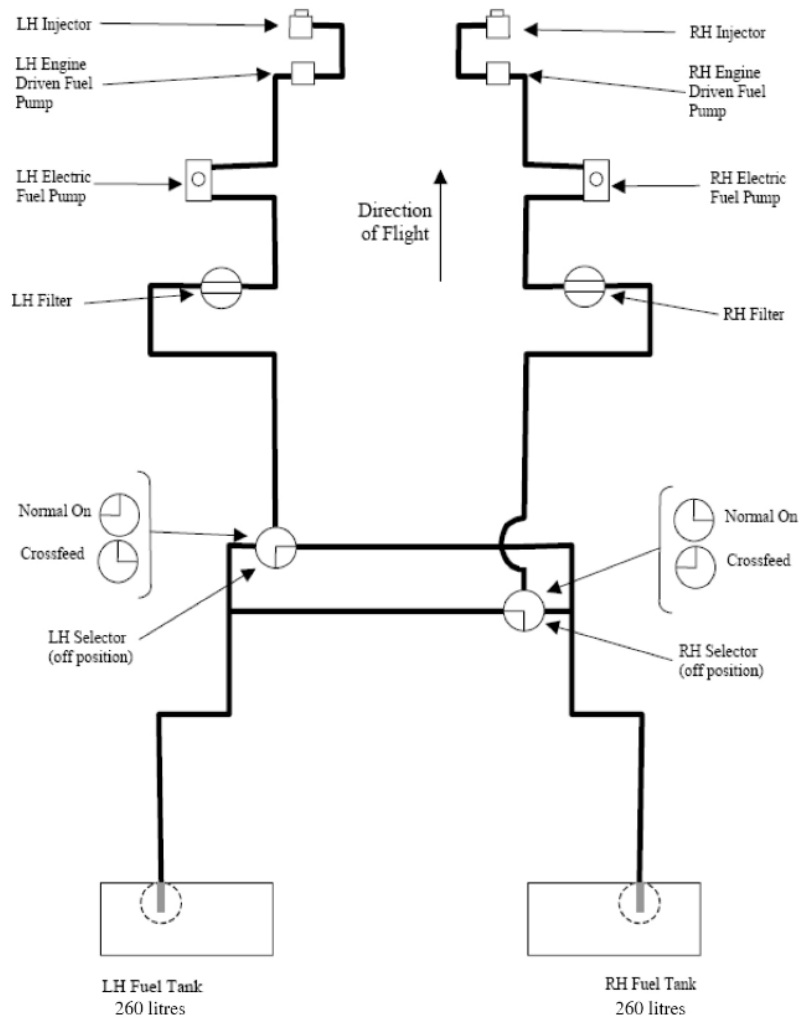
Figure 2: Schematic diagram of fuel system.

1.6.2 Fuel flow from the wing tanks to the engines is controlled by three (3)-position fuel selector control knobs, one for each engine. The selector knobs enabled the pilot to select which tank to feed which engine. Normally the fuel selector knobs would be selected for direct tank-to-engine flow; that is, the right engine fuel selector knob would be set to the right tank and the left engine selector knob to the left tank. Alternatively, cross-feed could be selected allowing for flow from a tank to the opposite engine, or if required from one tank to both engines. For example, if the left engine selector knob was rotated to its right tank setting, fuel from the right tank would feed both engines. The left tank setting on the right engine selector allowed fuel from the left fuel tank to also feed both engines. The final position was for fuel shut-off on the right-hand engine and intermediate between left-hand and right-hand tanks for the left-hand engine as depicted in Figure 4.

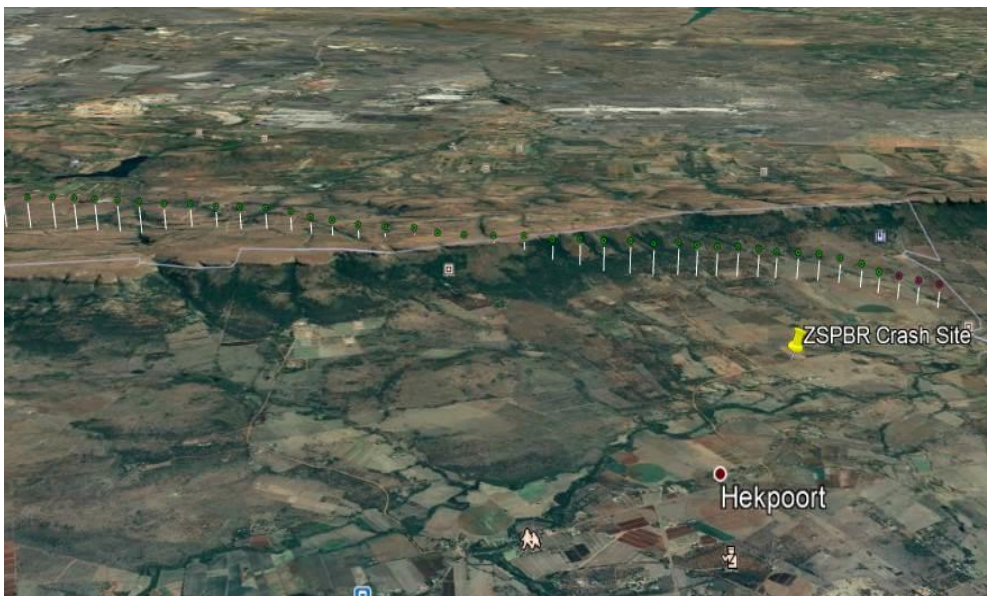
Figure 5: Radar image before the crash. (Picture courtesy of FALA)

Note: The radar image above provided by FALA Air Traffic and Navigation Services (ATNS), depicts the flight path of the aircraft minutes before the crash. It was noted that after the aircraft crossed the Magaliesberg mountain ridge line, it made a descending right turn before radar was lost. The radar started tracking the aircraft at 17.34 nautical miles (nm) from FALA airfield at a height of 6000 feet (ft). It was noted that the aircraft continued with that height until it crossed the ridge. The radar images showed a steady descend up to the point where the aircraft reached a height of 4900ft above mean sea level (AMSL). That is when the radar contact was lost at 1610Z.

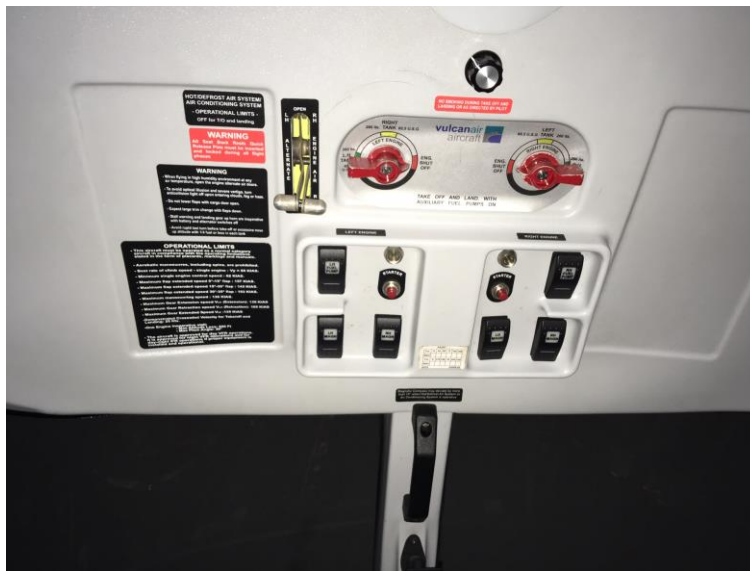
Figure 19: The flight simulator fuel control selectors.

1.18.2 Comparison between the accident aircraft and the aircraft and simulator that the pilot used for conversion did not reveal any discrepancies in the layout and position. The three fuel selector systems for both engines had a decal which had three positions: LH tank, RH tank and ENG shut-off for left-hand

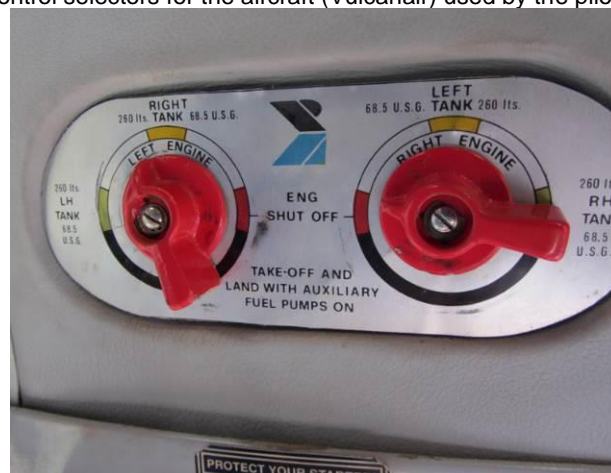
Figure 21: Accident aircraft fuel control selectors.

position of the engine fuel supply valve selectors as found on the scene were as follows: the left engine fuel selector control knob was pointing intermediate between the left- and the right-hand tank position; the right-hand engine fuel selector control knob was pointing to the shutdown position, the left-hand engine fuel selector control knob was stuck in the intermediate position between the left- and the right-hand tank position and could not be rotated, the right-hand engine fuel selector control knob was moving freely. All switches for the fuel pumps were in the off position. All circuit breakers were pushed in, except those that were intentionally pulled out and secured with cable ties.

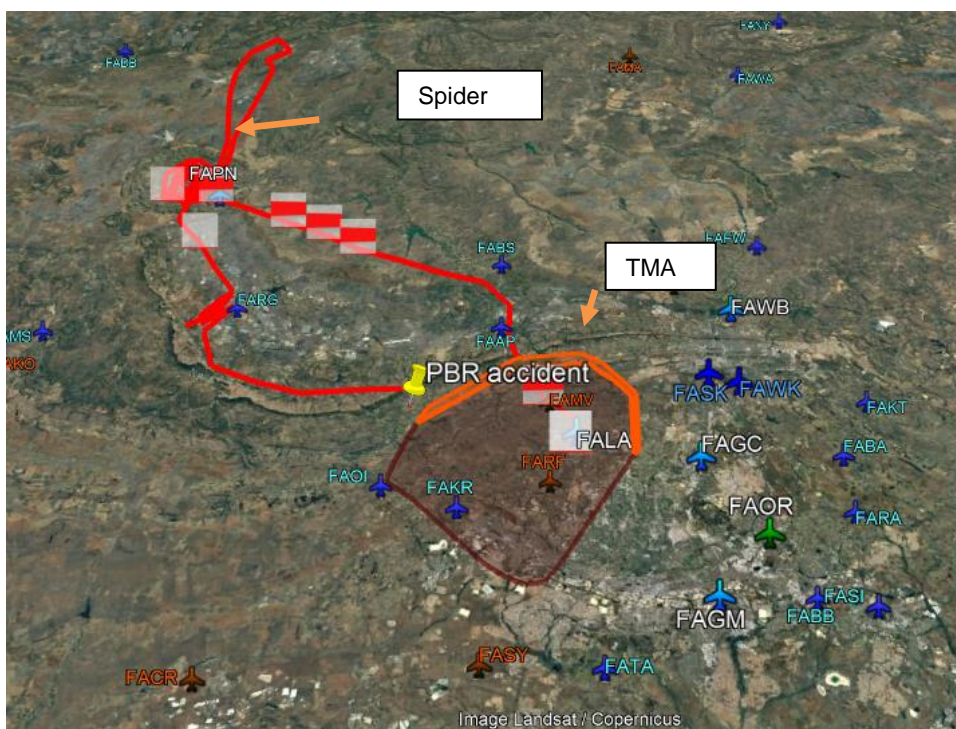
Figure 22: Spider track and TMA.

1.18.5 The Spider track (supplied by the operator) above represents the flight path of the aircraft. It was noted that the aircraft took off from FALA and routed to Pilanesberg airspace via Brits. The aircraft then went to Pilanesberg National Park and completed a race course pattern in that area. The aircraft was then noted flying towards Rustenburg area where it completed another race course pattern in the Tlhabane area before returning to FALA via the Magaliesberg mountain range ridge line. After crossing the ridge line at approximately 4nm, the track ended. It was noted that where the track ended the aircraft was still outside the terminal manoeuvring area (TMA), which is the controlled airspace for FALA. The area where the track ended was 17nm from FALA.
