AIRCRAFT ACCIDENT SHORT REPORT

CA18/2/3/9760: During an out landing, the glider collided with a perimeter fence, seriously injuring the pilot.

Date and time : 4 January 2019 at 1119Z
Aircraft registration : ZS-GXX
Aircraft manufacturer and model : Alexander Schleicher GmBh & Co, ASH 25 Glider
Last point of departure : New Tempe Aerodrome (FATP), Free State Province
Next point of intended landing : New Tempe Aerodrome (FATP), Free State Province
Location of accident site with reference to easily defined geographical points (GPS readings if possible) : S29°1'36" E026°9'34" elevation 4 500ft
Meteorological information : Surface wind: 330°/12kts; temperature: 31°C; visibility: good
Type of operation : Hire and fly (Part 94)
Persons on board : 1+1
Injuries : 1+1 (pilot - seriously injured; passenger - minor injuries)
Damage to the glider : Substantial

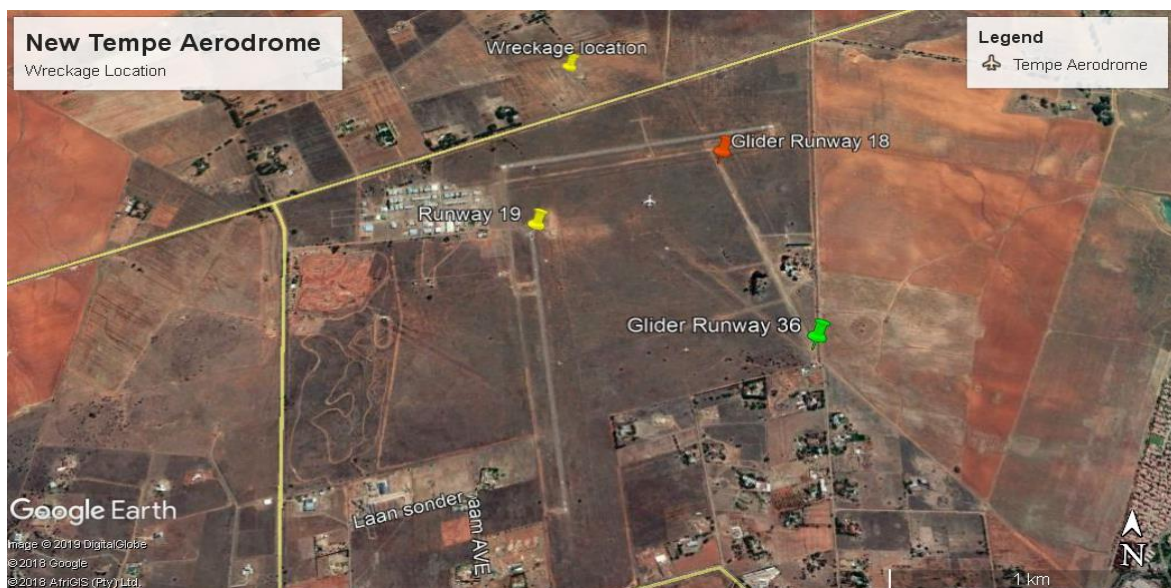
Figure 1: Google Earth overlay showing the wreckage location in relation to Runways 18 and 19

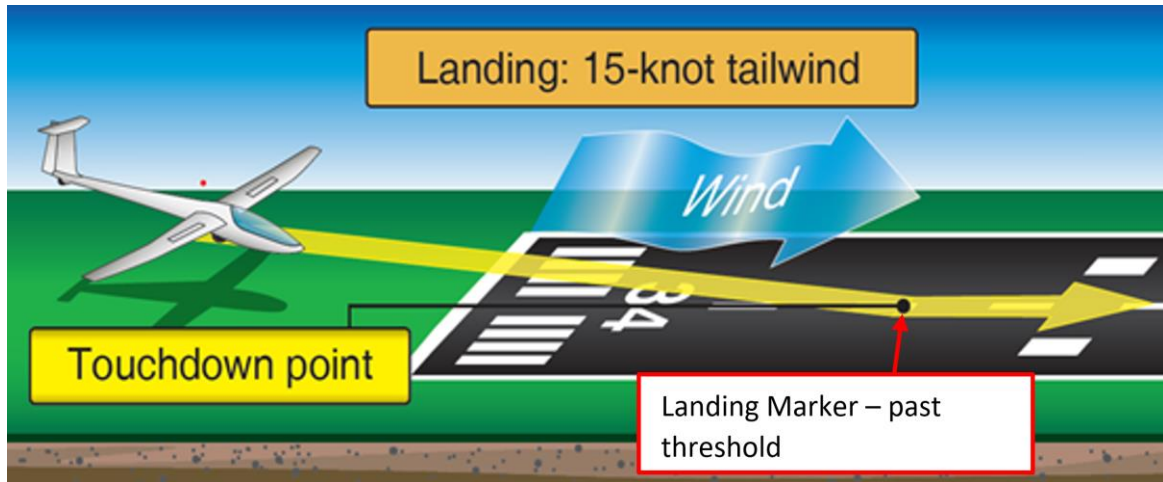
2.2.5. According to the Federal Aviation Administration Glider Flying Handbook 2013, a pilot landing with a tail wind has a higher groundspeed for an indicated airspeed. As the surface friction slows the winds, the pilot may see an increase in airspeed before the higher inertia-induced airspeed is dissipated. According to the Federal Aviation Administration (FAA) Glider Flying Handbook, the pilot should aim for a touchdown zone marker past the threshold and not for the start of the runway, because a tailwind can lead to major undershoots of the approach path and landing short if the winds are strong enough.

Figure 8: Illustration showing a typical landing marker with a tailwind
