## AIRCRAFT ACCIDENT SHORT REPORT

**CA18/2/3/9768:** ZU-INH: During a low-level aerial flight in the Kruger National Park the engine stopped, and the pilot executed a forced landing.

**Aircraft registration** : ZU-INH

**Aircraft manufacturer and model** : Aeroprakt Ltd, A22-LS

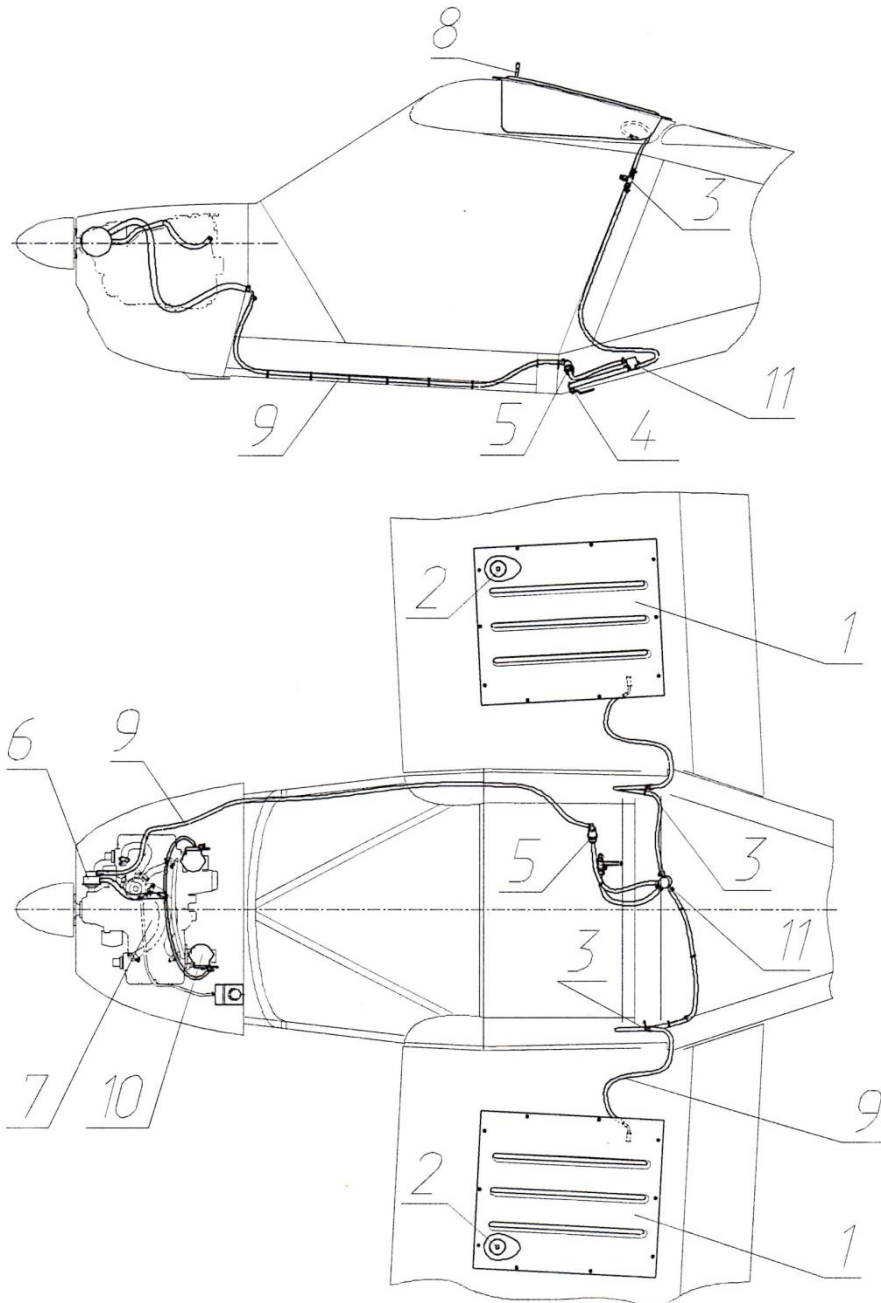
**Fig. 3. Fuel system schematic**

The airframe fuel system, specifically the plumbing, with regards to the fuel return line on this aircraft was found to differ from the guidance provided by the engine manufacturer as contained in the Rotax 912 Series Installation Manual, Edition 2. The fuel return line should feed back to the fuel tank suction side of the airframe fuel system, which was not the case.

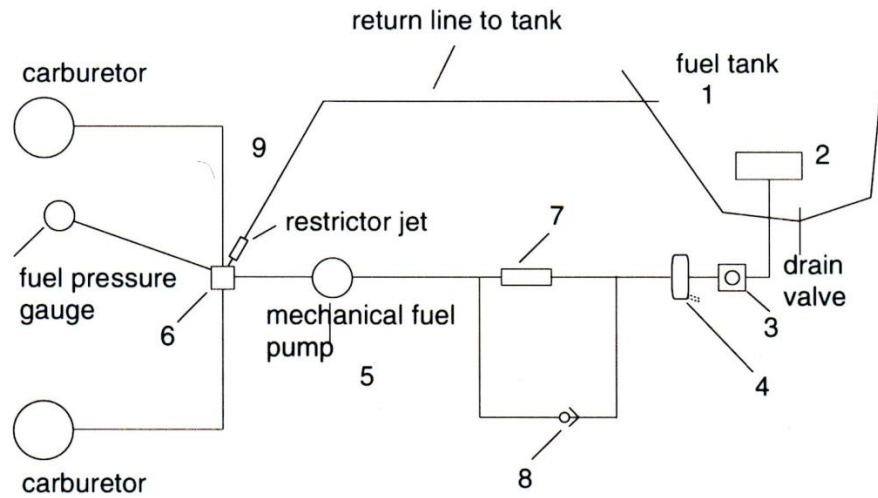
<b>General note</b>	See Fig. 2. NOTE: The fuel system from tank to the inlet of engine-driven fuel pump has to be installed by the aircraft manufacturer.
<b>Fuel</b>	The fuel flows from the tank (1) via a coarse filter and fire cock (3) continue to water trap/fine (4) to the mechanical fuel pump (5), from the pumps fuel passes on via the fuel manifold (6) to the two carburetors.
<b>Fuel lines</b>	Depending on the configuration of the engine the fuel lines from fuel pump to the carburetors are already installed by the manufacturer (optional on some engine). Only the following connections per Fig. 2 have to be established: <ul style="list-style-type: none"><li>- Feeding lines to suction side of the mechanical fuel pump (5).</li><li>- Lines from pressure side of the mechanical fuel pump to inlet of fuel manifold (6).</li><li>- Returnline from fuel pressure control to fuel tank.</li></ul>
<b>Return line</b>	Via the return line (5) surplus fuel flows back to the fuel tank and suction side of fuel system. NOTE: The return line prevents malfunctions caused by the formation of vapor lock.
