<b>AIRCRAFT ACCIDENT SHORT REPORT</b>
---------------------------------------

**CA18/2/3/9769**, Unsuccessful forced landing after an engine failure while turning crosswind for Runway 17 at Hoedspruit Aerodrome (FAHT).

<b>Date and time</b>	: 8 February 2019 at 0530Z
<b>Location</b>	: Zandspruit River, near Hoedspruit
<b>Aircraft registration</b>	: ZU-DOG
<b>Aircraft manufacturer and model</b>	: Micro Aviation New Zealand Ltd, Bantam B22J
<b>Last point of departure</b>	: Hoedspruit Aerodrome (FAHT)
<b>Next point of intended landing</b>	: Hoedspruit Aerodrome (FAHT)
<b>Location of accident site with reference to easily defined geographical points (GPS readings if possible)</b>	: Zandspruit River, 24°37'20.47" South 030°59'31.87" East
<b>Meteorological information</b>	: Surface wind: 170°/5kt, temperature: 25°C, CAVOK
<b>Type of operation</b>	: Training (Part 141)
<b>Persons on board</b>	: 1 + 1
<b>Injuries</b>	: None
<b>Damage to aircraft</b>	: Substantial

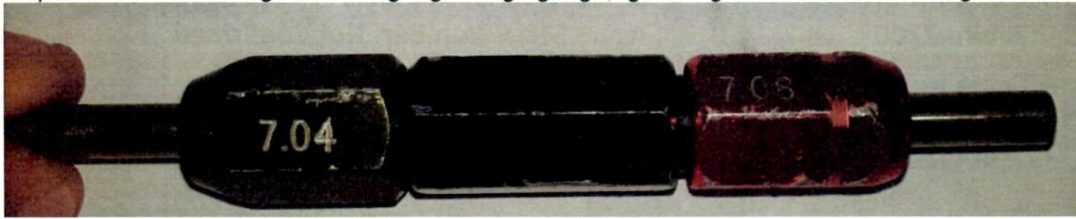
Inspection of the valve guides using a go-no-go gauge, go being 7.04mm and no being 7.08mm

Above picture of the Go-No-Go Gauge used to check valve guides.

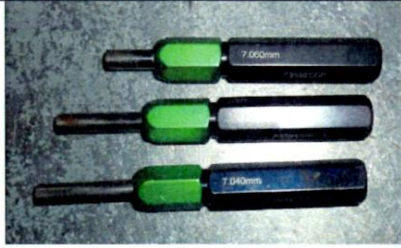
Figure 15 – Valve Guide Size Gauges

Go-Nogo gauges are used to quickly and accurately check the inner size of a valve guide. Sizes 7.03 / 7.04 / 7.05 / 7.06 / 7.07 / 7.08. Gauges produced by 'Prittie' ([www.prittie.com.au](http://www.prittie.com.au)) are used in the factory.
